# **LOUISIANA DEPARTMENT OF WILDLIFE & FISHERIES**

**WATERBODY MANAGEMENT PLAN SERIES**

**IVAN LAKE**

**LAKE HISTORY & MANAGEMENT ISSUES**

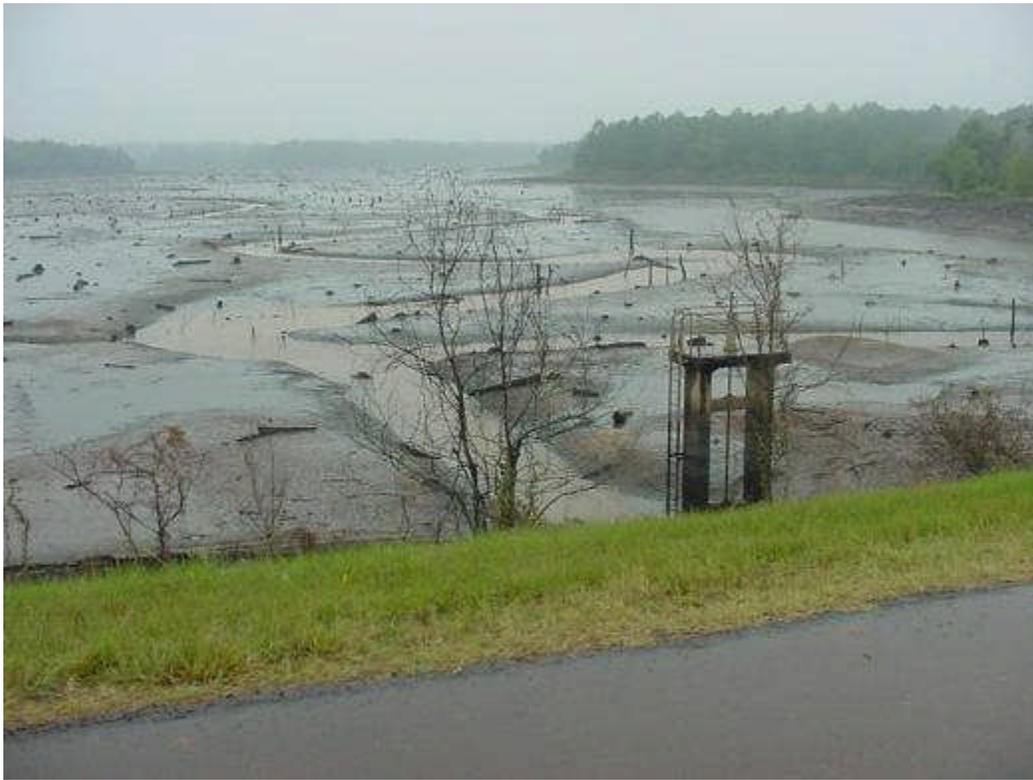
Figure 1. Ivan Lake following accidental complete dewatering in the fall of 2004. LDWF file photo.

Ivan Lake was completely dewatered by accident while undergoing a drawdown for hydrilla control in 2004 (Figure 1). The drawdown was to be the first of five consecutive fall-winter drawdowns for hydrilla control in accordance with the

Ivan Lake Aquatic Vegetation Management Plan prepared by LDWF. A fish kill followed this accidental dewatering, and an investigation showed a large number of sport fish died as a result of this event. Once it was discovered that the lake had been drained, DOTD was contacted, the gate closed, and the lake allowed to refill to the prescribed 6' drawdown level. Evaluations of the remaining fish population by LDWF personnel revealed an abundance of rough fish, with few sport fish remaining in the lake.

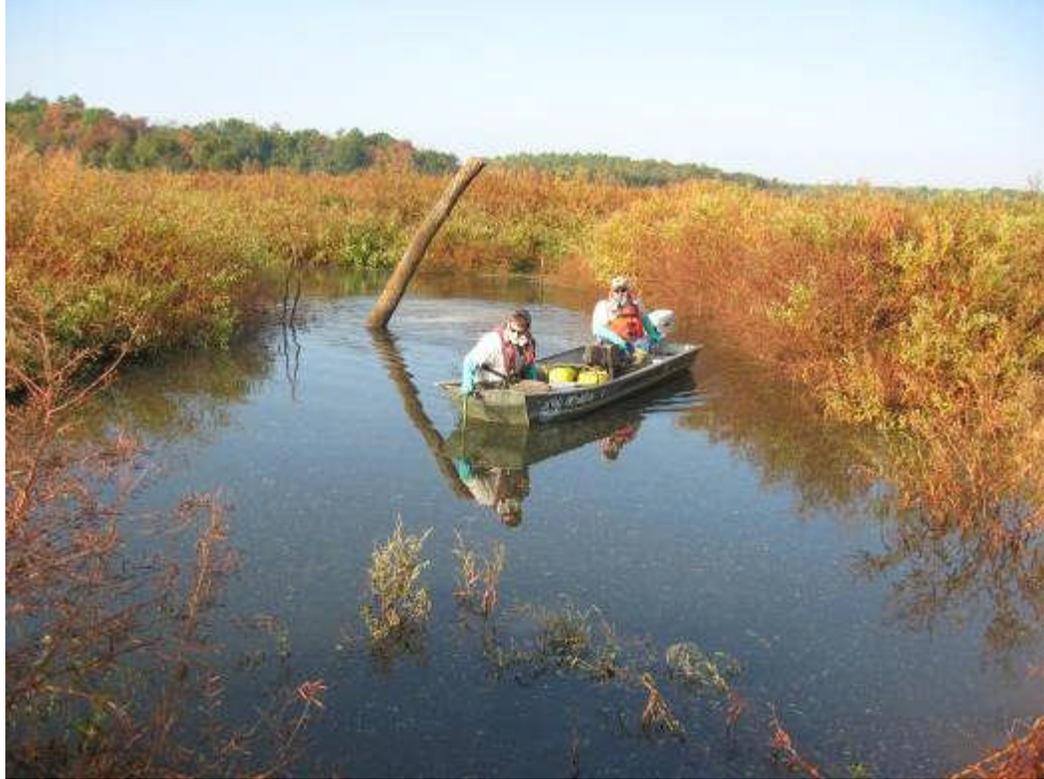
Figure 2. Application of liquid rotenone to water remaining in creek channel at maximum drawdown in an effort to eradicate the existing fish population prior to restocking following renovations to Ivan Lake. LDWF file photo taken October 12, 2010.

On October 12, 2010 an application of 5% liquid rotenone was made to the remaining pockets of water found within the lakebed (Figures 2 and 3). The application was made by LDWF personnel with assistance from local USACE personnel. This fish eradication effort was to remove any undesirable fish prior to future restocking efforts. Moribund fish observed following the treatment included spotted gar, bigmouth buffalo, largemouth bass, channel catfish, and gizzard shad. Several weeks after the treatment, 800 yards of 2" flag webbing was deployed in the creek and borrow pit, then checked periodically over the course of a month. One decomposed spotted gar was collected during this effort.

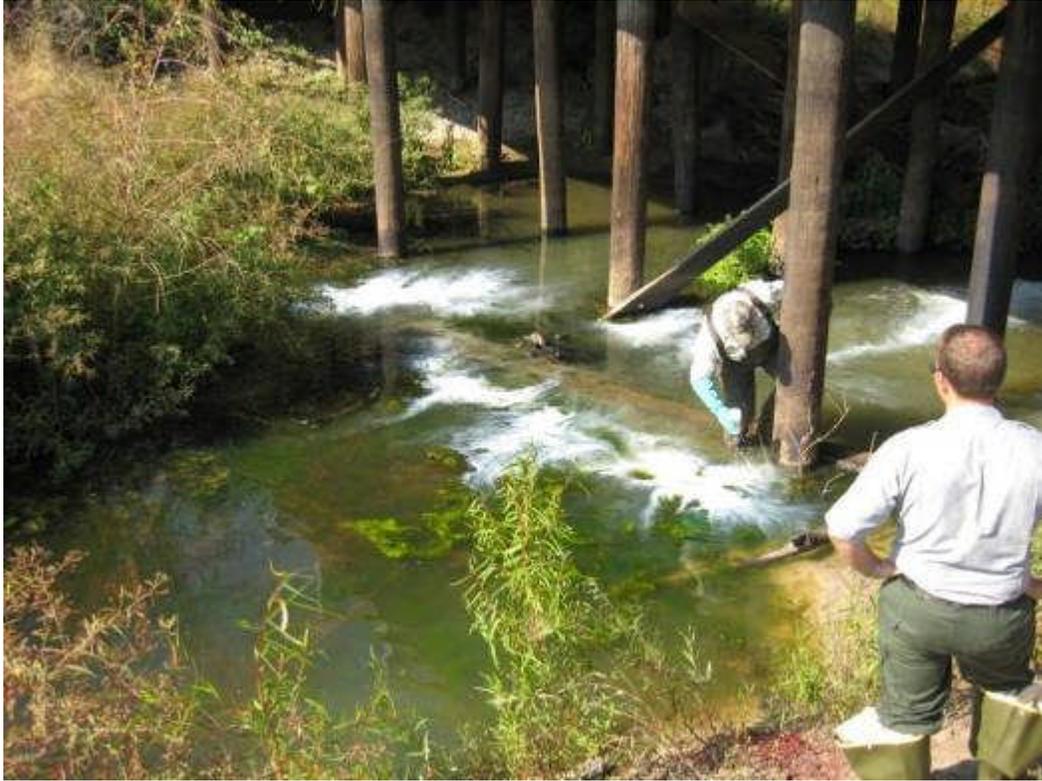
Figure 3. Liquid rotenone applied to creek channel and other areas not accessible by boat. LDWF file photo taken October 12, 2010.

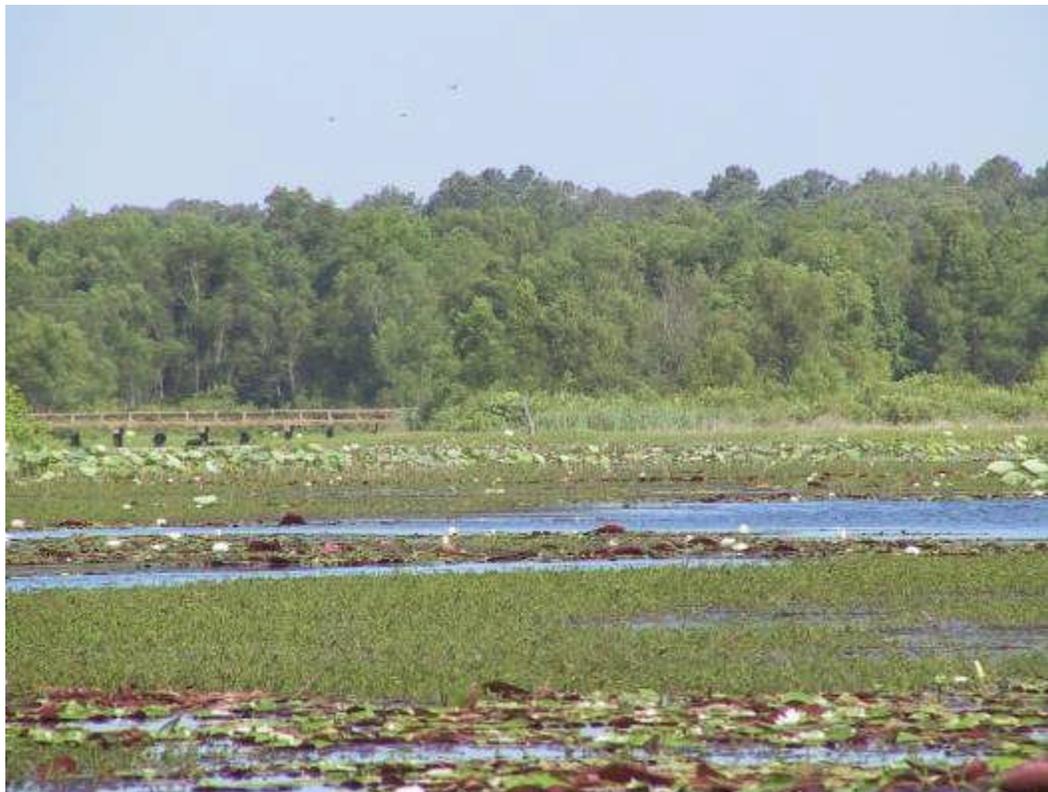
Figure 4. Aquatic vegetation is problematic in many areas of Ivan Lake due to the large expanses of shallow water. LDWF file photo.

Ivan Lake has extensive areas of shallow water that are susceptible to aquatic vegetation infestations (Figure 4). It is suspected that aquatic growth increased over time as the lake aged and the eutrophication process accelerated.

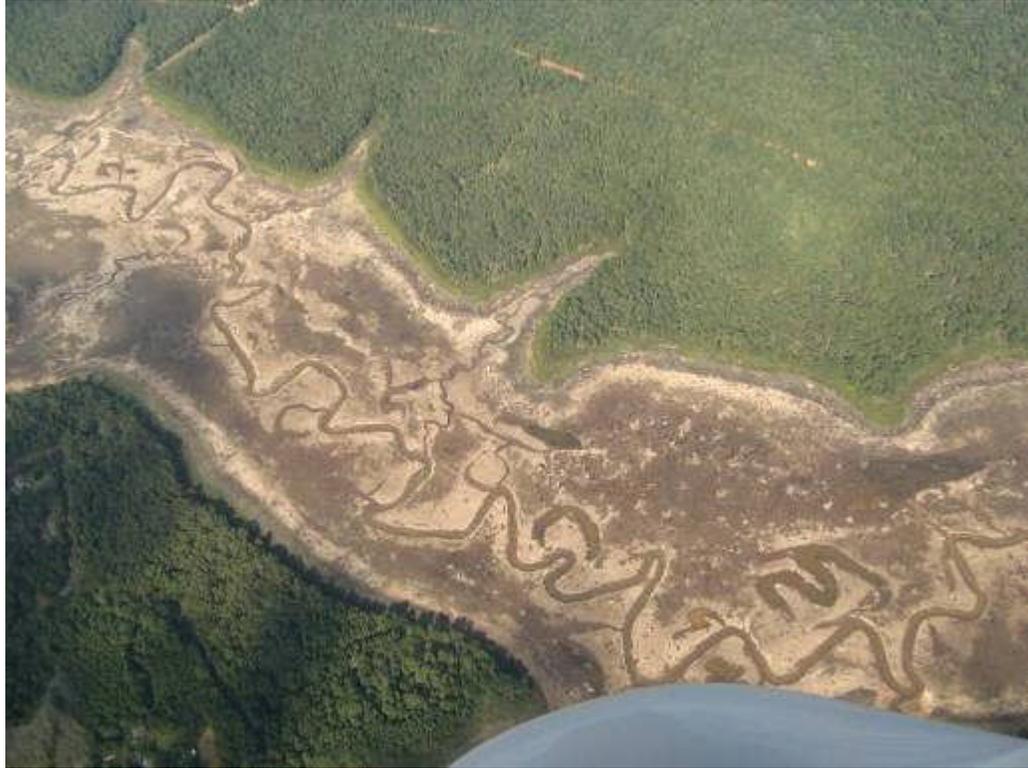
Figure 5. Aerial view of Ivan Lake following complete dewatering in preparation for lake renovations. LDWF file photo.

Hydrilla coverage was found to be greatly reduced during the 2005 vegetation survey. A determination was made to continue with the existing plan for hydrilla control and continue the drawdowns. Subsequently the lake has been dewatered much of the time since 2005 for various reasons pertaining to lake renovation (see Table 1, Drawdown History section). An aerial view of Ivan Lake during one of the drawdowns from 2005 until present is shown in Figure 5.

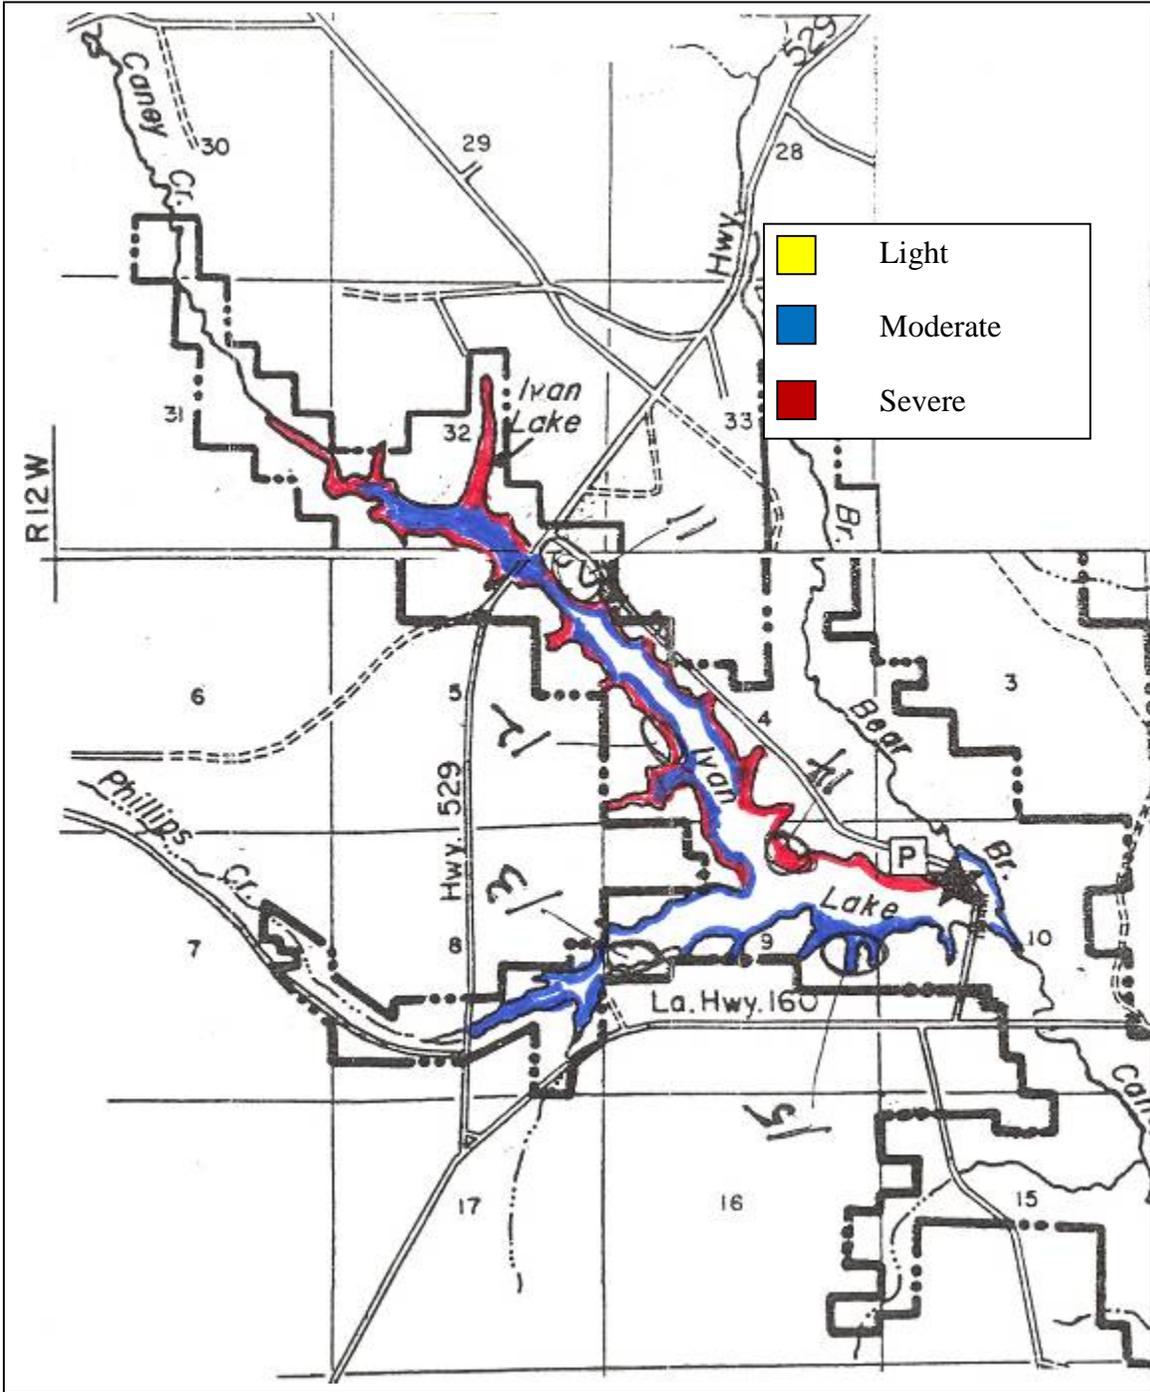
The severe infestation noted on the type map was hydrilla, whorled milfoil and coontail primarily.

The moderate infestation noted on the type map was hydrilla, milfoil, and coontail primarily.

The extreme upper end of each arms have a severe lotus and white water lily problem.

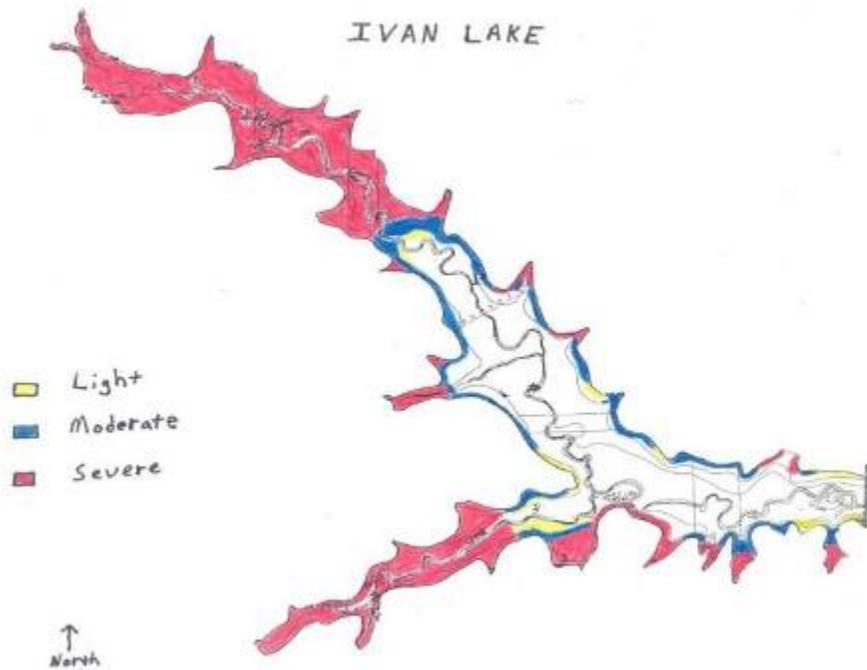
### VEGETATION TYPE MAP IVAN LAKE 2005

Ivan Lake is currently in the second year of a five year series of proposed Fall/Winter drawdowns for hydrilla control. The lake was slated to be drawn down 6' below pool stage in September of 2004; however, the lake was accidentally dewatered before the gates were closed and a large fish kill occurred. The lake quickly refilled with heavy

rains, and was only down for a few weeks. Little drying action was observed and the drawdown likely had little effect on the vegetation. During the 2005 drawdown, the lake has again been dewatered in order for Louisiana Department of Transportation and Development to assess the control structure, as it had been leaking. Drought conditions and extreme heat have likely aided the success of the drawdown. The organic layer on the lake bottom has dried and cracked and is decomposing. The vegetation has been exposed to dry conditions and several light frosts. The lake has remained down from late September until the time this document was completed (12/8/05). The lake is currently being assessed for possible renovation, and these future projects will likely affect the aquatic vegetation community of the lake.
