LOUISIANA DEPARTMENT OF WILDLIFE & FISHERIES

WATERBODY MANAGEMENT PLAN SERIES

IVAN LAKE

**WATERBODY EVALUATION &
RECOMMENDATIONS**

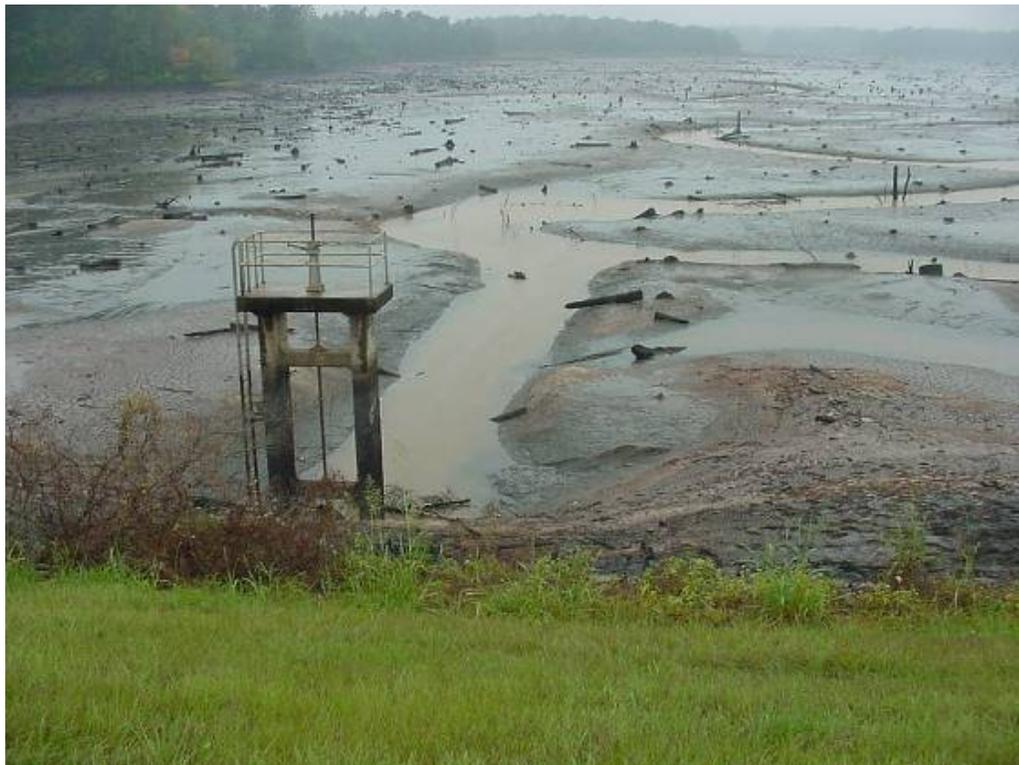
Figure 1. Ivan Lake, LA following accidental complete dewatering in the fall of 2004. View looking west along Ivan Creek from dam at the water control structure.

Ivan Lake was completely dewatered while undergoing a drawdown for hydrilla control in 2004 (Figure 1). A fish kill followed this accidental dewatering, and an investigation showed a large number of sport fish died as a result of this event. Subsequent sampling to evaluate the remaining fish population in the lake was conducted in 2004 and 2005, utilizing gill nets, electrofishing and seining. These samples indicated low abundances of all species in the reservoir. The gill net samples conducted in 2004 had predominately rough fish. Electrofishing samples in the spring of 2005 produced a total of 2.6 largemouth bass/hour and 1.3 black crappie/hour, as only two individual largemouth bass and one black crappie were collected during 45 minutes of sampling effort at three different stations on the lake. Seine sampling conducted in the summer of 2005 revealed some sport fish reproduction, but numbers were low.

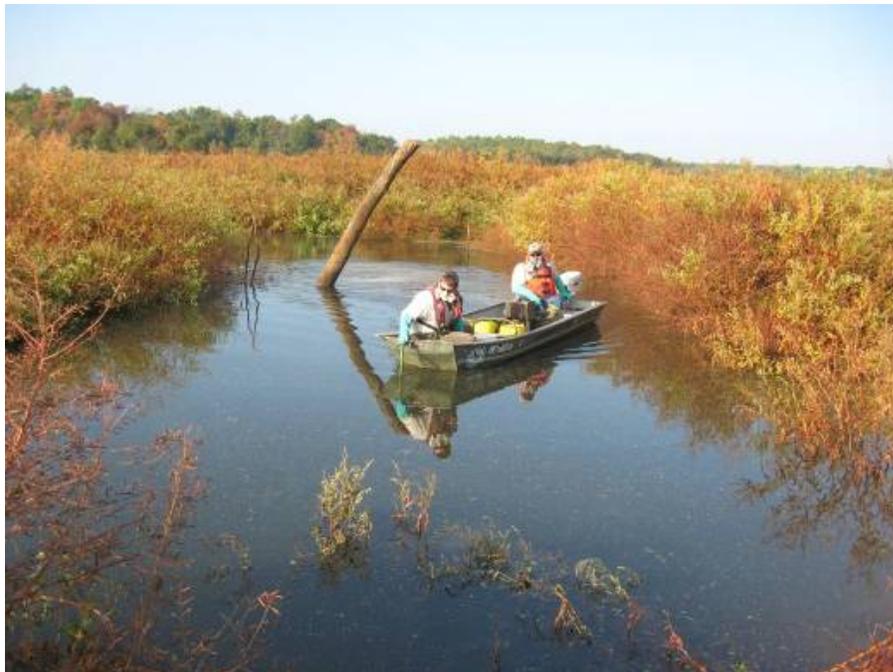
Figure 2. Application of liquid rotenone to water remaining in creek channel at maximum drawdown in an effort to eradicate the existing fish population prior to restocking following renovations to Ivan Lake, LA fall 2010.

On October 12, 2010 an application of 5% liquid rotenone was made to the remaining pockets of water found within the lake bed (Figure 2). The application was made by LDWF personnel with assistance from local USACE personnel (Figure 3). This fish eradication effort was to remove any undesirable fish prior to future restocking efforts. Moribund fish observed following the treatment included spotted gar, bigmouth buffalo, largemouth bass, channel catfish, and gizzard shad. Several weeks after the treatment, 800 yards of 2" flag webbing was deployed in the creek and borrow pit, then checked periodically over the course of a month. One decomposed spotted gar was collected during this effort. A follow up application of rotenone was conducted during the fall of 2011 in order to try and eradicate any fish which may be left in the creek and borrow pit since the previous effort. Fishes removed during this effort included young of the year crappie, fliers, largemouth bass and bullheads. Small crappies were the predominant species with several hundred being eliminated during this effort.

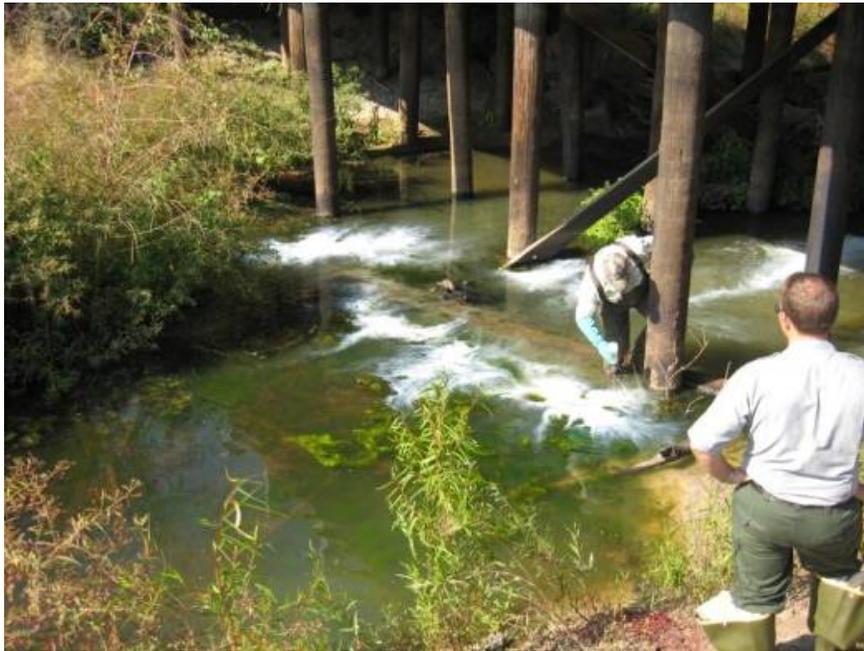
Figure 3. Liquid rotenone applied to creek channel and other areas not accessible by boat in order to remove existing fish population prior to refilling and restocking in Ivan Lake, LA, fall 2010.

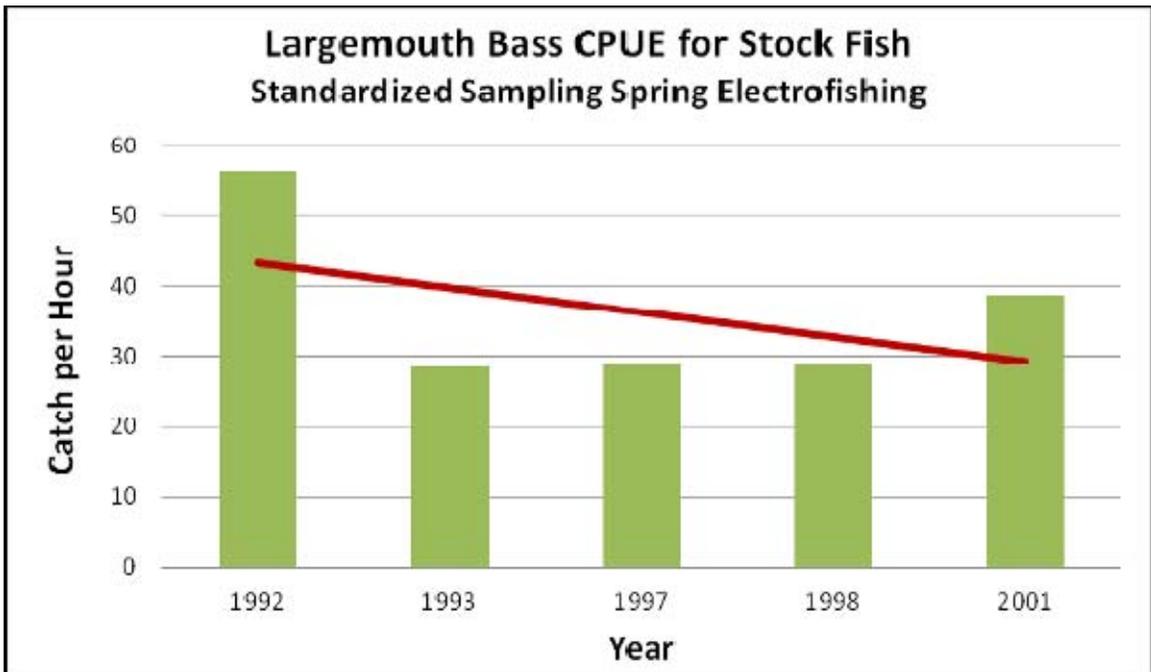
Figure 4. Spring electrofishing catch-per-unit-of-effort (CPUE) for stock-size (8" and up) largemouth bass on Ivan Lake, LA from 1992-2001. The trend line indicates a moderate decline in stock-size fish over this time period.

Electrofishing has been the primary sampling technique utilized on Ivan Lake. Results from electrofishing samples for stock-size largemouth bass from 1992 – 2001 are presented in Figure 4 below. The trend line from data collected during this time period indicates a moderate decline in stock-size fish in Ivan Lake.

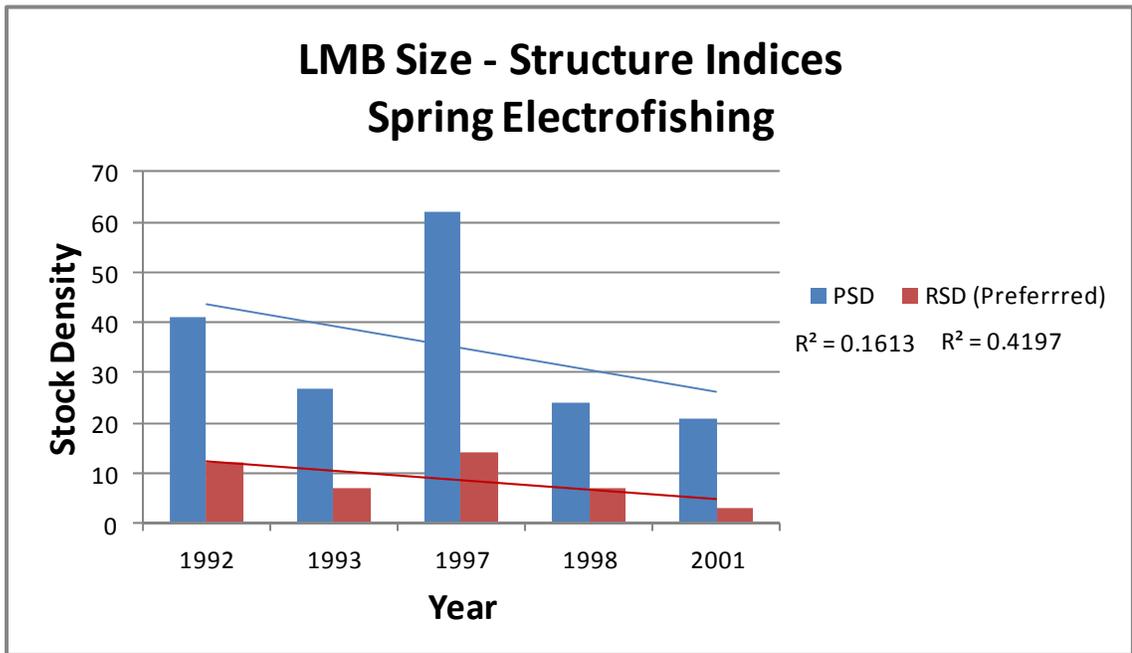
Figure 5. Largemouth bass size-structure indices on Ivan Lake, LA, from 1992 to 2001 for spring electrofishing samples. The trend lines indicate that there is a minor decrease in the proportion of stock-size and preferred-size fish over time ($R^2 < 0.60$).

Proportional stock density (PSD) and relative stock density (RSD) are indices used to numerically describe size distribution (length) data. Proportional stock density compares the number of fish of quality-size (greater than 12 inches for largemouth bass) to the number of bass of stock-size [greater than 8 inches in total length (TL)]. The PSD is expressed as a percentage. A fish population with a high PSD consists mainly of larger individuals, whereas a population with a low PSD consists mainly of smaller fish. Relative stock density compares the number of fish of a given size range to the number of bass of stock size. A common calculation used in fisheries management is for RSD-Preferred or RSD-P. This value compares the number of largemouth bass > 15 inches TL to the number of stock-size largemouth bass in the population. This is also commonly called RSD-15 values. Values for PSD and RSD – Preferred (> 15 inches in TL), are shown in Figure 5 below. Ideal PSD and RSD-P values for largemouth bass range from 40-70 and 10-40, respectively. There has been a decrease in the proportion of both stock-size and preferred-size fish in Ivan Lake from the period 1992 to 2001.

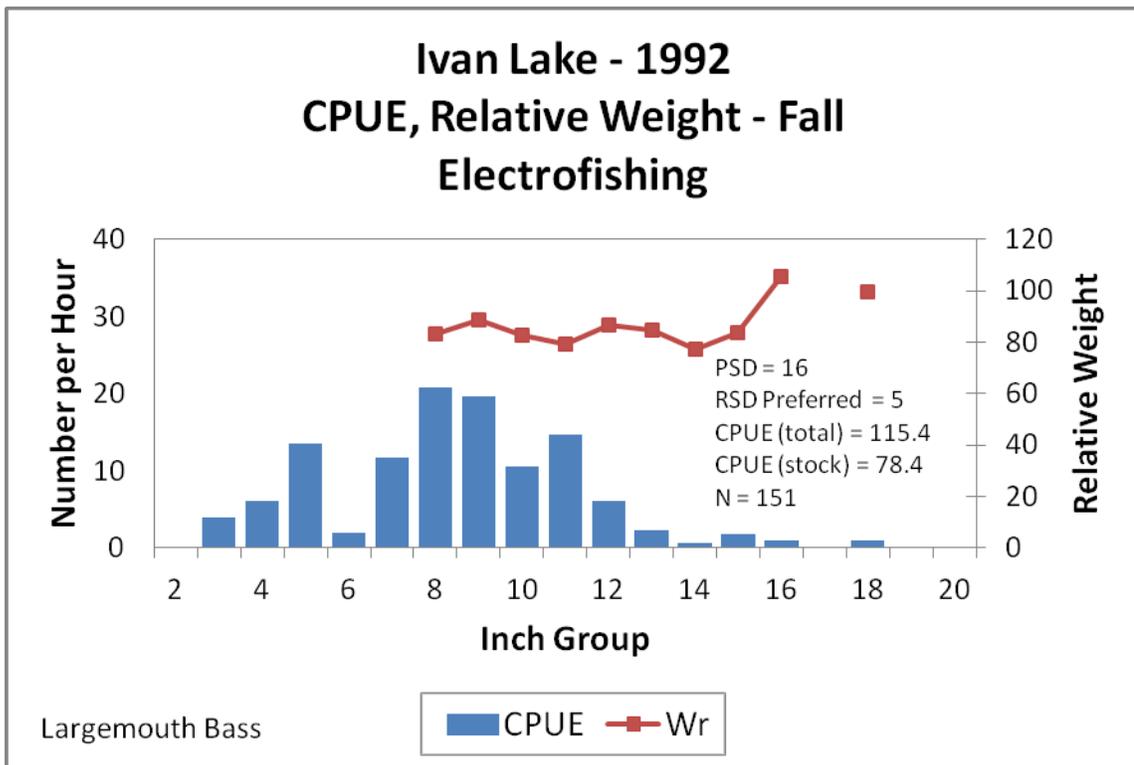
Figure 6. The CPUE, size distribution and relative weights for largemouth bass from fall 1992 electrofishing samples on Ivan Lake, LA. Relative weights indicate marginally adequate forage availability for the stock-size largemouth bass in the reservoir.

Figure 6 illustrates the CPUE and size distribution of largemouth bass for the fall 1992 electrofishing sample along with the W_r for stock-size fish collected during this sample. The relative weights indicate that forage availability was marginal for most size groups of fish during this time. Relative weights and CPUE for the 2001 fall electrofishing sample are shown in Figure 7. Relative weights for stock-size largemouth bass were slightly higher than the 1992 sample indicating sufficient forage was available at that time.

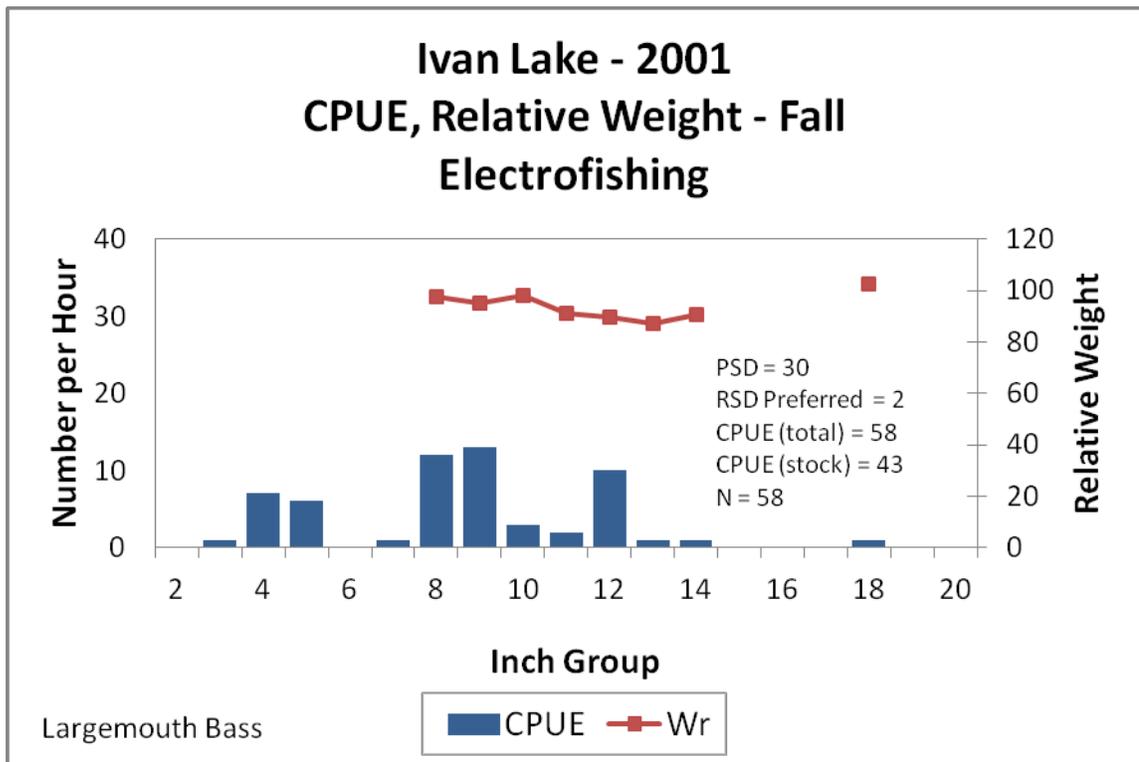
Figure 7. The CPUE, size distribution and relative weights of largemouth bass from fall 2001 electrofishing samples on Ivan Lake, LA. Relative weights indicate sufficient forage availability for the stock-size fish present in the lake at this time.

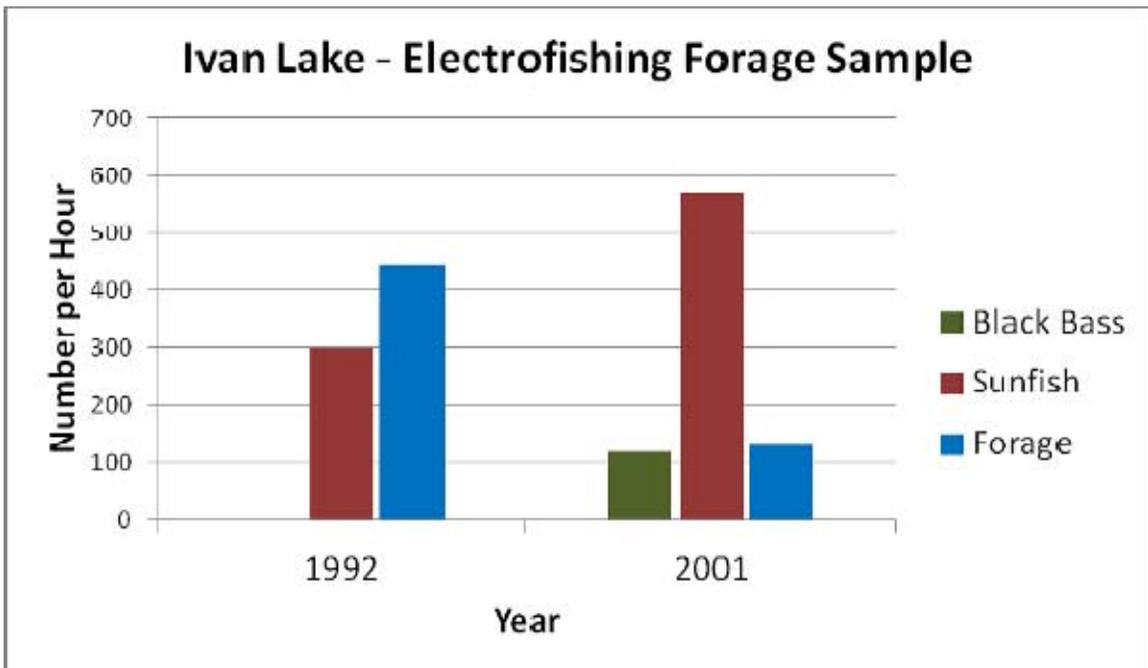
Figure 8. The CPUE in number per hour of fishes ≤ 5 inches TL from forage samples captured in Ivan Lake, LA in 1992 and 2001. Sunfishes (*Lepomis spp.*) and brook silversides comprised the majority of the species available as forage for the largemouth bass in the reservoir.

Forage samples were collected in conjunction with fall electrofishing samples in 1992 and 2001. Only fishes ≤ 5 inches TL are considered as forage for the purpose of evaluating the available forage in the reservoir. *Lepomis spp.* and fishes in the "Forage" category which consisted almost entirely of brook silversides, (*Labidesthes sicculus*) comprised the majority of the forage available in the lake by number (Figure 8). *Lepomis spp.* comprised the majority of the biomass collected in these samples with nearly 6 pounds of bream ≤ 5 inches TL captured in the fall 1992 forage sample and over 10 pounds collected in the 2001 sample (Figure 9).

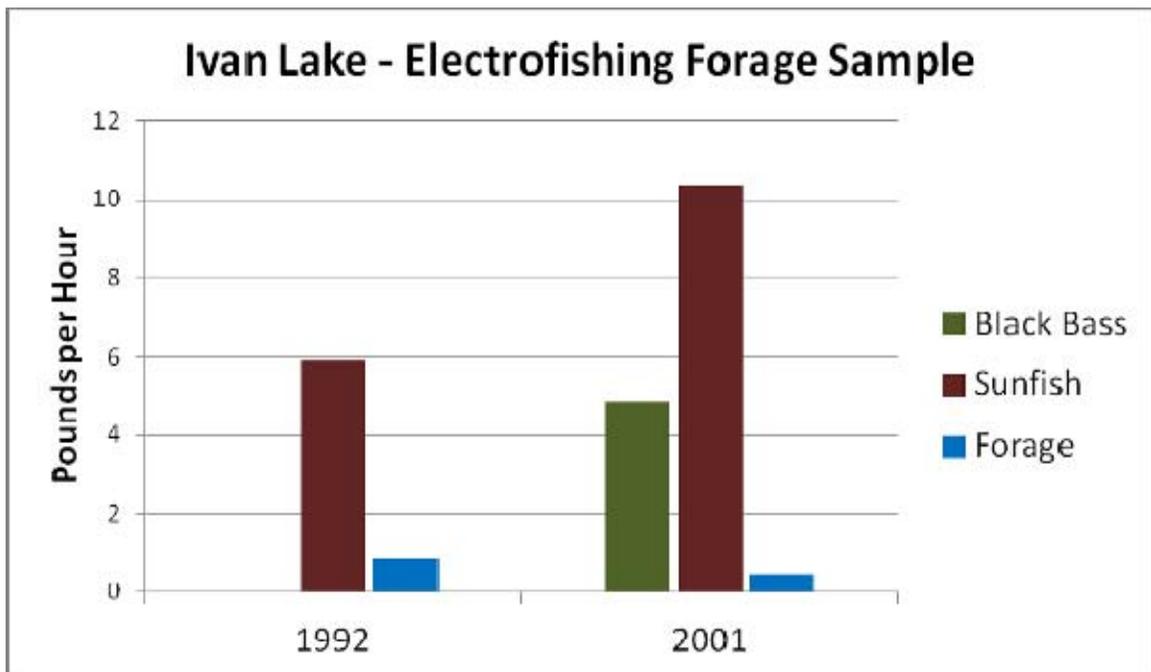
Figure 9. The catch in pounds per hour of fishes ≤ 5 inches TL from forage samples captured in Ivan Lake, LA in 1992 and 2001. Sunfish (*Lepomis spp.*) comprised the largest component by weight of the available forage in the lake. Fishes in the “Forage” category consisted primarily of brook silversides.

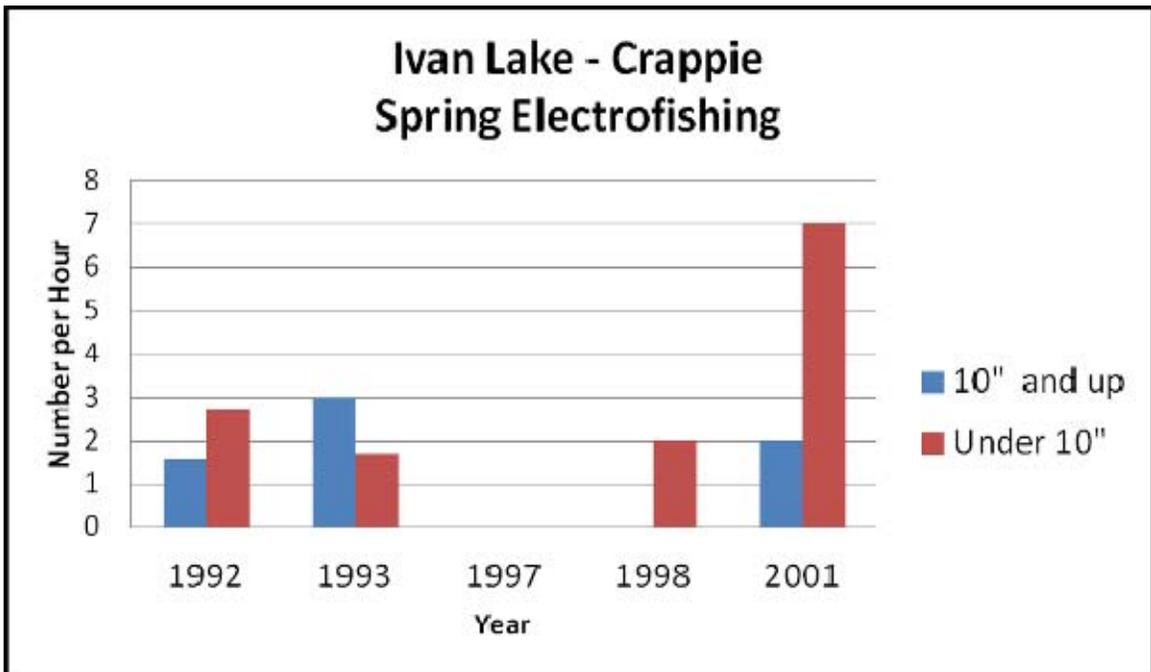
Figure 10. The CPUE of crappie captured during spring electrofishing samples from Ivan Lake, LA from 1992 to 2001. Overall numbers are low and no crappies were collected in the 1997 sample. Black crappie is the predominant species in the reservoir as only one white crappie was collected during the years sampled.

Few crappie were collected during spring electrofishing samples from 1992 – 2001 as depicted in Figure 10. The population consisted primarily of black crappie with only one white crappie collected in the 1998 sample. Anecdotal information from fishermen indicates that Ivan Lake once was a popular lake for crappie and supported a good population of these fish in the earlier years of the reservoir.

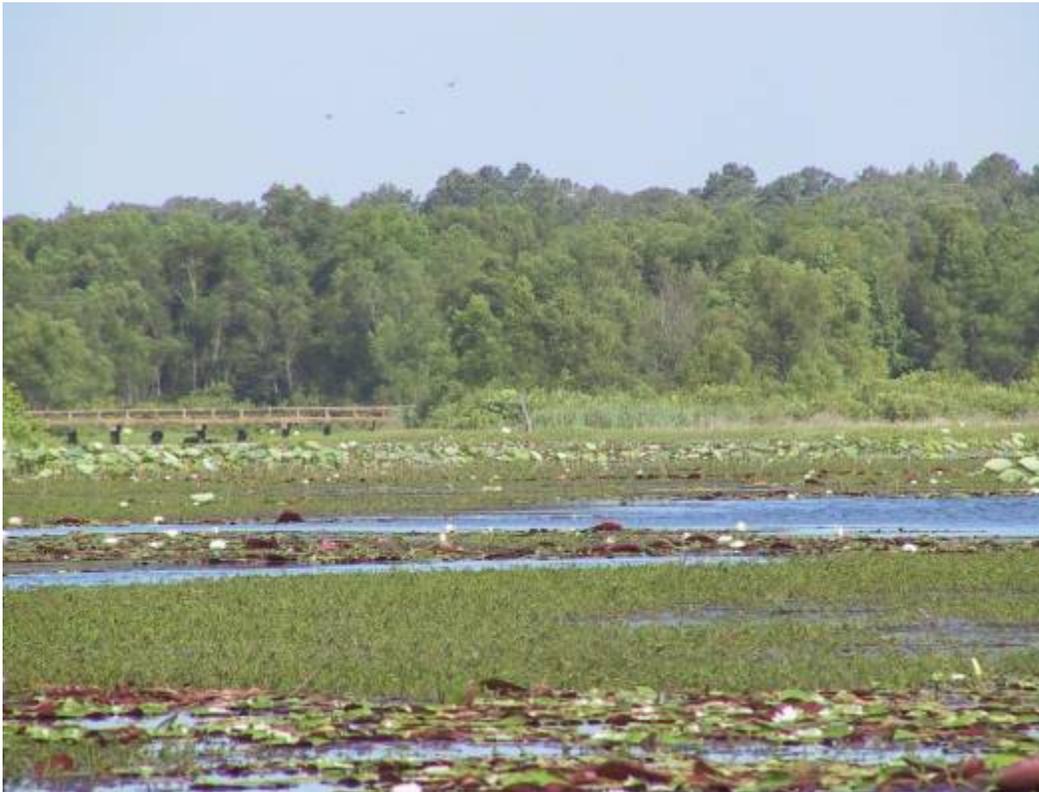
Figure 11. Aquatic vegetation is often problematic in many areas of Ivan Lake, LA due to the large expanses of shallow water. LDWF file photo - July 15, 2003.

An overabundance of aquatic vegetation is typical in this shallow water. Emergent species such as fragrant water lily (*Nymphaea odorata*), American Lotus (*Nelumbo lutea*) and alligator weed (*Alternanthera philoxeroides*) are typically present in severe to moderate infestations in this reservoir (Figure 11). Hydrilla (*Hydrilla verticillata*), variable leaf milfoil (*Myriophyllum heterophyllum*) and coontail (*Ceratophyllum demersum*) are the most troublesome submersed species in Ivan Lake and are often present in moderate to severe amounts in a fringe around the lake out to the six foot contour. The area of the lake approaching the Highway 529 Bridge is most severely impacted by aquatic vegetation with boating access often restricted to the creek channel. Bladderwort (*Utricularia spp.*), water-shield (*Brasenia schreberi*), water primrose (*Ludwigia octovalvis*), and fanwort (*Cabomba caroliniana*) are also often present in problematic levels throughout the lake. The shoreline is typically lined by lizard's tail (*Saururus cernuus*), giant cutgrass (*Zizaniopsis miliacea*), cattail (*Typha spp.*) and smartweed (*Polygonum spp.*).

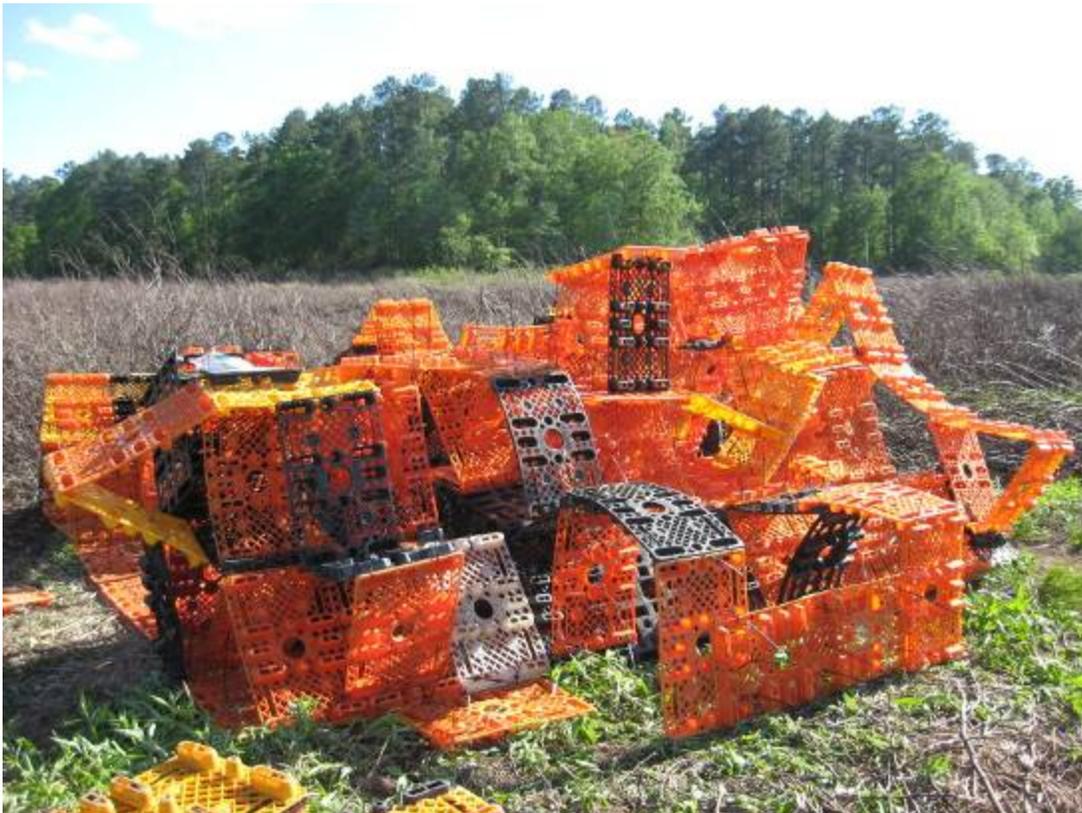
Figure 12. Artificial fish attractor constructed of plastic feed pallets in Ivan Lake, LA. Photo taken in 2011 – LDWF file.

The complex cover in Ivan Lake consists primarily of stumps and aquatic vegetation. In an effort to attract fish to areas more accessible to anglers, artificial cover has been added to the lake. Submerged pallet tree type structures and large structures of plastic feed pallets such as the one depicted in Figure 12 were placed in the lake bottom in the summer of 2011. These artificial fish habitats were constructed to provide complex cover and contain a large number of interstitial spaces to attract fish to a specific area.

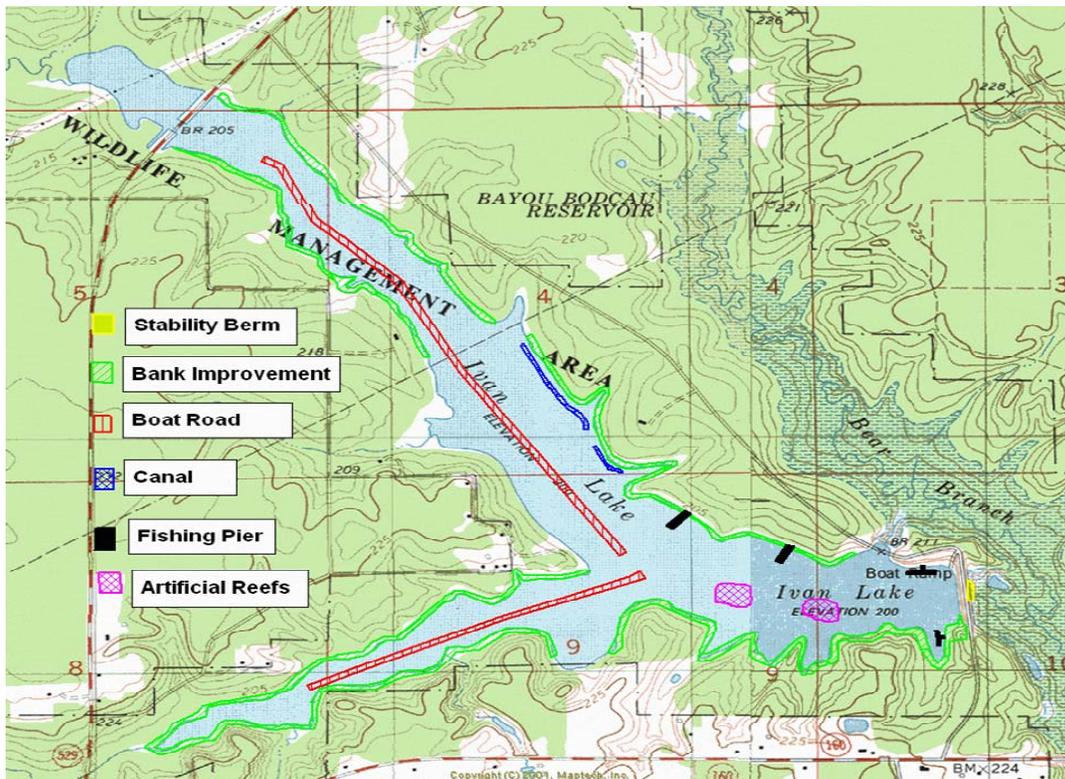
Figure I-A. Proposed improvements to fisheries habitat and for fishing access on Ivan Lake, LA.

- 4) Boat Lane Construction—each of the two arms of the lake extending westward contain dense stump fields which impede safe boat travel. The attached map (Figure I-A) shows an approximate boat road which will be created by a dozer. The removed stumps will be pushed to the side and heaped into piles for fish attraction. The boat lane boundaries will be marked with buoys in order to promote safe boating operation. Again, this will be completed within a cooperative endeavor between LDWF and local USACE personnel.

- 5) Artificial Reefs—artificial reefs will be constructed and placed by LDWF personnel into suitable deep water locations. These locations will be marked with buoys in order to promote use by anglers. The attached map shows possible reef locations (Figure I-A).

- 6) Fishing Piers—LDWF will contract construction of several handicapped accessible fishing piers. The piers will be placed near borrow ditches for winter fishing opportunities and near creek bed channels/improved banks for spring & summer fishing. Piers may be enhanced with automatic fish feeders. The map in Figure I-A shows probable locations.

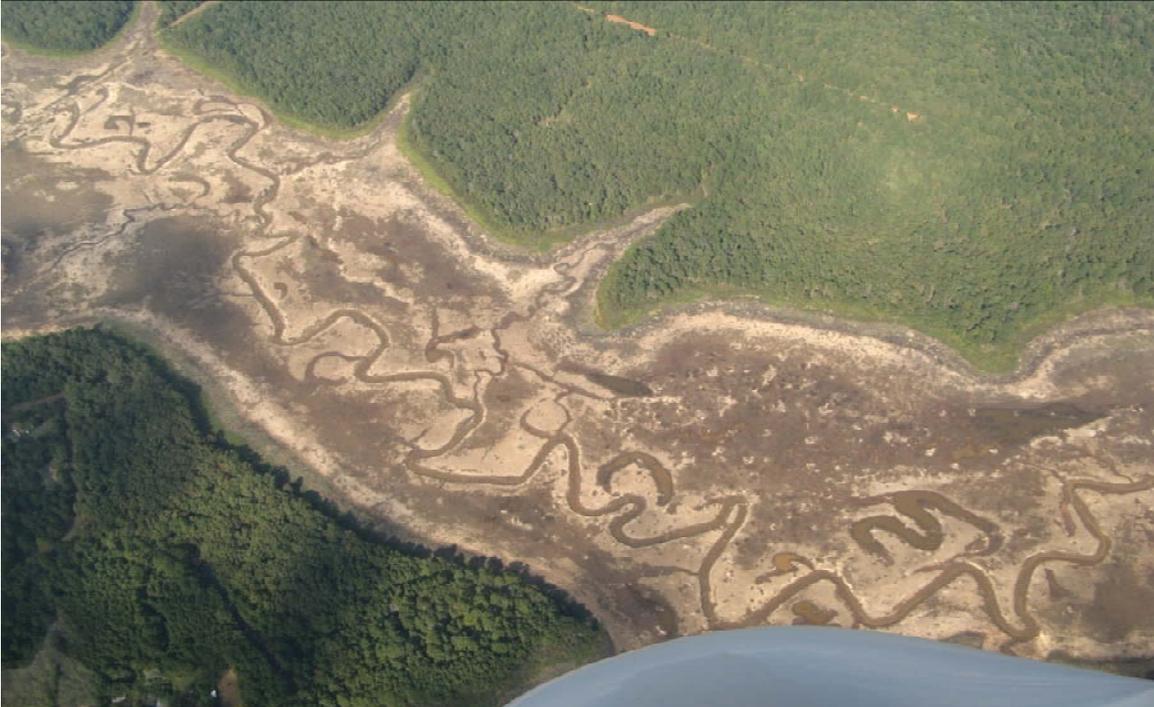
Rotenone & flag net existing population in creek bed & bar pits.

Figure I-B. Areas on the bed of Ivan Lake, LA, which retain water during maximum drawdown and will require an application of rotenone to remove existing fish populations prior to restocking efforts. LDWF file photo.

- 9) Rotenone Applications—LDWF employees will rotenone and flag net the small creek channel and borrow ditches that have held water in order to remove any remaining fish populations. The attached aerial photograph (Figure I-B) shows the extent of residual channel in need of rotenone application.

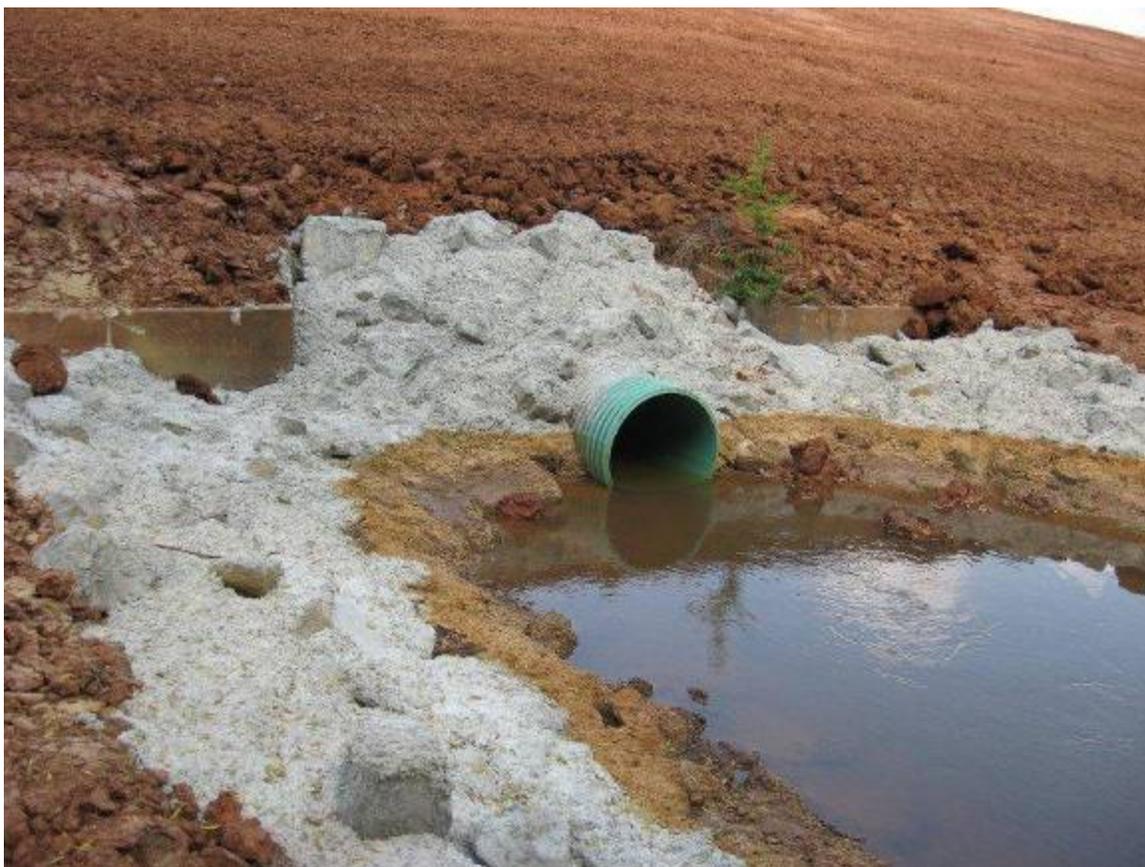
Figure II-A. Outflow pipe for Ivan Lake, LA, following replacement by the Bossier Parish Police Jury. Photo taken in the spring 2012.

The outflow pipe depicted in Figure II-A was replaced by the Bossier Parish Police Jury. Following this work the support berm described in item 1 of the renovation plan was completed.

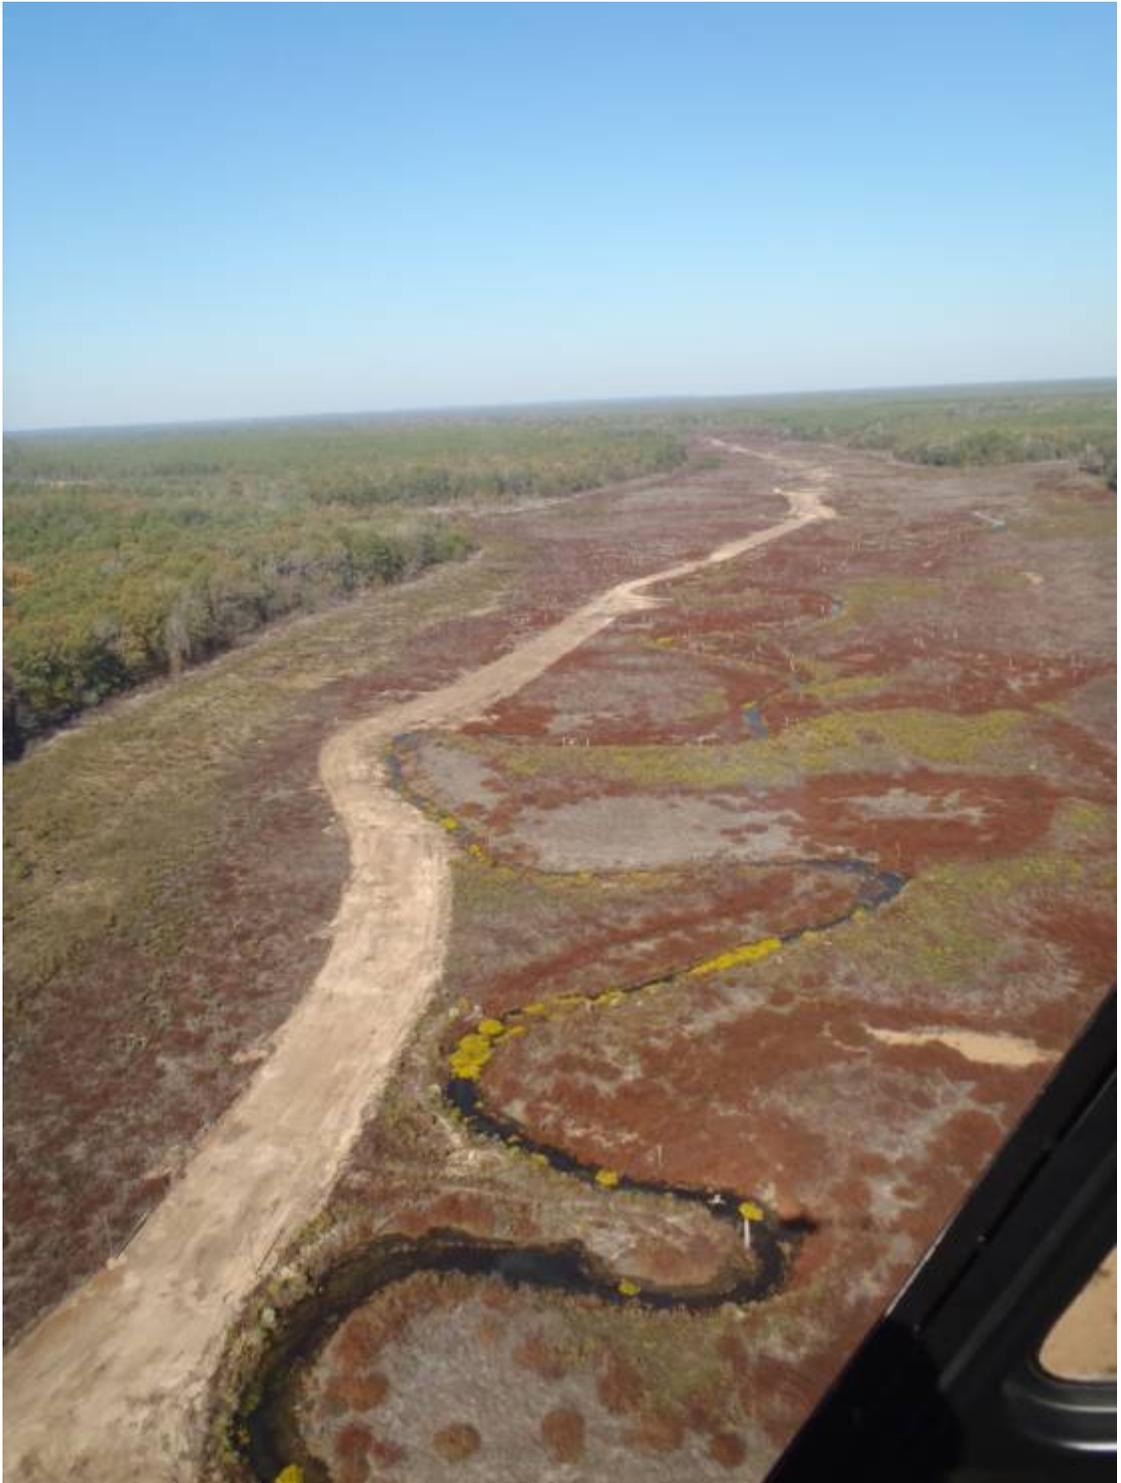
Figure II-B. Aerial photo of the newly created boat lane in Ivan Lake, LA. Stumps and obstructions were cleared by a bulldozer and the edges marked with pilings. Photo taken in fall 2011.

The boat lane described in item 4 of the renovation plan has been completed. The boat lane was created by a bulldozer and is easily visible in the aerial photograph in Figure II-B. This boat lane is well marked with navigational day marks mounted on pilings in accordance with the U. S. Aids to Navigation System (ATON).as shown in Figures II-C and II-D

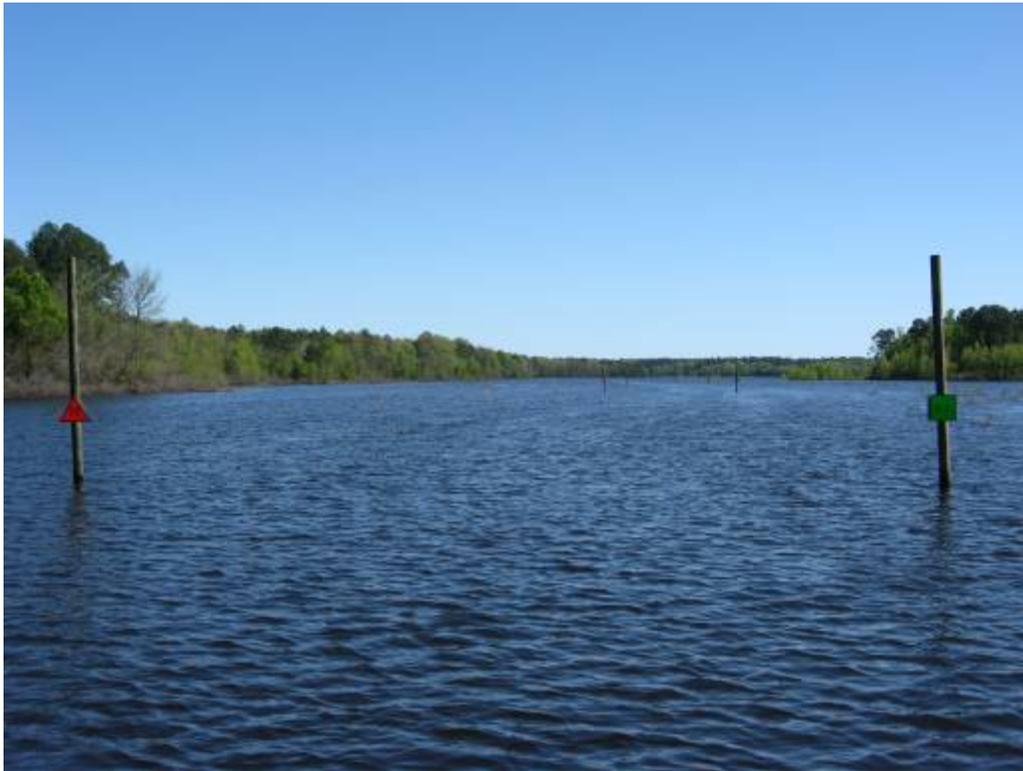
Figure II-C. Edges of the boat lane in Ivan Lake, LA were marked with day marks in accordance with the U.S. Aids to Navigation System (ATON). Photo taken in spring 2012.

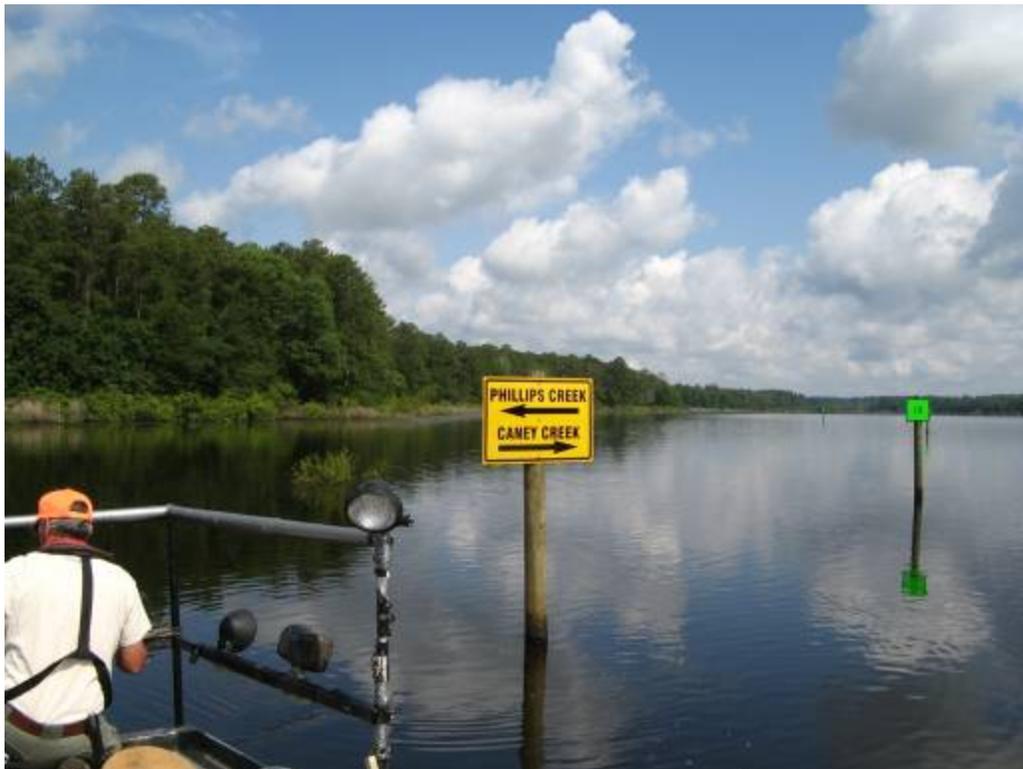
Figure II-D. Boat lane markers on Ivan Lake, LA, at the intersection of Phillips and Caney Creeks. Photo taken in spring 2012.
