# **LOUISIANA DEPARTMENT OF WILDLIFE & FISHERIES**

**WATERBODY MANAGEMENT PLAN SERIES**

**IVAN LAKE**

**WATERBODY EVALUATION &  
RECOMMENDATIONS**

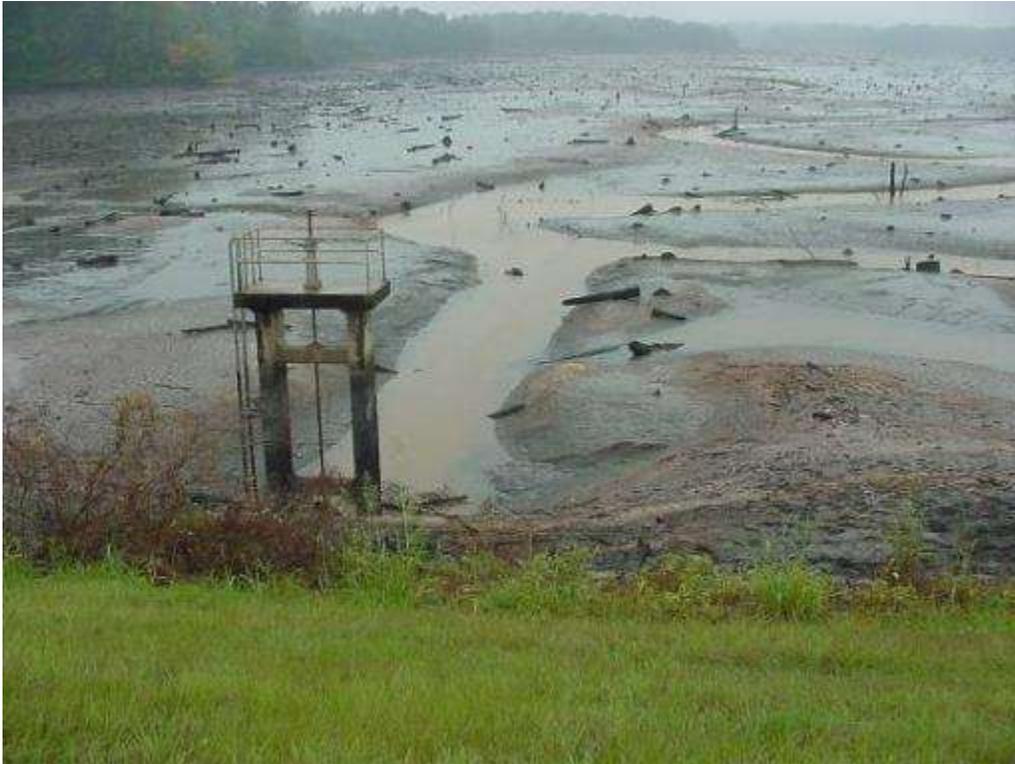
Figure 1. Ivan Lake, LA following accidental complete dewatering in the fall of 2004. View looking west along Caney Creek from dam at the water control structure.

Ivan Lake was completely dewatered while undergoing a drawdown for hydrilla control in 2004 (Figure 1). A fish kill followed this accidental dewatering, and an investigation showed a large number of sport fish died as a result of this event. Subsequent sampling to evaluate the remaining fish population in the lake was conducted in 2004 and 2005, utilizing gill nets, electrofishing and seining. These samples indicated low abundance of all fish species. Gill

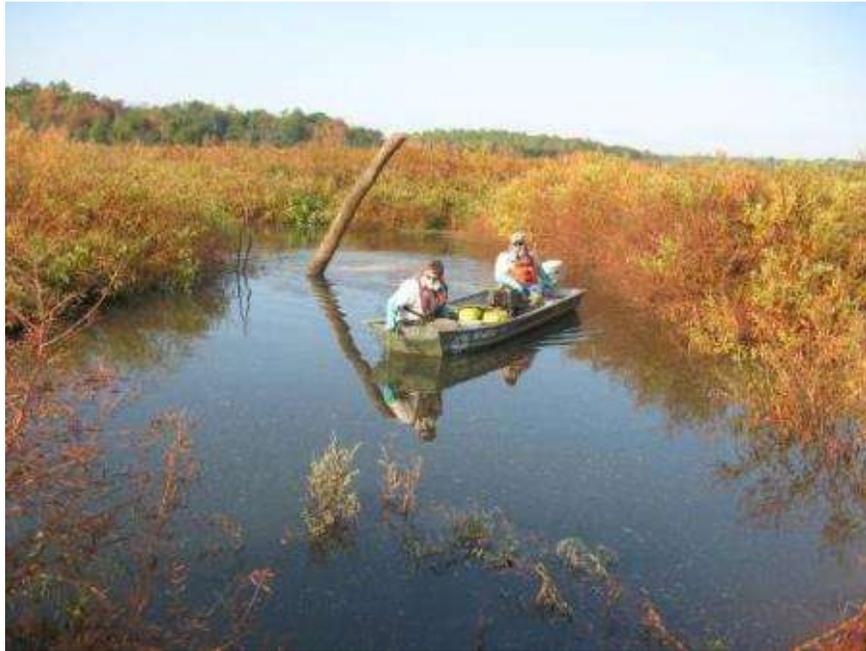
Figure 2. Application of liquid rotenone to Ivan Lake, LA fall 2010.

On October 12, 2010 an application of 5% liquid rotenone was made to the remaining pockets of water found within the lake bed (Figure 2). The application was made by LDWF personnel with assistance from local USACE personnel (Figure 3). This fish eradication effort was conducted to remove all fish prior to future restocking efforts. Dead fish observed following the treatment included spotted gar, bigmouth buffalo, largemouth bass, channel catfish, and gizzard shad. Several weeks after the treatment, 2" flag webbing was deployed in the creek and borrow pit. One decomposed spotted gar was observed in net, subsequent to the rotenone application. A follow up application of rotenone was conducted during the fall of 2011. Fishes removed during this effort included young of the year crappie, fliers,

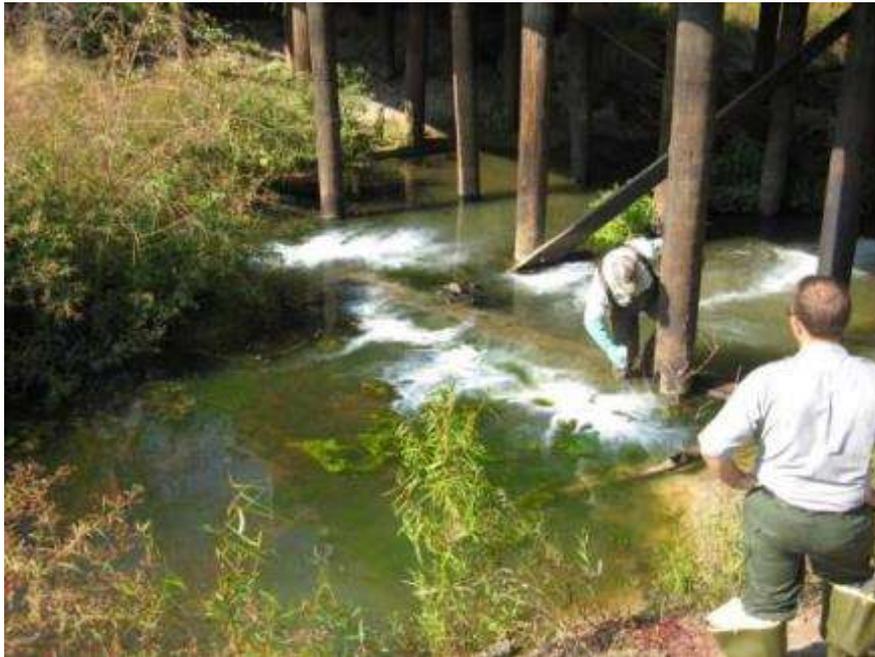
Figure 3. Liquid rotenone applied to areas not accessible by boat in Ivan Lake, LA, fall 2010.

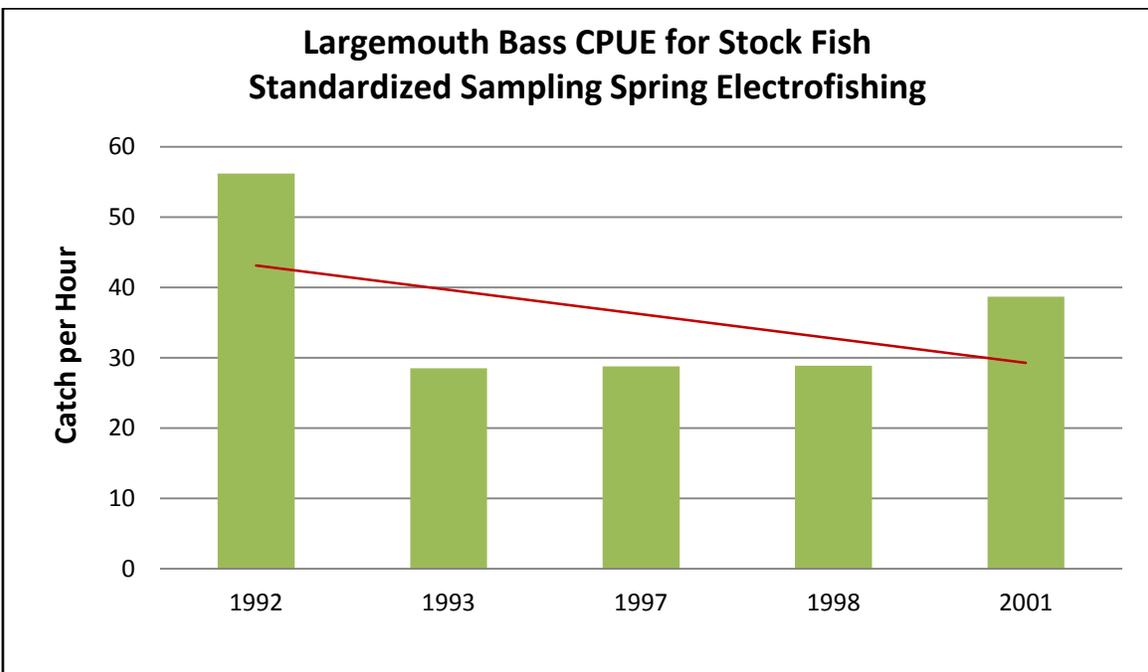
Figure 4. Spring electrofishing catch-per-unit-of-effort (CPUE) for stock-size (8" and up) largemouth bass on Ivan Lake, LA from 1992-2001. The trend line indicates a moderate decline in stock-size fish over this time period.

Electrofishing has been the primary sampling technique utilized on Ivan Lake. Results from electrofishing samples for stock-size largemouth bass from 1992 – 2001 are presented in Figure 4 below. The trend line from data collected during this time period indicates a moderate decline in stock-size fish in Ivan Lake.

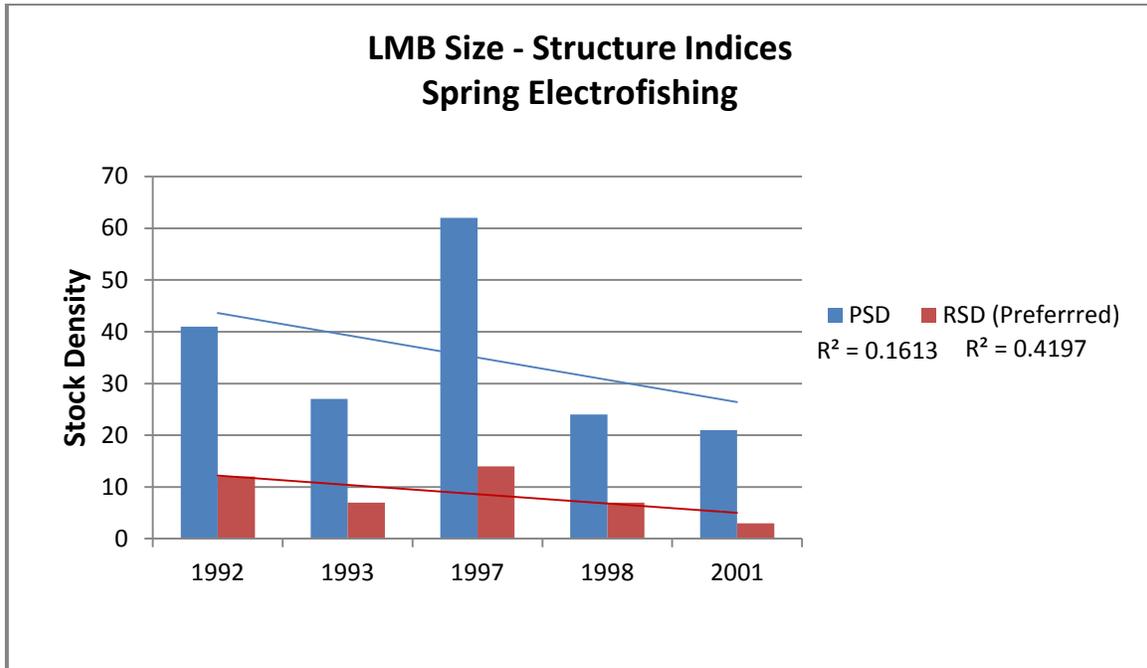
Figure 5. Largemouth bass size-structure indices on Ivan Lake, LA, from 1992 to 2001 for spring electrofishing samples. The trend lines indicate that there is a minor decrease in the proportion of stock-size and preferred-size fish over time ( $R^2 < 0.60$ ).

common calculation used in fisheries management is for RSD-Preferred or RSD-P. This value compares the number of largemouth bass > 15 inches TL to the number of stock-size largemouth bass in the population. This ratio is also commonly referred to as RSD-15 values. Values for PSD and RSD – Preferred (> 15 inches in TL), are shown in Figure 5 below. Healthy PSD and RSD-P values for largemouth bass range from 40-70 and 10-40, respectively. There was a decrease in the proportion of both stock-size and preferred-size fish in Ivan Lake from the period 1992 to 2001.

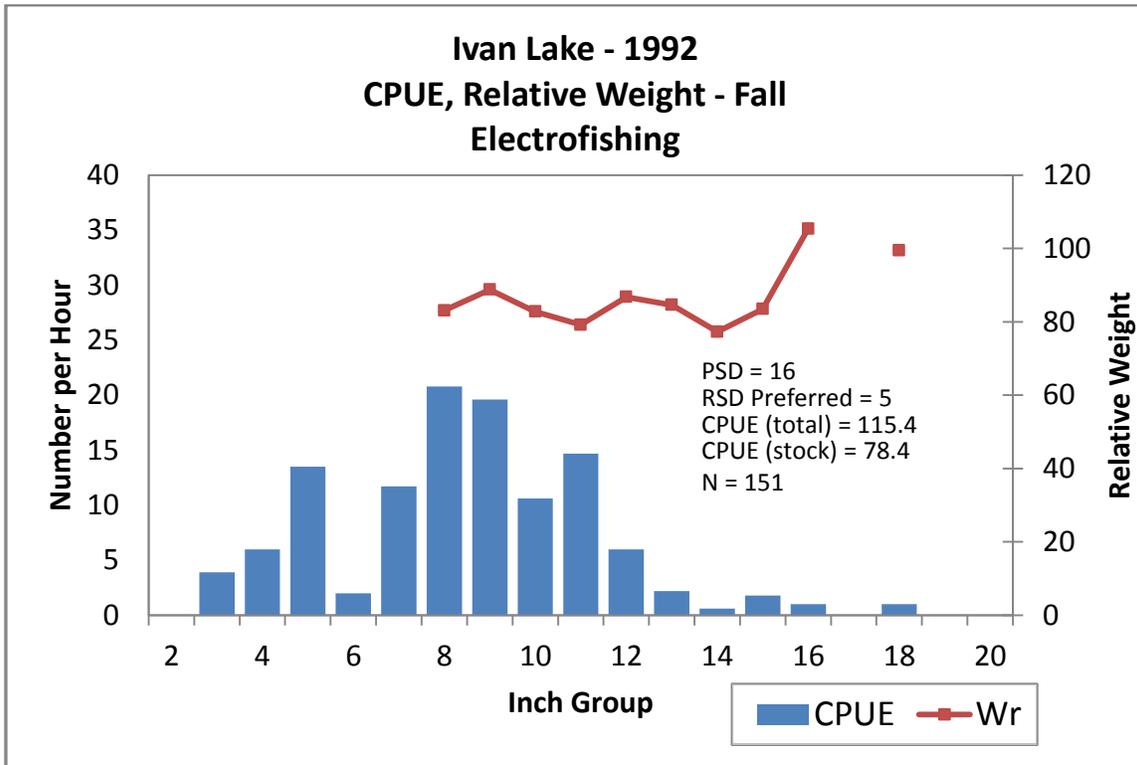
Figure 6. The CPUE, size distribution and relative weights for largemouth bass from fall 1992 electrofishing samples on Ivan Lake, LA. Relative weights indicate marginally adequate forage availability for the stock-size largemouth bass in the reservoir.

Figure 6 illustrates the CPUE and size distribution of largemouth bass for the fall 1992 electrofishing sample along with the  $W_r$  for stock-size fish collected during this sample. The relative weights indicate that forage availability was marginal for most size groups of fish during this time. Relative weights and CPUE for the 2001 fall electrofishing sample are shown in Figure 7. Relative weights for stock-size largemouth bass were slightly higher than the 1992 sample indicating sufficient forage was available at that time.

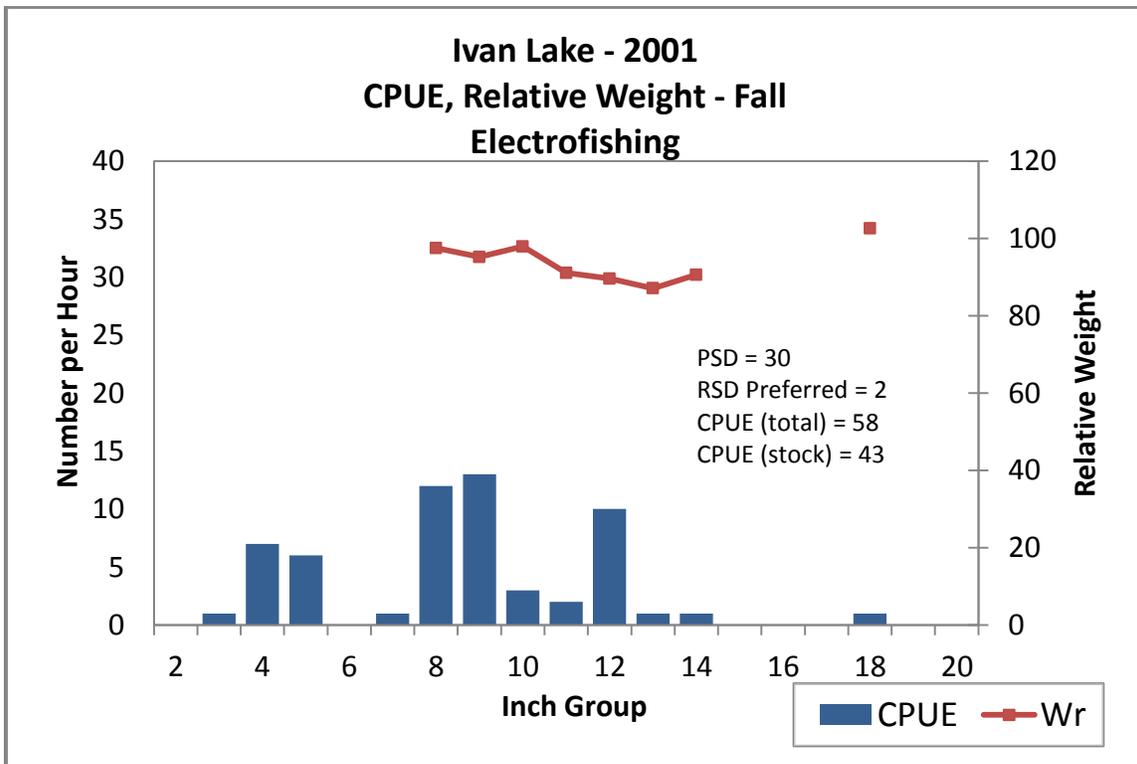
Figure 7. The CPUE, size distribution and relative weights of largemouth bass from fall 2001 electrofishing samples on Ivan Lake, LA. Relative weights indicate sufficient forage availability for the stock-size fish present in the lake at this time.

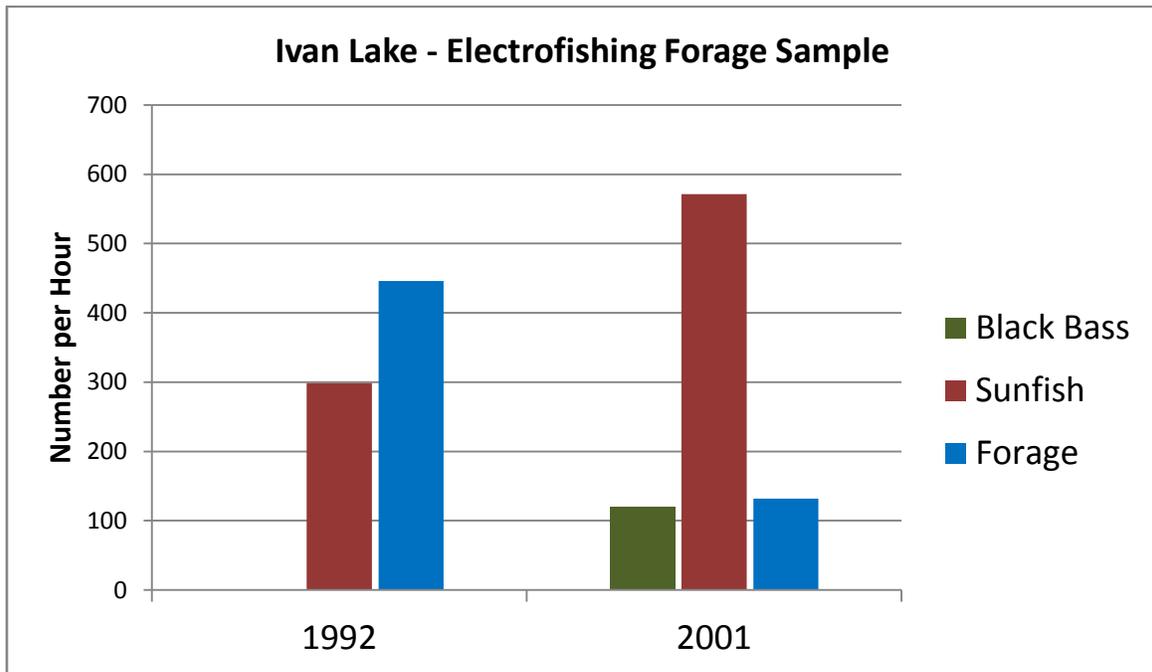
Figure 8. The CPUE in number per hour of fishes  $\leq 5$  inches TL from forage samples captured in Ivan Lake, LA in 1992 and 2001. Sunfishes (*Lepomis spp.*), and brook silversides comprised the majority of the species available as forage for the largemouth bass in the reservoir.

Forage samples were collected in conjunction with fall electrofishing samples in 1992 and 2001. Only fishes  $\leq 5$  inches TL are considered as forage for the purpose of evaluating the available forage in the reservoir. *Lepomis spp.* and fishes in the "Forage" category which consisted almost entirely of brook silversides, (*Labidesthes sicculus*) comprised the majority of the forage available in the lake by number (Figure 8). *Lepomis spp.* comprised the majority of the biomass collected in these samples with nearly 6 pounds of bream  $\leq 5$  inches TL captured in the fall 1992 forage sample and over 10 pounds collected in the 2001 sample (Figure 9).

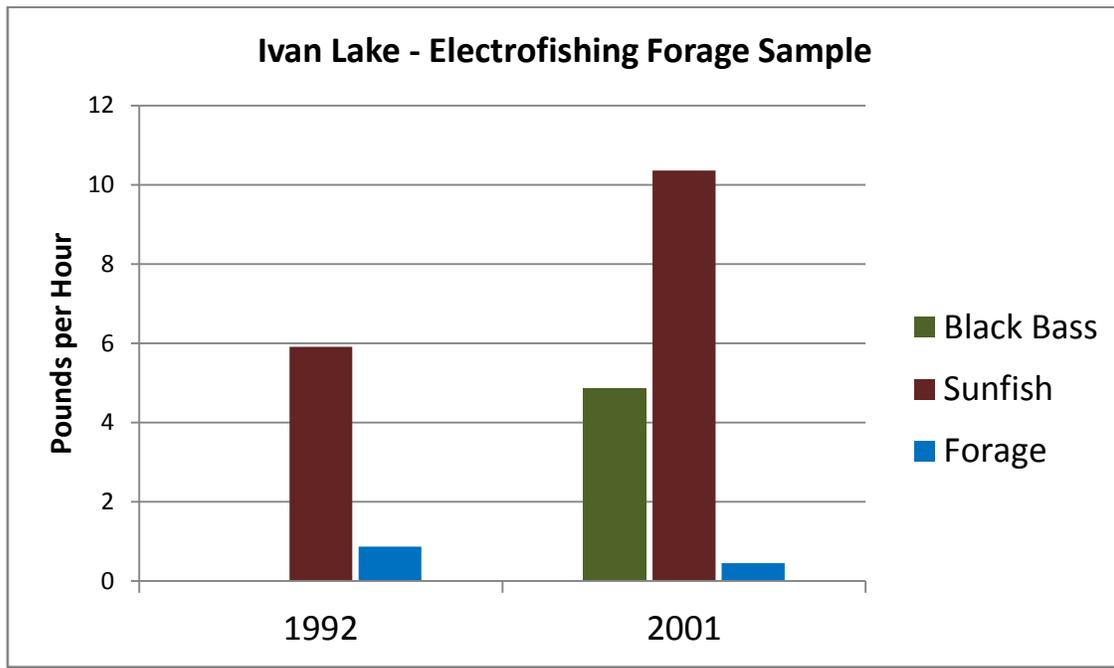
Figure 9. The catch in pounds per hour of fishes  $\leq 5$  inches TL from forage samples captured in Ivan Lake, LA in 1992 and 2001. Sunfish comprised the largest component by weight of the available forage in the lake. Fishes in the “Forage” category consisted primarily of brook silversides.

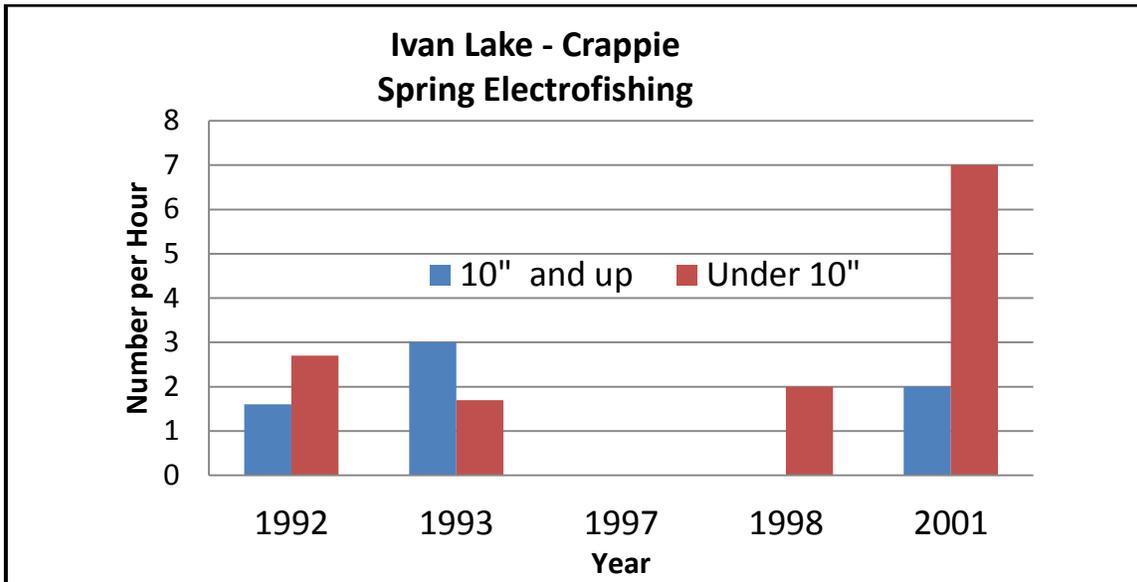
Figure 10. The CPUE of crappie captured during spring electrofishing samples from Ivan Lake, LA from 1992 to 2001.

Few crappie are collected during spring electrofishing samples from 1992 – 2001 as depicted in Figure 10. The population consisted primarily of black crappie. Anecdotal information from fishermen indicates that Ivan Lake was a popular lake for crappie anglers in the earlier years of the reservoir.

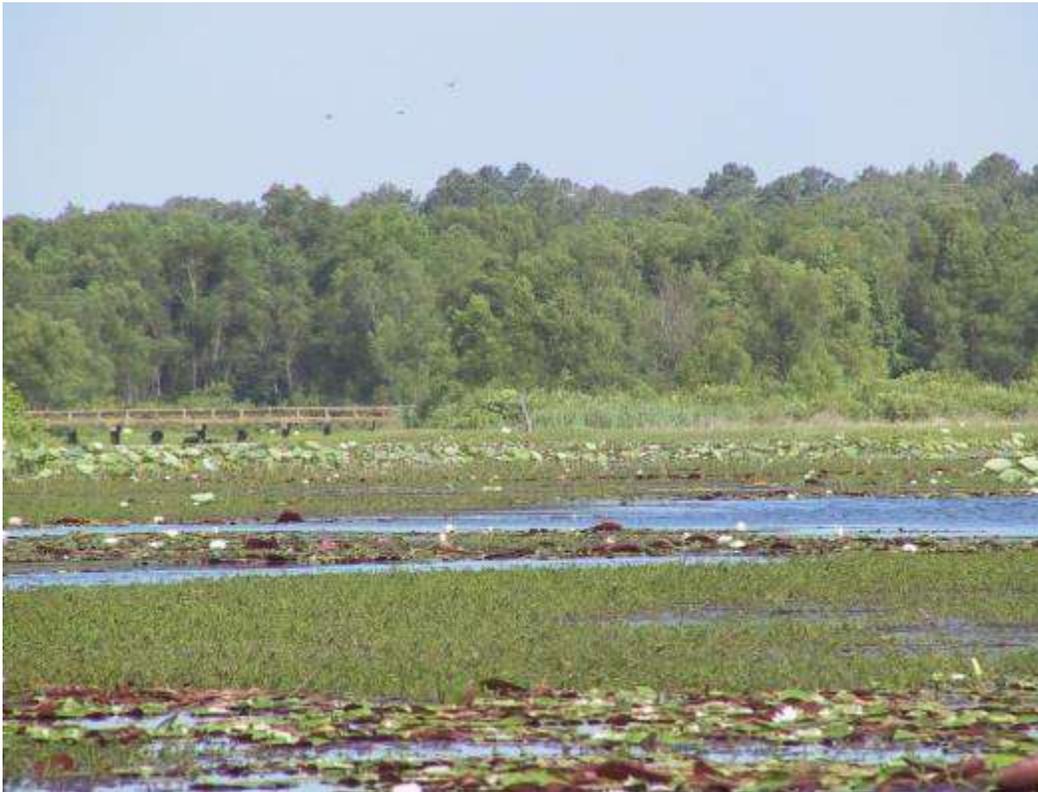
Figure 11. Aquatic vegetation is often problematic in many areas of Ivan Lake, LA due to the large expanses of shallow water. LDWF file photo - July 15, 2003.

An overabundance of aquatic vegetation was typical in this shallow water reservoir. Emergent species such as fragrant water lily (*Nymphaea odorata*), American Lotus (*Nelumbo lutea*) and alligator weed (*Alternanthera philoxeroides*) were historically present in moderate to severe infestations (Figure 11). Hydrilla (*Hydrilla verticillata*), variable leaf milfoil (*Myriophyllum heterophyllum*) and coontail (*Ceratophyllum demersum*) were the most troublesome submersed species in Ivan Lake. These species were often present in moderate to severe amounts in a fringe around the lake out to the six foot contour. The area of the lake approaching the Highway 529 Bridge was most severely impacted by aquatic vegetation with boating access often restricted to the creek channel. Bladderwort (*Utricularia spp.*), water-shield (*Brasenia schreberi*), water primrose (*Ludwigia octovalvis*), and fanwort (*Cabomba caroliniana*) were also often present in problematic levels throughout the lake. The shoreline was typically lined by lizard’s tail (*Saururus cernuus*), giant cutgrass (*Zizaniopsis miliacea*), cattail (*Typha spp.*), buttonbush (*Cephalanthus occidentalis*), and smartweed (*Polygonum spp.*).

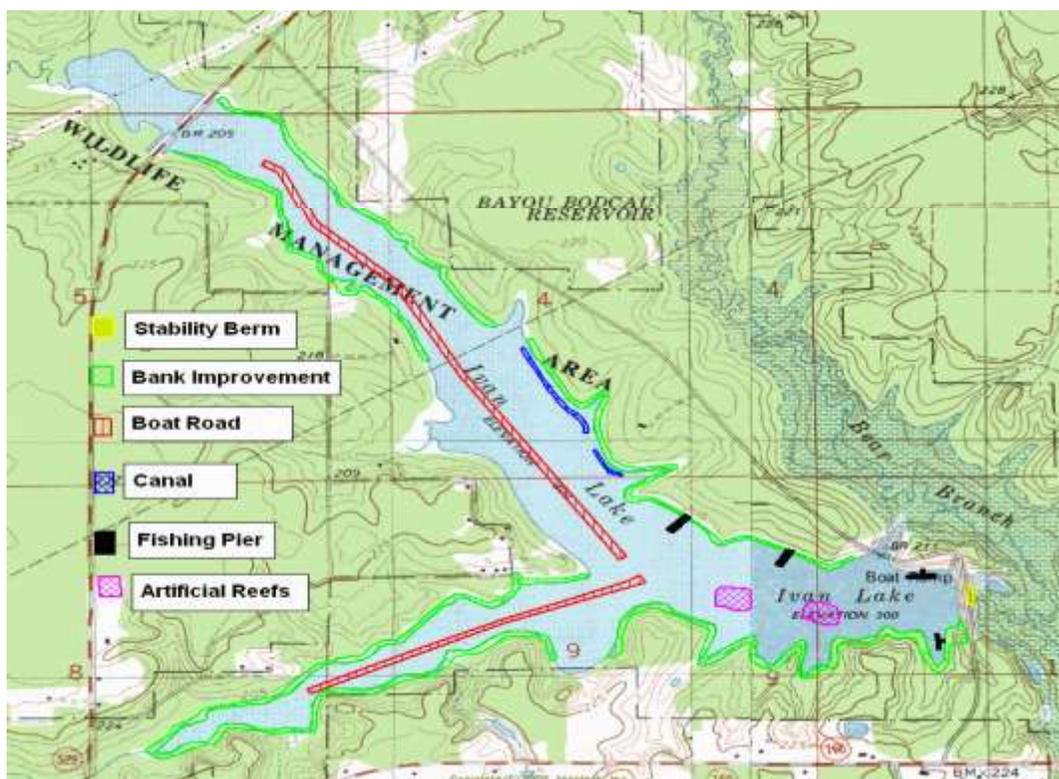
Figure I-A. Proposed improvements to fisheries habitat and for fishing access on Ivan Lake, LA.

- 4) Boat Lane Construction—each of the two arms of the lake extending westward contain dense stump fields which impede safe boat travel. The attached map (Figure I-A) shows an approximate boat road which will be created by a dozer. The removed stumps will be pushed to the side and heaped into piles for fish attraction. The boat lane boundaries will be marked with buoys in order to promote safe boating operation. Again, this will be completed within a cooperative endeavor between LDWF and local USACE personnel.

- 5) Artificial Reefs—artificial reefs will be constructed and placed by LDWF personnel into suitable deep water locations. These locations will be marked with buoys in order to promote use by anglers. The attached map shows possible reef locations (Figure I-A).

- 6) Fishing Piers—LDWF will contract construction of several handicapped accessible fishing piers. The piers will be placed near borrow ditches for winter fishing opportunities and near creek bed channels/improved banks for spring & summer fishing. Piers may be enhanced with automatic fish feeders. The map in Figure I-A shows probable locations.

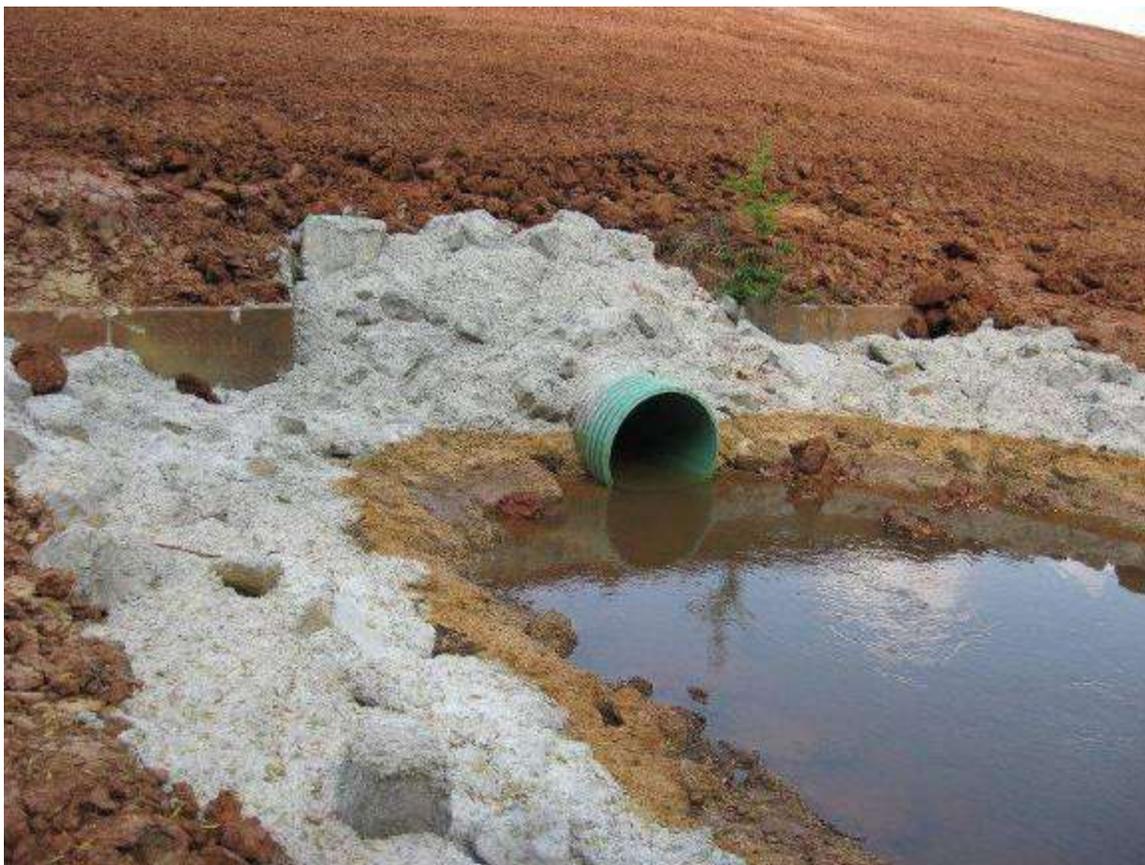
Figure II-A. Outflow pipe for Ivan Lake, LA, following replacement by the Bossier Parish Police Jury. Photo taken in the spring 2012.

The outflow pipe depicted in Figure II-A was replaced by the Bossier Parish Police Jury. Following this work the support berm described in item 1 of the renovation plan was completed.

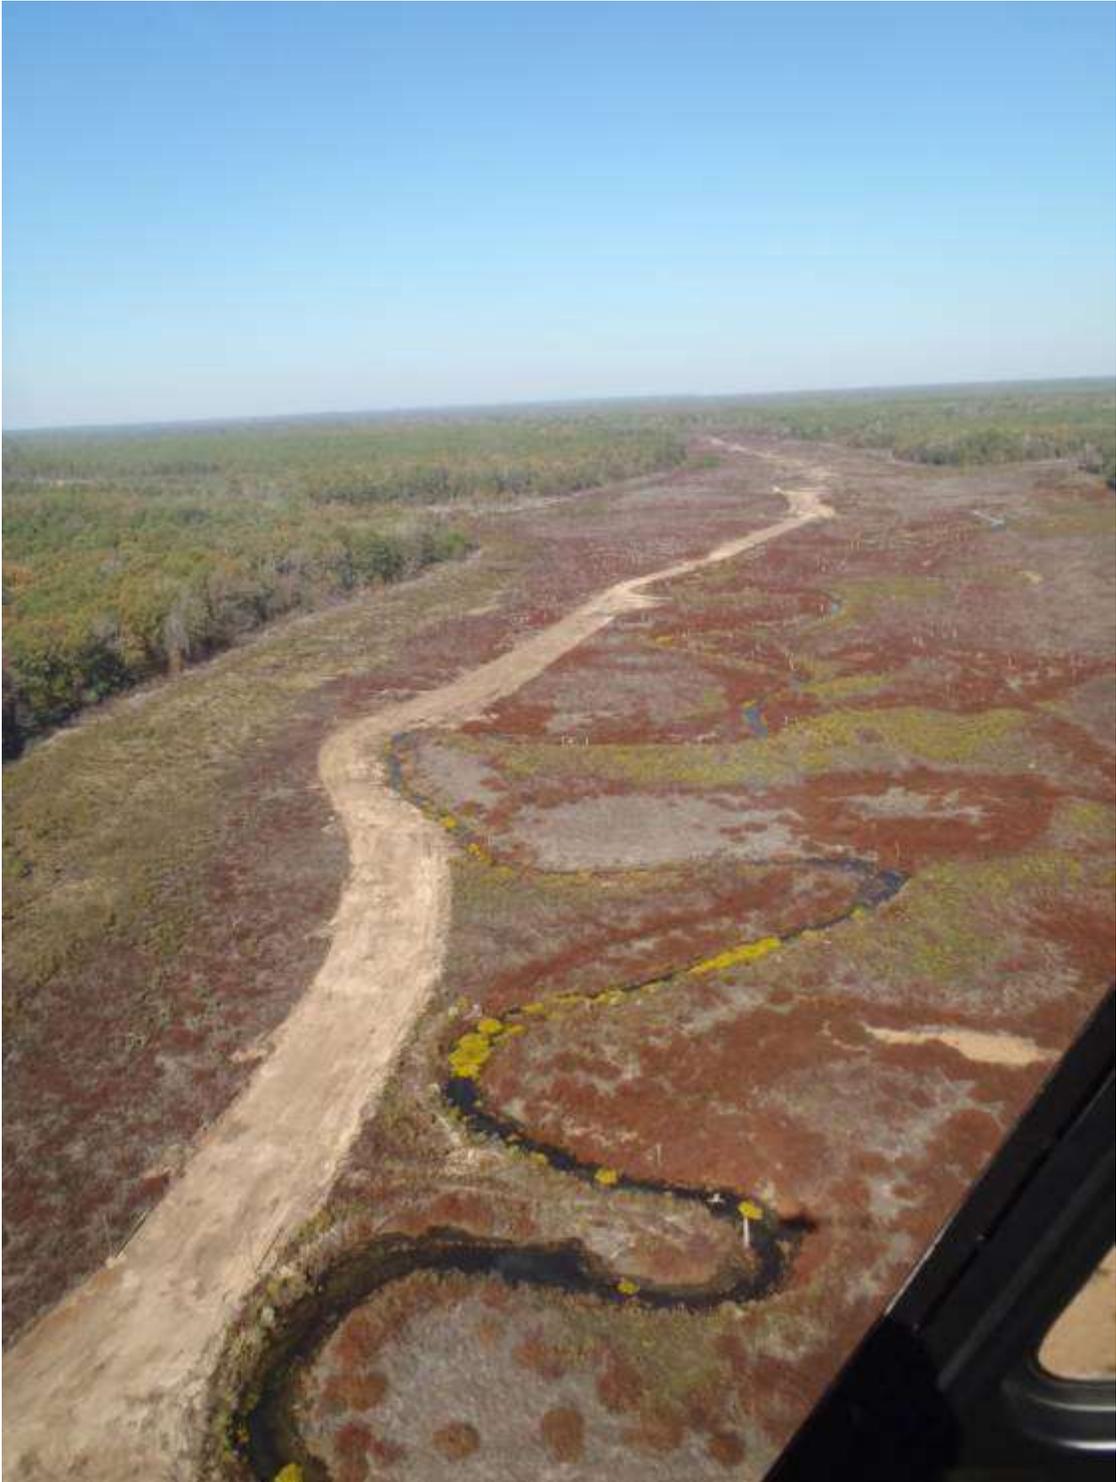
Figure II-B. Aerial photo of the newly created boat lane in Ivan Lake, LA. Stumps and obstructions were cleared by a bulldozer and the edges marked with pilings. Photo taken in fall 2011.

The boat lane described in item 4 of the renovation plan has been completed. The boat lane was created by a bulldozer and is easily visible in the aerial photograph in Figure II-B. This boat lane is well marked with navigational day marks mounted on pilings in accordance with the U. S. Aids to Navigation System (ATON).as shown in Figures II-C and II-D

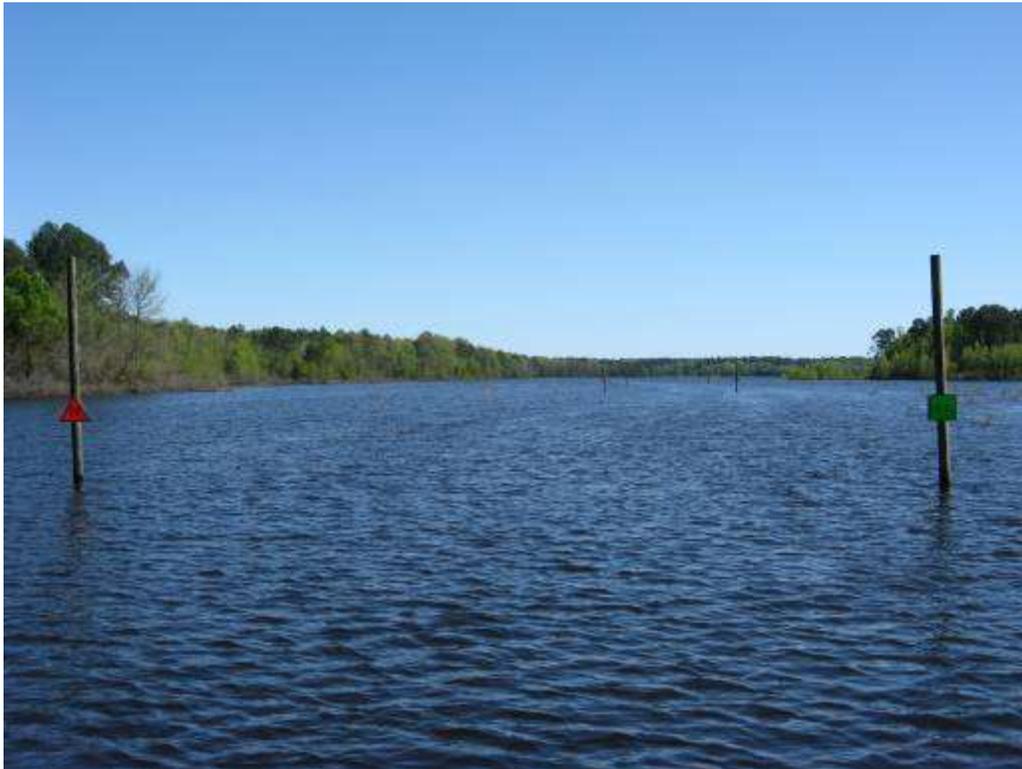
Figure II-C. Edges of the boat lane in Ivan Lake, LA were marked with day marks in accordance with the U.S. Aids to Navigation System (ATON). Photo taken in spring 2012.

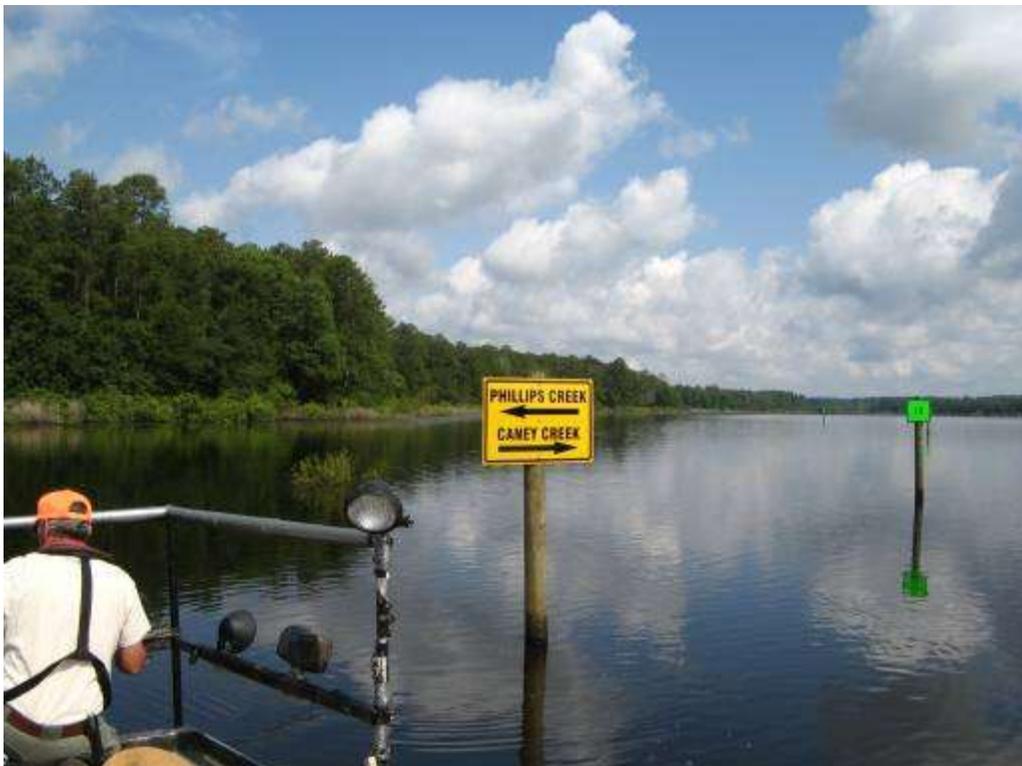
Figure II-D. Boat lane markers on Ivan Lake, LA, at the intersection of Phillips and Caney Creeks. Photo taken in spring 2012.
