LOUISIANA DEPARTMENT OF WILDLIFE & FISHERIES

IVAN LAKE

**AQUATIC VEGETATION TYPE MAPS
AND NARRATIVES**

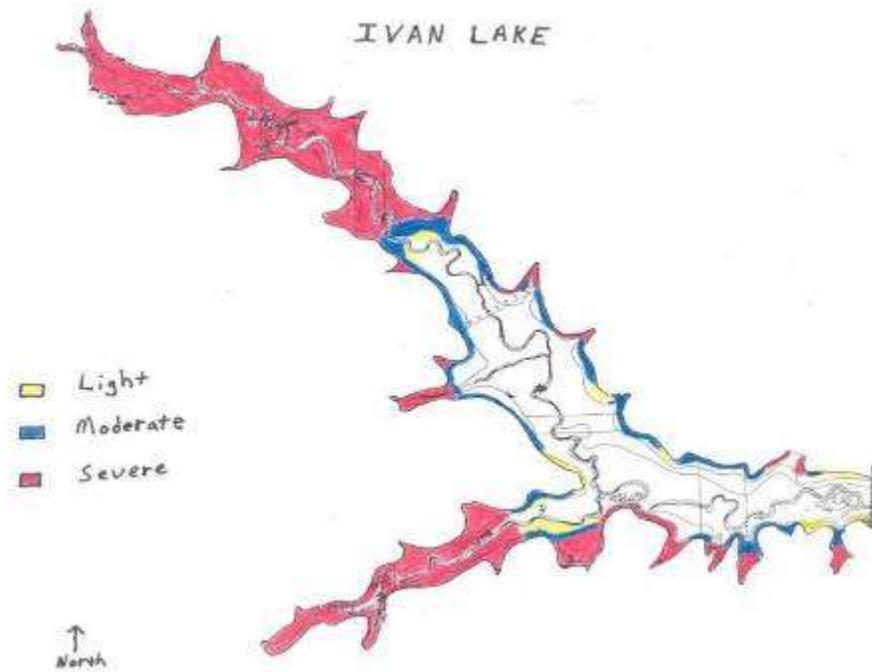
VEGETATION TYPE MAP IVAN LAKE 2005

The vegetation type mapping survey was conducted on July 22, 2005 by Louisiana Department of Wildlife and Fisheries personnel. Jeff Sibley, Biologist Supervisor District 1, was assisted by Todd Bridges in identifying the major aquatic plant species present in the lake and assessing the extent of coverage around the lake. At the time of the survey, the lake was one foot below pool and the water color was clear.

Aquatic vegetation covers approximately 30-35% of Ivan Lake. Gently sloping shorelines and vast areas of shallow water contribute to the vegetation problems. American lotus and fragrant water lilies pose the largest problems to access on the lake, as the upper ends of both major arms of the lake are nearly 100% covered (see attached map). Access is restricted to the creek channels in these upper reaches. The vegetation community here becomes a conglomerate of all the species listed above.

Ivan Lake has a 10-20' fringe of vegetation around almost the entire shoreline. A combination of giant cutgrass, cattails, lily pads and lotus line the shores of the lake. The shallow ends of all coves are wrapped up with either lilies or lotus. Submerged vegetation is scattered throughout the lake, but is most dense on the shallow points and in the far upper reaches of lake. Submergents were growing in as deep as 7' of water. There are some areas of the lake with dense, localized stands of hydrilla or chara; but emergent plants pose more of a threat to public access.

Ivan Lake is currently in the second year of a five year series of proposed Fall/Winter drawdowns for hydrilla control. The lake was slated to be drawn down 6' below pool stage in September of 2004; however, the lake was accidentally dewatered before the gates were closed and a large fish kill occurred. The lake quickly refilled with heavy rains, and was only down for a few weeks. Little drying action was observed and the drawdown likely had little effect on the vegetation. During the 2005 drawdown, the lake has again been dewatered in order for Louisiana Department of Transportation and Development to assess the control structure, as it

had been leaking. Drought conditions and extreme heat have likely aided the success of the drawdown. The organic layer on the lake bottom has dried and cracked and is decomposing. The vegetation has been exposed to dry conditions and several light frosts. The lake has remained down from late September until the time this document was completed (12/8/05). The lake is currently being assessed for possible renovation, and these future projects will likely affect the aquatic vegetation community of the lake.

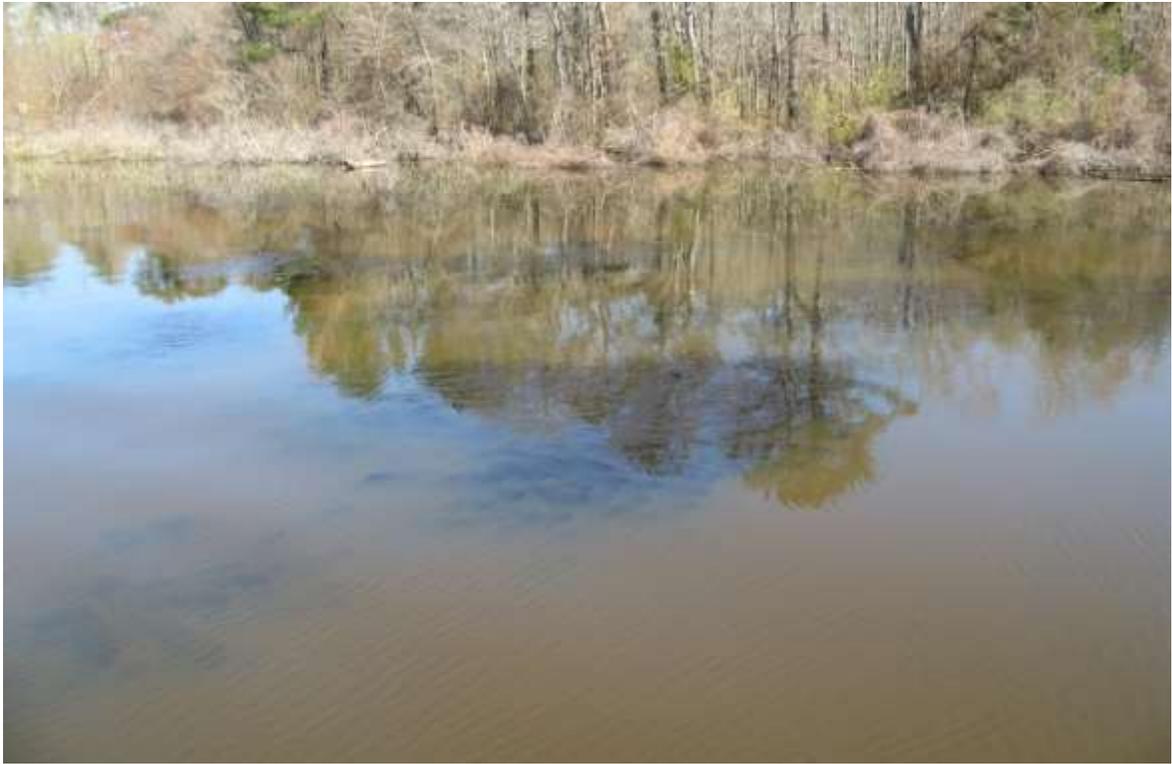
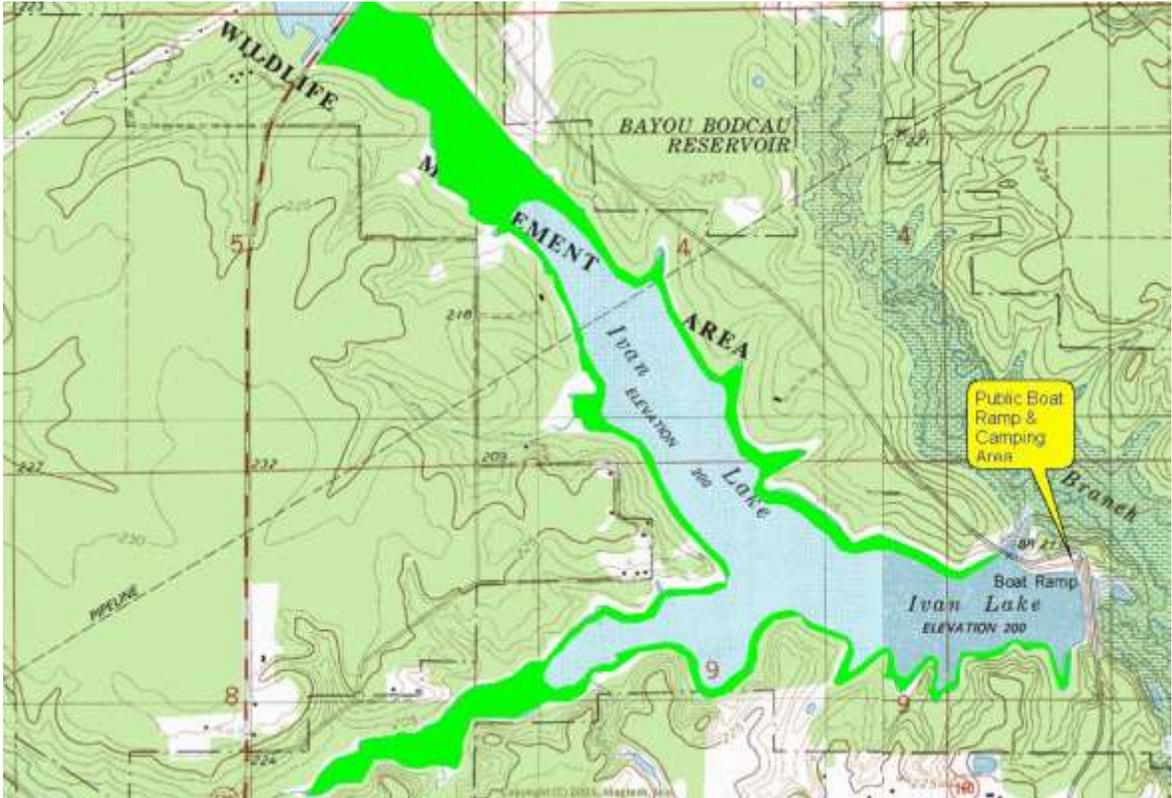
Aquatic vegetation covers approximately 20-25% of Ivan Lake. While this coverage is not severe, there are dense patches of submerged vegetation around the shoreline extending approximately 40 yards from the shore. Eurasian milfoil and southern naiad are the most abundant species present (90% total coverage). The remaining coverage is a conglomeration of the species listed above. Giant salvinia was found near the boat ramp in the rocks along the dam, and a couple of pieces were found floating along the shoreline during the survey. Only a couple of hydrilla stems were observed. The total acreage affected by submerged vegetation is 121.5 acres.

Giant salvinia coverage should be monitored regularly and applications made as the need arises. A typical shoreline view of milfoil patches in Ivan Lake & Ivan Lake submerged vegetation coverage.

Based upon the vegetation control plan, a recommendation of 600 grass carp should be stocked into Ivan Lake in the spring of 2013 in an attempt to maintain submerged aquatics at an acceptable level.
