LOUISIANA DEPARTMENT OF WILDLIFE & FISHERIES

WATERBODY MANAGEMENT PLAN SERIES

CROOKED CREEK RESERVOIR

May 2013 - Prepared by
Jody David, Fisheries Biologist Manager, District 6

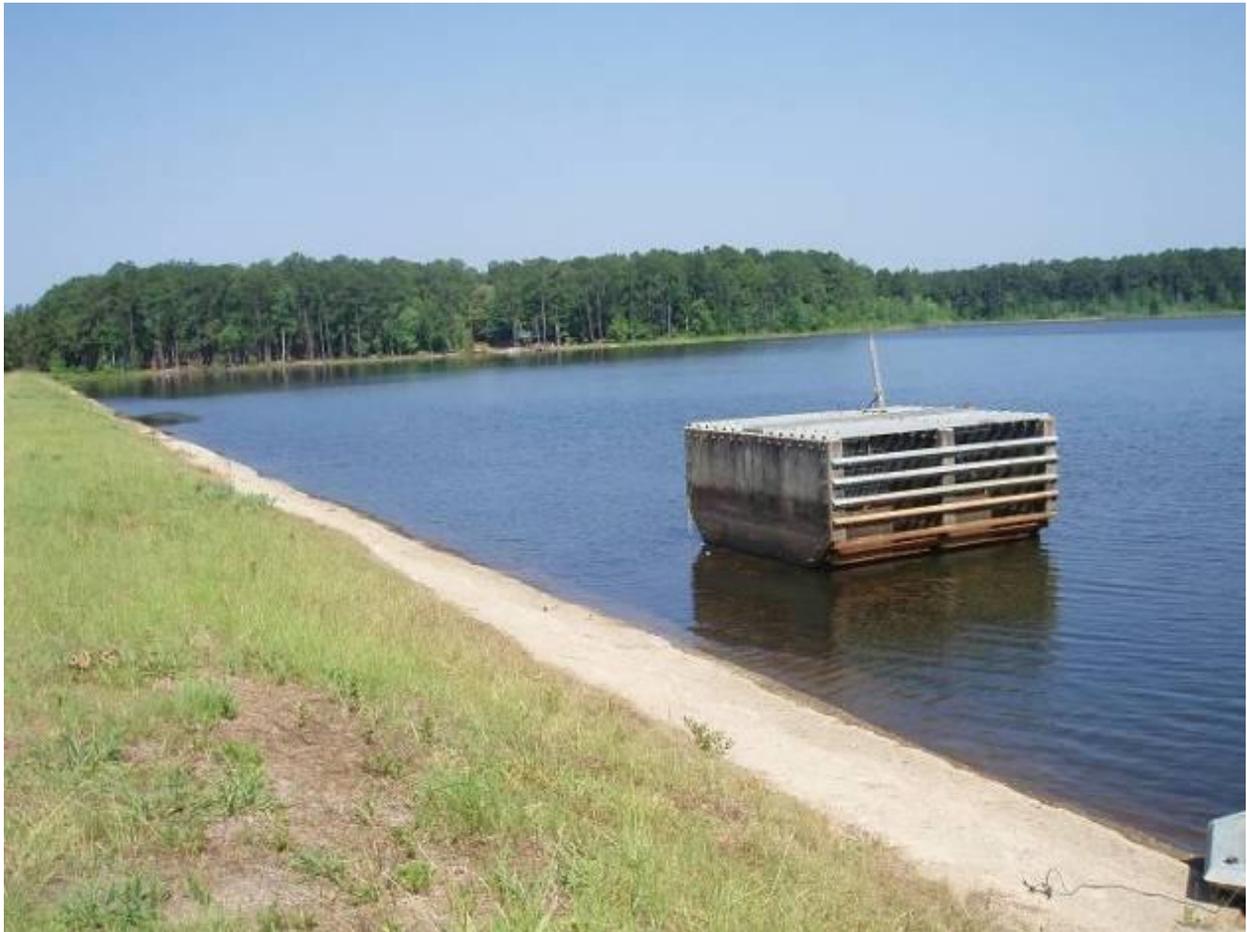
Figure 1. Looking west along the dam of Crooked Creek Reservoir, LA at the spillway and control structure. LDWF file photo taken October 2, 2012.

Dam Length – 2, 150 ft. (entire dam length serves as secondary/emergency spillway)

Spillway size – 16 ft. total, 8 ft. openings on each end of structure serves as primary overflow (Figure 1).

Spillway design – square concrete and steel structure based on standpipe design with openings on each end.

Gate size – drawdown gate with a 4 ft. x 4 ft. opening.

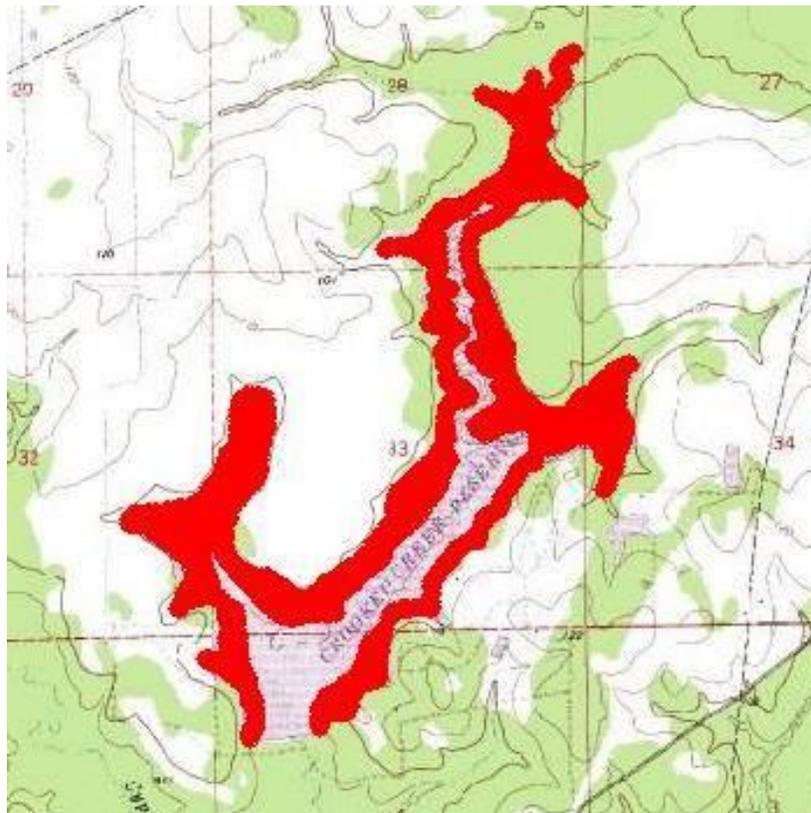
Crooked Creek Reservoir Vegetation Survey - Feb. 2006

Red areas are thick with hydrilla (*Hydrilla verticillata*), mature water shield (*Brasenia schreberi*) and water primrose (*Ludwigia spp.*). All area of the reservoir in red is shallow areas of the reservoir with less than 7 feet of water. The location of the historical creek can be seen on the map. All areas of the reservoir outside of the creek bottom, except for the area of the reservoir adjacent to the spillway on the southern end of the reservoir, are shallow and possess the potential for further spread of nuisance vegetation such as hydrilla.

Other vegetation observed included coontail (*Ceratophyllum demersum*), bladderwort (*Utricularia spp.*), fanwort (*Cabomba caroliniana*) and bulrush (*Scirpus spp.*). There was a surprising lack of common salvinia (*Salvinia minima*) observed.

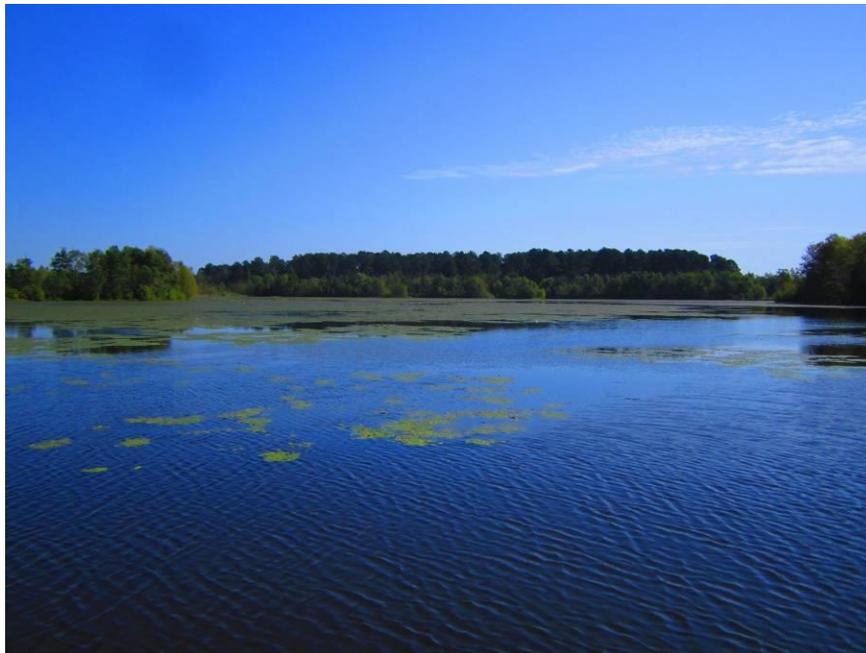
Water shield growth on north end of Crooked Creek Reservoir, LA LDWF file photo taken on Oct. 2, 2012.

Crooked Creek continues to have a heavy infestation of water shield (*Brasenia schreberi*) with a thick mat of this plant covering the entire north end of the reservoir just north of the public swimming area of the reservoir. Patches of water shield were found throughout the reservoir primarily along the bank however these patches were small and not continuous as are the mats located on the north end of the reservoir. This north end location is shallow at an average depth of 4 feet. Within this accumulation of water shield is a very thick growth of fanwort (*Cabomba caroliniana*). Moderate amounts of hydrilla (*Hydrilla verticillata*) were found mixed with the fanwort as well as small amounts of coontail (*Ceratophyllum demersum*). A noticeable decrease in the amount of hydrilla found within the reservoir was observed. The cove across the reservoir from the boat launch was only slightly marked with hydrilla. The same was true of the boat launch and spillway with only a small patch of hydrilla seen adjacent to the boat launch and in corners of the spillway. Shoreline amounts of hydrilla were thin. In spring of 2012, 500 grass carp were stocked into the reservoir. On the shallow shoreline locations found around the reservoir were growing light amounts of duck potato (*Sagittaria lancifolia*), flat sedge (*Cyperus odoratus*), and water primrose (*Ludwigia spp.*). No floating vegetation was observed. No giant salvinia (*Salvinia molesta*) observed. Below are pictures of Crooked Creek Reservoir taken on Oct. 2, of 2012.

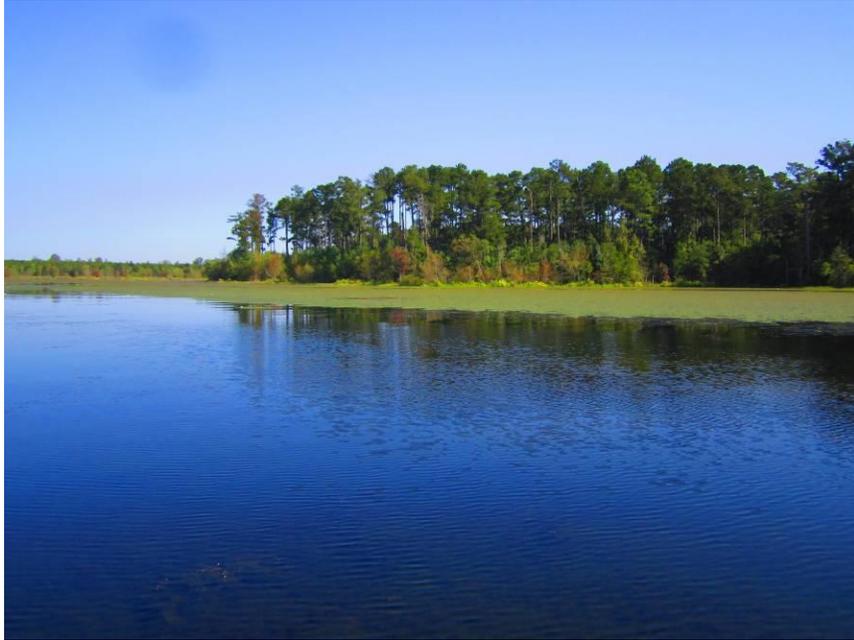
North end Crooked Creek Reservoir looking left from above picture. Fringe vegetation is primarily water shield. LDWF file photo taken October 2, 2012.

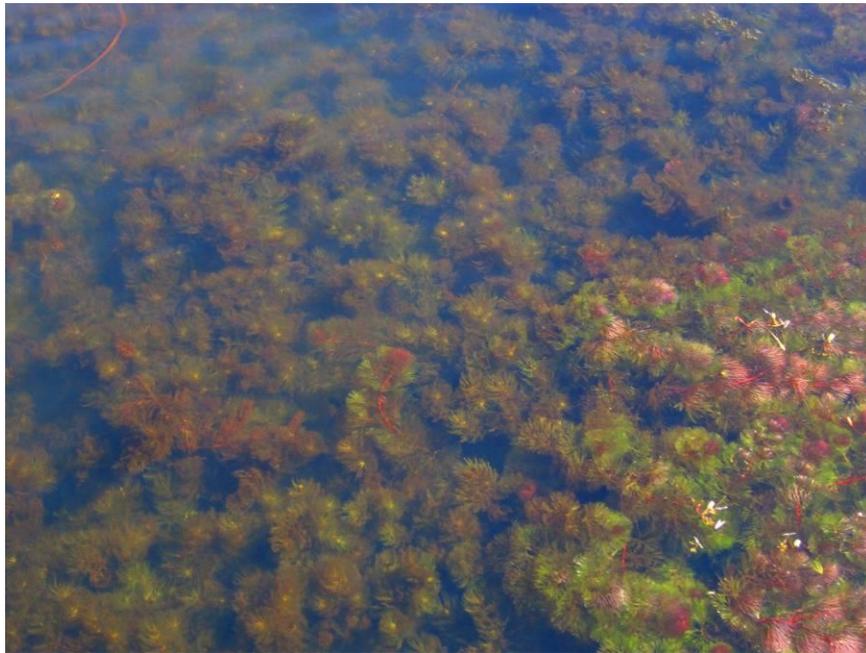
Close up of submerged vegetation found in north end of Crooked Creek Reservoir. LDWF file photo taken October 2, 2012.

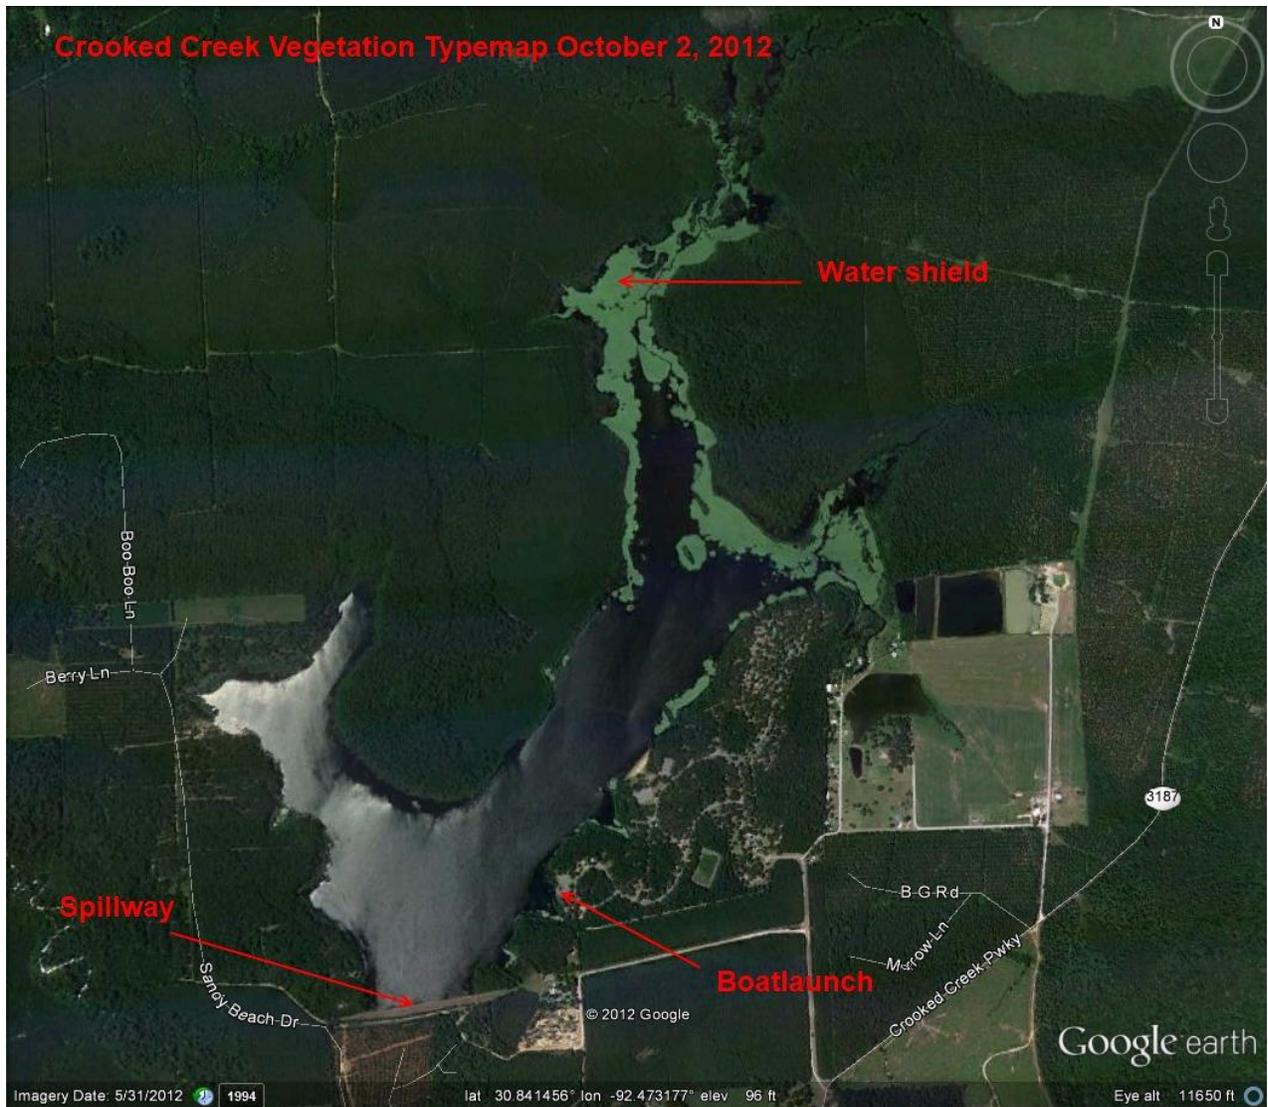
Crooked Creek Reservoir. Green mat on north end is water shield with heavy amounts of fanwort. Google Earth imagery on 5-31-12.
