# LOUISIANA DEPARTMENT OF WILDLIFE & FISHERIES

WATERBODY MANAGEMENT PLAN SERIES

**BUNDICK LAKE**

LAKE HISTORY & MANAGEMENT ISSUES

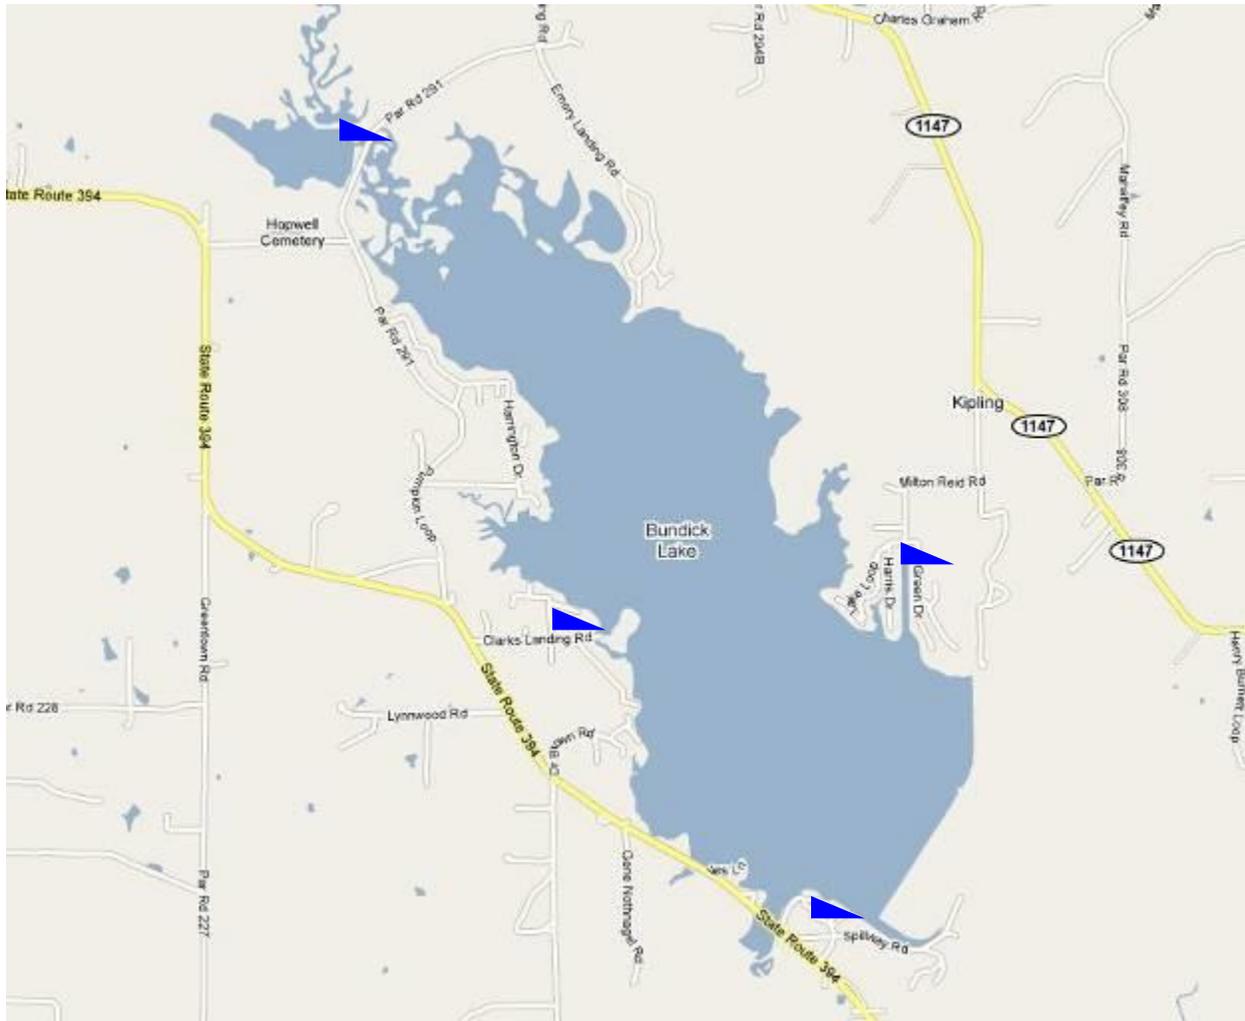
## LAKE MAP W/BOAT LAUNCHES AND PIERS

Ramp Name – clockwise from lower center	Coordinates	Ramp	Parking
Spillway Park	<u>30°43'36.64" N - 93°05'43.76" W</u>	concrete	Dirt, 25 trailers
Clark's Landing	<u>30°44'26.95" N - 93°06' 35.25" W</u>	gravel	Dirt, 5 trailers
Hopwell Bridge	<u>30°45'56.52" N - 93°07'26.44" W</u>	concrete	Gravel 10 trailers
Ray Coonce Landing	<u>30°44'42.73" N - 93°05' 35.29" W</u>	concrete	Asphalt, 5 trailers

Currently four boat ramps are associated with the public boat landings on Bundick Lake. They are located at the Spillway Park, Hopewell Bridge, Ray Coonce Landing and Clark’s Landing Road (SEE [APPENDIX I – LAKE MAP W/BOAT LAUNCHES](#)). There are numerous private wharves and piers around the lake.

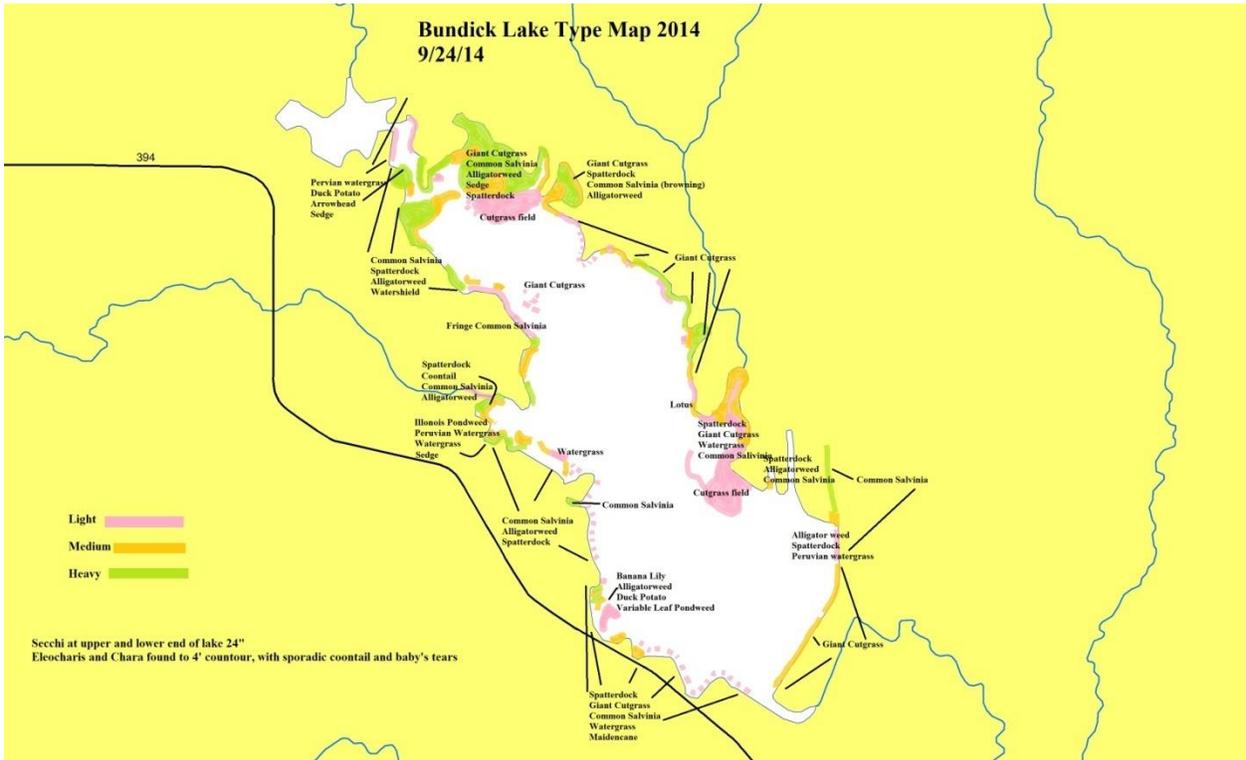
**Bundick Lake Type Map 2014**  
9/24/14

Plant densities on the type map were designated as "Low," "Medium," or "High." Heaviest infestations were on the flats in the northwestern portion of the lake. Other heavily infested areas were in shallow coves. Giant cutgrass (*Zizaniopsis miliacea*) has become a very significant cause of concern, with large stands on the northern end, eastern end, and along the dam. The other most common species of concern in these areas were common salvinia (*Salvinia minima*) and alligator weed (*Alternanthera philoxeroides*). Other species of concern that occurred more sporadically included Peruvian water grass (*Luziola peruviana*), and Cuban bulrush (*Oxycaryum cubense*).

Other species that were noted in varying densities included spatterdock (*Nuphar luteum*) on multiples shorelines, elephant ear (*Colocasia esculenta*) on multiple shorelines, American lotus (*Nelumbo lutea*) on the western end, arrowhead (*Sagittaria sp.*), maidencane (*Panicum hemitomom*), and water shield (*Brasenia schreberi*).

Submerged aquatic vegetation was observed in varying amounts throughout the lake, and was found up to the 3' contour of the lake. Species observed included coontail (*Ceratophyllum demersum*) in the northern half of the lake, variable leaf pondweed (*Potamogeton diversifolius*) on the western shoreline, Illinois pondweed (*Potamogeton illinoensis*), and stonewort (*Nitella sp.*) though out the lake.

Common salvinia continues to be a chronic problem on the lake, and Cuban bulrush is sporadically observed wherever salvinia is found. We will continue our efforts to control the problem. Many areas of high coverage are filling in and too shallow to access. We will address these areas as much as our equipment and water levels will allow.
