LOUISIANA DEPARTMENT OF WILDLIFE & FISHERIES

WATERBODY MANAGEMENT PLAN SERIES

CHICOT LAKE

**AQUATIC VEGETATION TYPE MAPS
AND NARRATIVES**

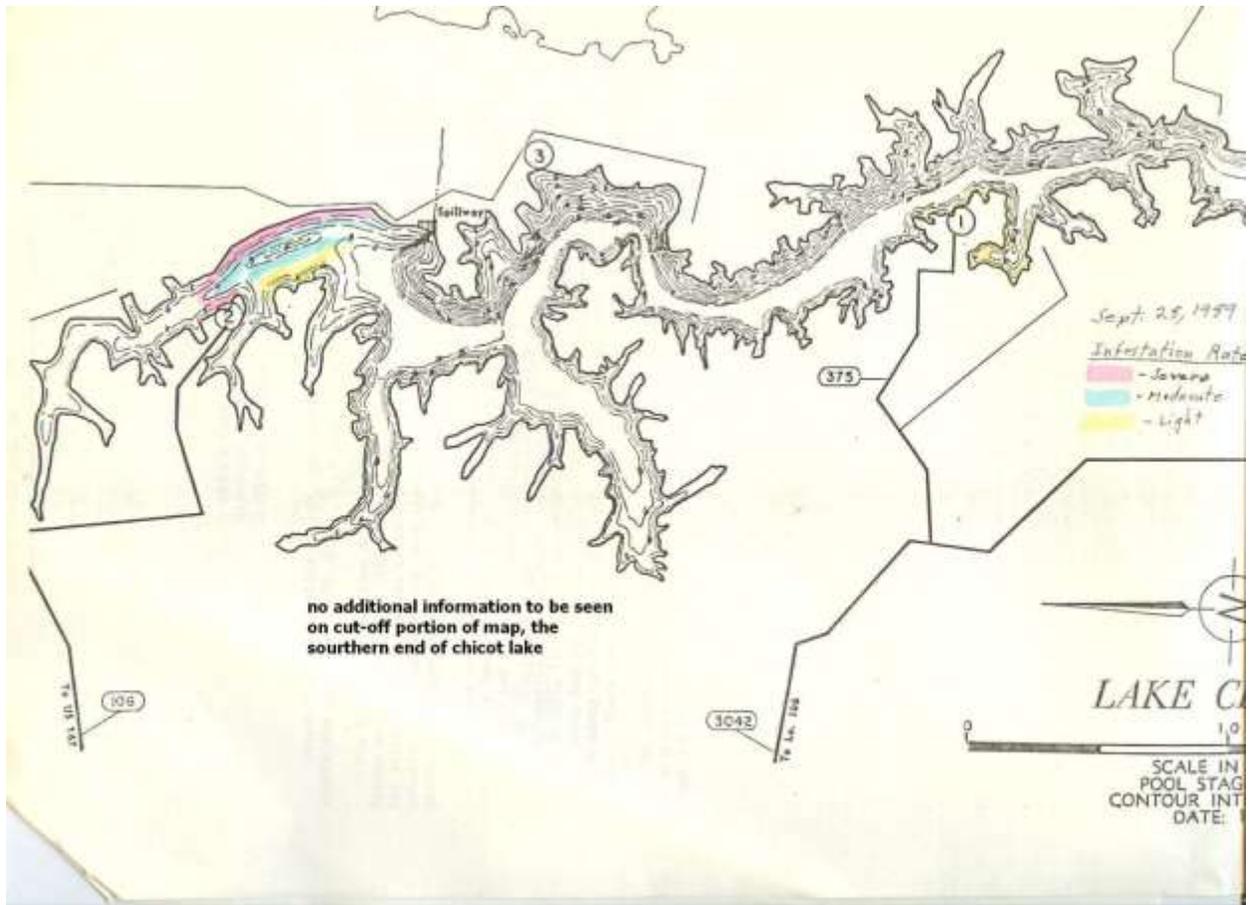
CHICOT LAKE
September, 1989
Charles N. Dugas

Chicot Lake, Evangeline Parish, was surveyed for the presence of aquatic vegetation on September 28, 1989.

The lake was drawn down during 1986 and 1987. During this time, the lake became severely infested with willow trees (Salix nigra). In October of 1988, the willow infestation was treated with herbicide and a 90-95% control rate was achieved. The stems of the dead trees will probably take several years to completely disappear (from decay and boat traffic).

Submersed vegetation has appeared in several places around the lake. The most severely infested area was the north end near the dam. Fanwort (Cabomba caroliniana) and coontail (Ceratophyllum demersum) predominate, with some bladderwort (Utricularia sp.), pondweed (Potamogeton sp.), white water lily (Nymphaea odorata), and milfoil (Myriophyllum sp.) mixed in. This infestation was out to five (5) feet of water on either side of a dredged channel leading to the north landing. There were spotty light infestations of coontail and fanwort along the bank from the spillway down to just south of the south landing. There was no aquatic vegetation encountered in the rest of the lake.

The weather on the day of the survey was cloudy and drizzly. The water was slightly turbid. The lake was approximately six (6) inches below pool stage (46 MSL).

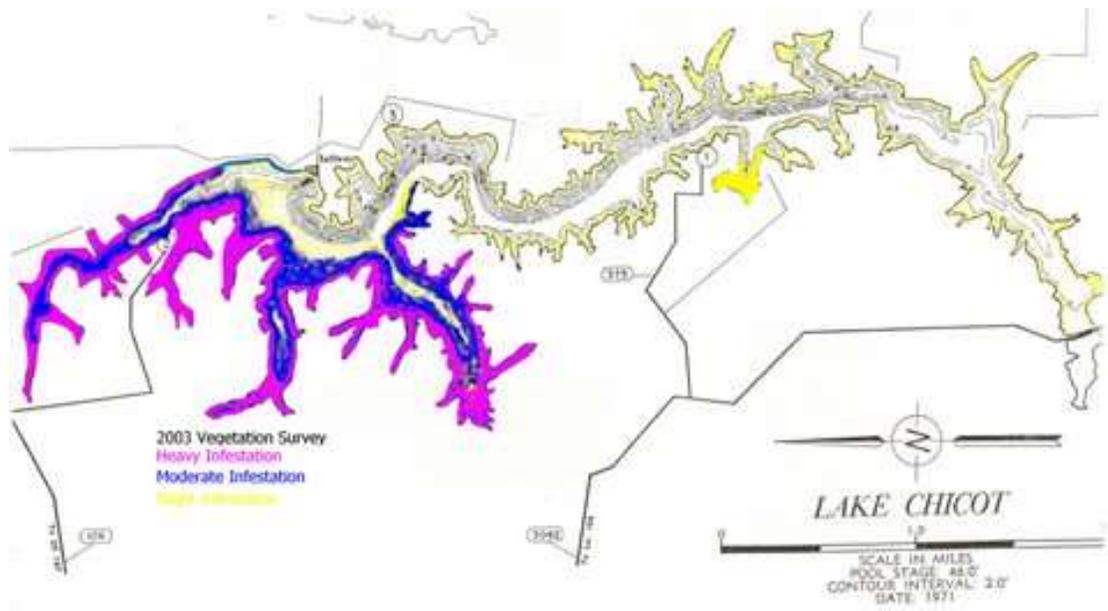
CHICOT LAKE

Chicot Lake, Evangeline Parish, was surveyed for the presence of aquatic vegetation on September 3, 2003. On the day of the survey the water was clear with secchi disk readings of 1.1-1.5 m. Water levels in the lake were at pool stage (46.0 MSL).

In an effort to eradicate the severe infestations of hydrilla (*Hydrilla verticillata*), an herbicide treatment of Sonar was applied May 15, 2003. The areas treated were Walker's Branch and from the spillway northward to the northern boat landing. Hydrilla in some portions of these areas has been depleted, although severe amounts are still present in other portions of the treated areas. Bleaching of the leaves on various plants was observed inside and adjacent to the treated areas, this is a positive sign that plants are still being affected by the herbicide treatment. Moderate to heavy amounts of filamentous algae were also present in these treated areas.

Hydrilla was the most dominant submersed vegetation in the northern section of the lake, and light amounts were observed in other areas of the lake. Coontail (*Ceratophyllum demersum*) and fanwort (*Cabomba caroliniana*) were found in light to moderate amounts throughout the lake. A nearly continuous fringe of coontail was present in the non-wooded sections of the southern half of the lake.

Other submersed plants observed during the survey were bladderwort (*Utricularia spp.*), variable leaf milfoil (*Myriophyllum heterophyllum*), and ottelia (*Ottelia alismoides*). Floating plants observed during the survey were water hyacinth (*Eichhornia crassipes*), duckweed (*Lemna minor*), common salvinia (*Salvinia minima*), frogbit (*Limnobium spongia*), and watermeal (*Wolffia spp.*). Moderate amounts of water hyacinth was present throughout the northern half of the lake with the most severe amounts located in Walker's Branch; duckweed was the most dominant plant located in the wooded areas in the southern part of the lake. Emerged plants observed during the survey were alligatorweed (*Alternanthera philoxeroides*), water primrose (*Ludwigia spp.*), American lotus (*Nelumbo lutea*), pennywort (*Hydrocotyle umbellate*), white water lily (*Nymphaea odorata*), smartweed (*Polygonum hydropiperoides*), duck potato (*Sagittaria spp.*), sedge (*Carex spp.*), giant cutgrass (*Zizaniopsis miliacea*), and pickerelweed (*Pontederia cordata*).

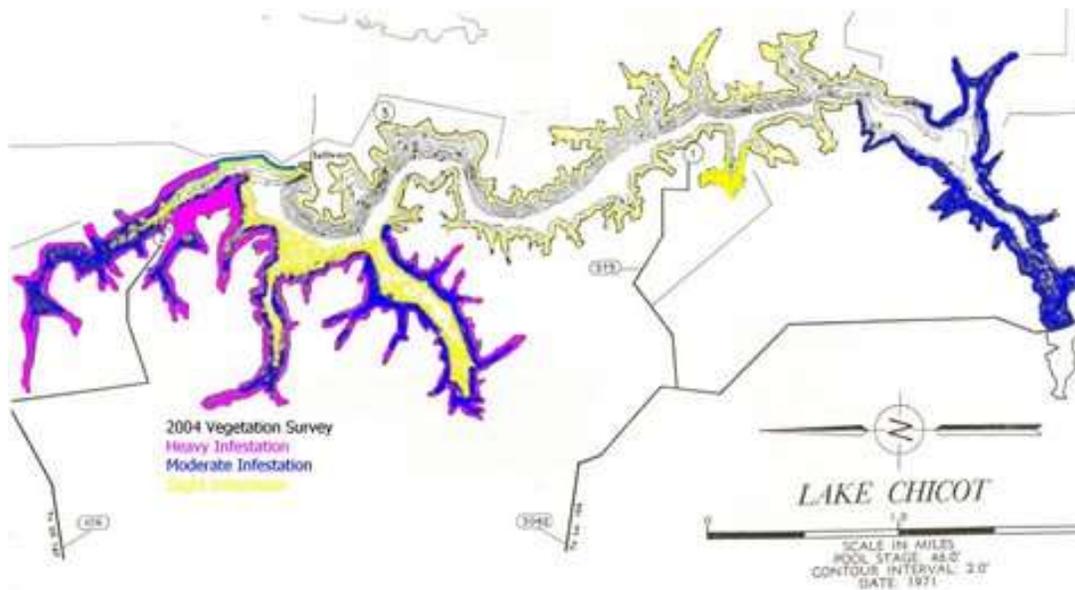
CHICOT LAKE

Chicot Lake, Evangeline Parish, was surveyed for the presence of aquatic vegetation on August 10, 2004. On the day of the survey the water was clear with secchi disk readings of 86-97 cm. Water levels in the lake were approximately 6" below pool stage (pool stage = 46.0' MSL).

In an ongoing effort to eradicate the hydrilla (*Hydrilla verticillata*) infestation, a herbicide treatment of Sonar was applied (July 29, 2004) for the second consecutive year. This application was delayed due to excessive rainfall throughout the spring and early summer. The areas treated were Walker's Branch and from the spillway northward to the northern boat landing. During the survey bleaching of the leaves on various plants in the treated areas was observed, this is a positive sign that the plants are being affected by the herbicide treatment.

Moderate to heavy amounts of hydrilla were observed from Walker's branch northward, and light amounts were observed in various locations in the southern part of the lake. Coontail (*Ceratophyllum demersum*) was observed in moderate amounts throughout the lake, and fanwort (*Cabomba caroliniana*) was observed in moderate amounts in the northern section of the lake. Light amounts of bladderwort (*Utricularia spp.*) were found in a few locations throughout the lake. Moderate amounts of filamentous algae were observed in one cove near the north boat landing.

Moderate amounts of water hyacinth (*Eichhornia crassipes*) and duckweed (*Lemna minor*) were observed throughout the lake, the heaviest amounts of duckweed were located in the wooded areas in the southern part of the lake. Other floating plants observed during the survey in light amounts were frogbit (*Limnobium spongia*) and watermeal (*Wolffia spp.*). Emergent plants observed during the survey in various parts of the lake were American lotus (*Nelumbo lutea*), white water lily (*Nymphaea odorata*), giant cutgrass (*Zizaniopsis miliacea*), alligatorweed (*Alternanthera philoxeroides*), water primrose (*Ludwigia spp.*), pennywort (*Hydrocotyle umbellata*), smartweed (*Polygonum hydropiperoides*), duck potato (*Sagittaria spp.*), and pickerelweed (*Pontederia cordata*).

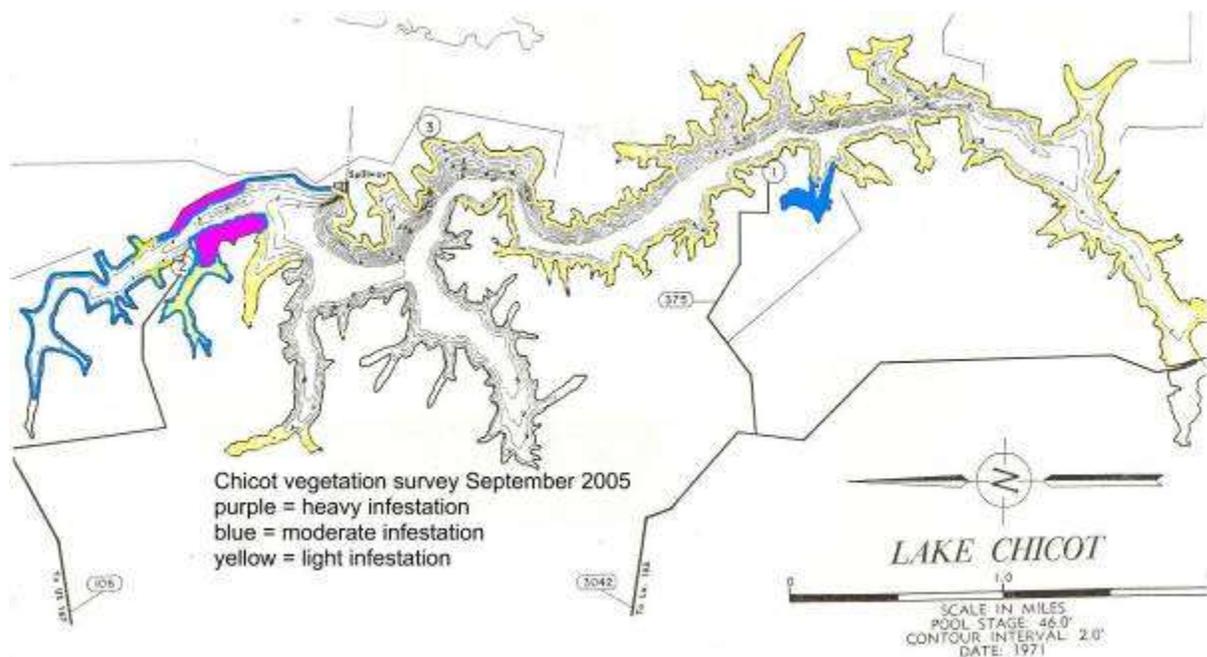
Chicot Lake
September 2005
Jody T. David

Chicot Lake, Evangeline parish, was surveyed for the presence of aquatic vegetation on September 14, 2005. On the day of the survey the water was clear with a secchi disk reading of 2 feet. Water levels in the lake were approximately 3 feet below pool stage (pool stage = 46.0' MSL).

In an ongoing effort to eradicate the hydrilla (*Hydrilla verticillata*) infestation, a herbicide treatment of Sonar was applied (April 26, 2005). The areas treated were Walker's Branch and from the spillway northward to the northern boat landing. During the survey bleaching of the leaves on various plants in the treated areas was observed, this is a positive sign that the plants are being affected by the herbicide treatment.

Light amounts of hydrilla amounts were observed in various locations in the southern part of the lake. Coontail (*Ceratophyllum demersum*) was observed in moderate amounts throughout the lake, and fanwort (*Cabomba caroliniana*) was observed in moderate amounts in the northern section of the lake. Light amounts of bladderwort (*Utricularia spp.*) were found in a few locations throughout the lake. Moderate amounts of filamentous algae were observed in one cove near the north boat landing.

Moderate amounts of water hyacinth (*Eichhornia crassipes*) and duckweed (*Lemna minor*) were observed throughout the lake, the heaviest amounts of duckweed were located in the wooded areas in the southern part of the lake. Other floating plants observed during the survey in light amounts were frogbit (*Limnobium spongia*) and watermeal (*Wolffia spp.*). Emergent plants observed during the survey were American lotus (*Nelumbo lutea*), white water lily (*Nymphaea odorata*) noticed on the north end of lake in severe amounts. Other emergents throughout the lake was giant cutgrass (*Zizaniopsis miliacea*), alligatorweed (*Alternanthera philoxeroides*), water primrose (*Ludwigia spp.*), pennywort (*Hydrocotyle umbellata*), smartweed (*Polygonum hydropiperoides*), duck potato (*Sagittaria spp.*), and pickerelweed (*Pontederia cordata*).

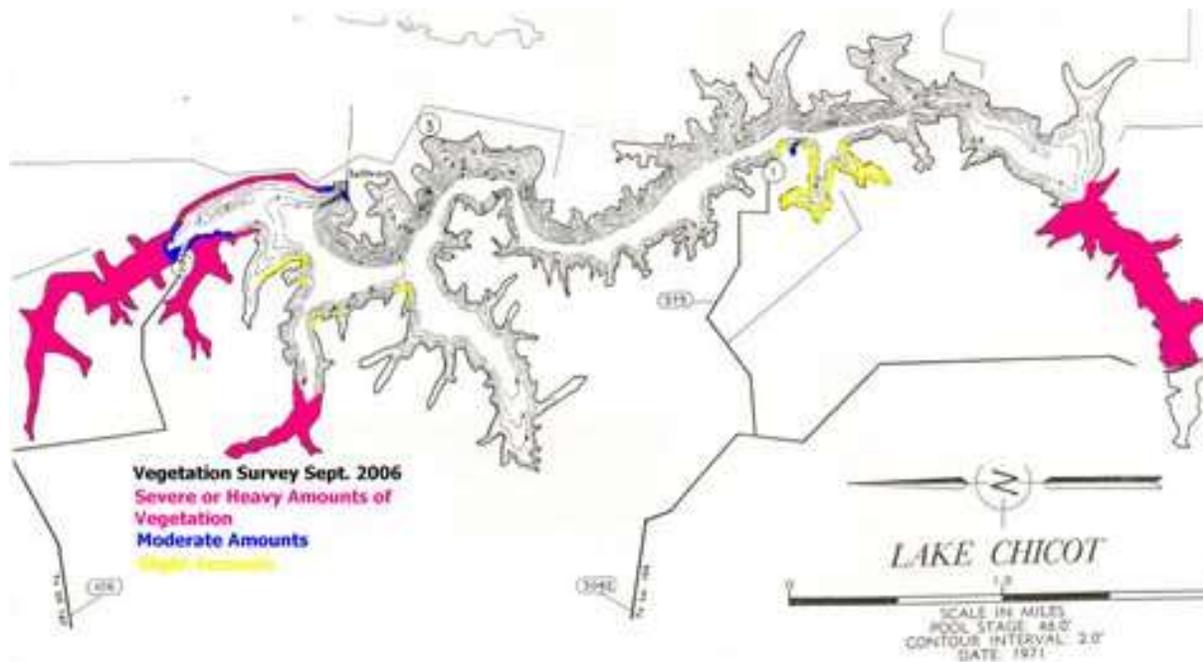
Chicot Lake
September 2006
Jody T. David

Chicot Lake, Evangeline parish, was surveyed for the presence of aquatic vegetation on September 14, 2005. On the day of the survey the water was clear with a secchi disk reading of 2 feet. Water levels in the lake were approximately 1 foot below pool stage (pool stage = 46.0' MSL).

In an ongoing effort to eradicate the hydrilla (*Hydrilla verticillata*) infestation, a herbicide treatment of Sonar was applied (April 26, 2005). The areas treated were Walker's Branch and from the spillway northward to the northern boat landing. During the survey there was no sign of re-infestation of Hydrilla in these areas.

Light amounts of hydrilla amounts were observed in various locations in the southern part of the lake. Coontail (*Ceratophyllum demersum*) was observed in moderate amounts throughout the lake, and fanwort (*Cabomba caroliniana*) was observed in moderate amounts in the northern section of the lake. Light amounts of bladderwort (*Utricularia spp.*) were found in a few locations throughout the lake. Moderate amounts of filamentous algae were observed near the north boat landing.

Moderate amounts of water hyacinth (*Eichhornia crassipes*) and duckweed (*Lemna minor*) were observed throughout the lake, the heaviest amounts of duckweed were located in the wooded areas in the southern part of the lake. Other floating plants observed during the survey in light amounts were frogbit (*Limnobium spongia*) and watermeal (*Wolffia spp.*). Emergent plants observed during the survey were American lotus (*Nelumbo lutea*), white water lily (*Nymphaea odorata*) noticed on the north end of lake in severe amounts. Other emergents throughout the lake was giant cutgrass (*Zizaniopsis miliacea*), alligatorweed (*Alternanthera philoxeroides*), water primrose (*Ludwigia spp.*), pennywort (*Hydrocotyle umbellata*), smartweed (*Polygonum hydropiperoides*), duck potato (*Sagittaria spp.*), and pickerelweed (*Pontederia cordata*).

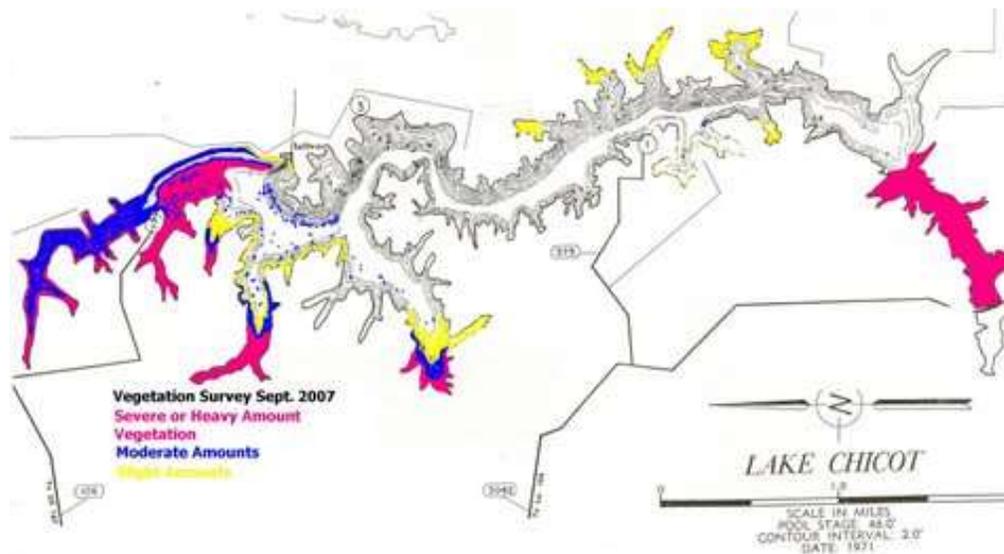
Chicot Lake
September 2007
Jody T. David

Chicot Lake, Evangeline parish, was surveyed for the presence of aquatic vegetation on September 5, 2007. On the day of the survey the water was clear with a secchi disk reading of 2 feet. Water levels in the lake were at pool stage (pool stage = 46.0' MSL).

Moderate to heavy amounts of hydrilla (*Hydrilla verticillata*) were observed on the northern part of the lake. Areas such as the Ski Lake, near the North Landing, Conservation lodge, Turtle Island and Walker Branch.

Light amounts of hydrilla were observed in various locations in the southern part of the lake. Coontail (*Ceratophyllum demersum*) was observed in moderate amounts throughout the lake, and fanwort (*Cabomba caroliniana*) was observed in moderate amounts in the northern section of the lake. Light amounts of bladderwort (*Utricularia spp.*) were found in a few locations throughout the lake. Moderate amounts of filamentous algae were observed near the north boat landing.

Moderate amounts of water hyacinth (*Eichhornia crassipes*) and duckweed (*Lemna minor*) were observed throughout the lake, the heaviest amounts of duckweed was located in the wooded areas in the southern part of the lake, behind the bridge in Walker Branch and back of Turtle Island. Other floating plants observed during the survey in light amounts were frogbit (*Limnobium spongia*) and watermeal (*Wolffia spp.*). Emergent plants observed during the survey were American lotus (*Nelumbo lutea*), white water lily (*Nymphaea odorata*) noticed on the north end of lake in severe amounts. Other emergents throughout the lake was giant cutgrass (*Zizaniopsis miliacea*), alligatorweed (*Alternanthera philoxeroides*), water primrose (*Ludwigia spp.*), pennywort (*Hydrocotyle umbellata*), smartweed (*Polygonum hydropiperoides*), duck potato (*Sagittaria spp.*), and pickerelweed (*Pontederia cordata*).

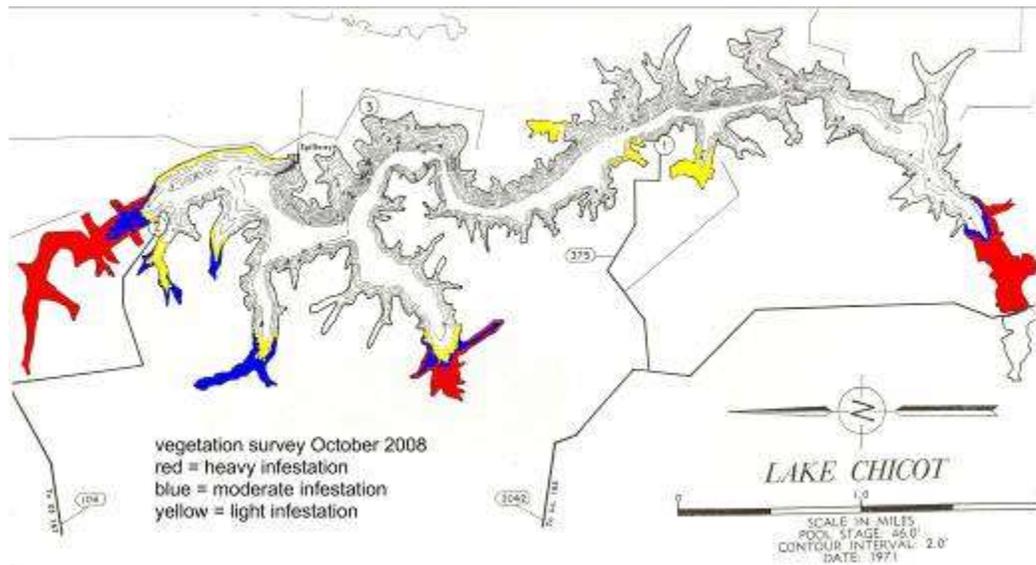
Chicot Lake
October 2008
Jody T. David

Chicot Lake, in Evangeline parish, was surveyed for the presence of aquatic vegetation on October 15th 2008. On the day of the survey the water was clear with a secchi disk reading of 2.5 feet. Water levels in the lake were at pool stage (pool stage = 46.0' MSL).

Due to a SONAR application in June 2008 very little hydrilla (*Hydrilla verticillata*) were observed on the northern part of the lake. Areas such as the Ski Lake, near the North Landing, Conservation lodge, Turtle Island and Walker Branch.

Light amounts of hydrilla were observed in various locations in the southern part of the lake along the shoreline. Coontail (*Ceratophyllum demersum*) was observed in light amounts throughout the lake, and fanwort (*Cabomba caroliniana*) was observed in light amounts in the northern section of the lake. Light amounts of bladderwort (*Utricularia spp.*) were found in a few locations throughout the lake.

Moderate amounts of water hyacinth (*Eichhornia crassipes*) and duckweed (*Lemna minor*) were observed throughout the lake, the heaviest amounts of duckweed was located in the wooded areas in the southern part of the lake, behind the bridge in Walker Branch and back of Turtle Island. Other floating plants observed during the survey in light amounts were frogbit (*Limnobium spongia*) and watermeal (*Wolffia spp.*). Emergent plants observed during the survey were American lotus (*Nelumbo lutea*), white water lily (*Nymphaea odorata*) noticed on the north end of lake in light amounts. Other emergents throughout the lake was giant cutgrass (*Zizaniopsis miliacea*), alligatorweed (*Alternanthera philoxeroides*), water primrose (*Ludwigia spp.*), pennywort (*Hydrocotyle umbellata*), smartweed (*Polygonum hydropiperoides*), duck potato (*Sagittaria spp.*), and pickerelweed (*Pontederia cordata*).

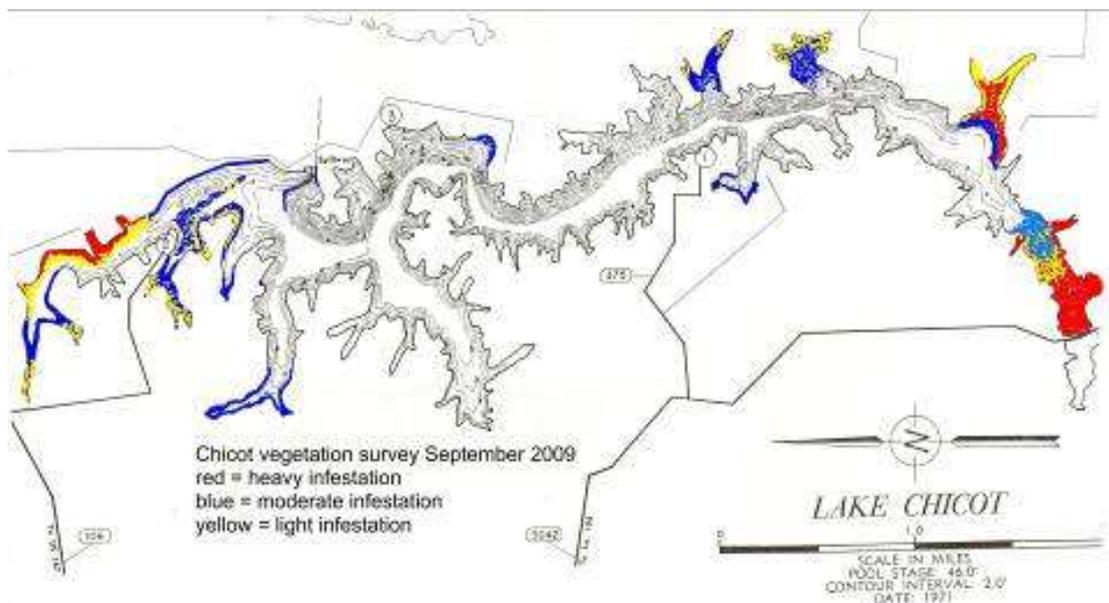
Chicot Lake
15th of September, 2009
Jody T. David

Chicot Lake, in Evangeline parish, was surveyed for the presence of aquatic vegetation on September 15th, 2009. Water level in the lake was at pool stage, 46.0' MSL.

Due to a SONAR application in June 2008, only moderate amounts of hydrilla (*Hydrilla verticillata*) were observed on the northern part of the lake adjacent to the north landing. Hydrilla amounts have increased in this area of the lake; however, the other treated areas such as conservation cove are still only slightly infected with hydrilla. A Sonar application is planned for many of the same areas of the lake in 2010. Amounts of hydrilla to be treated in 2010 should be less than what was treated in 2008. Hydrilla control and reduction is apparent. Resistance to the fluridone herbicide is not desired but eventually expected.

Light amounts of hydrilla were observed in fewer locations in the southern part of the lake along the shoreline than observed in 2008. Fanwort (*Cabomba caroliniana*), coontail (*Ceratophyllum demersum*), hydrilla, and bladderwort (*Utricularia spp.*) were observed in moderate to heavy amounts in the northern cove of the lake located to the east of the north landing. Light amounts of bladderwort (*Utricularia spp.*) and coontail were found in a few locations throughout the lake.

The heaviest amounts of duckweed (*lemma sp.*) were located in the wooded areas of the southern part of the lake, behind the bridge in Walker Branch, the conservation cove, and the back of Turtle Island in 2008. The Continual applications of diquat though out the lake onto duckweed have resulted in open water in these areas this year. Moderate amounts of duckweed were observed in several of the many coves of the southern end of the lake. Treatments subsequent to this report have been made with diquat onto these areas. The southern end of the lake near the southern walking bridge continues to be infested with heavy amounts of common salvinia (*S. minima*) despite multiple application of diquat. **No giant salvinia (*S. molesta*) observed in the lake.**

Other floating plants observed during the survey in light amounts were frogbit (*Limnobium spongia*), water hyacinth (*Eichhornia crassipes*), and watermeal (*Wolffia spp.*). Emergent plants observed during the survey were American lotus (*Nelumbo lutea*), white water lily (*Nymphaea odorata*) observed on the north end of lake in light amounts. Other emergents throughout the lake was giant cutgrass (*Zizaniopsis miliacea*), alligatorweed (*Alternanthera philoxeroides*), water primrose (*Ludwigia spp.*) found in large mats on the south end of the lake along with moderate amounts of pennywort (*Hydrocotyle umbellata*) Very light amounts of smartweed (*Polygonum hydropiperoides*), duck potato (*Sagittaria spp.*), and pickerelweed (*Pontederia cordata*) were observed mostly on southern end of the lake.

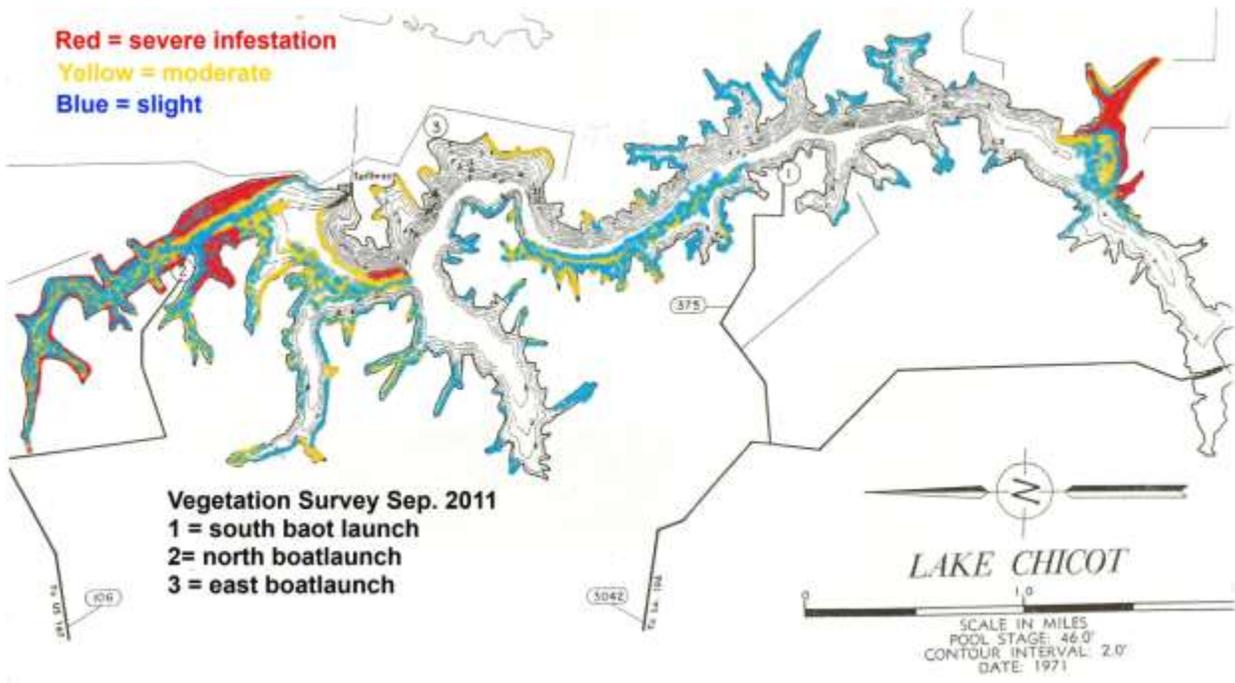
Chicot Vegetation Type Map

Chicot lake water level was 18 inches below pool and the bridge on the spillway road was being re-surfaced. Chicot Lake was de-watered 7 feet from pool the first Tuesday after Labor Day, 2010. The lake has remained below pool since that day due to a serious drought in that area during 2011. No fish kills were observed or reported during the drawdown procedure. The lake was de-watered in order to facilitate the repair of pilings of the Walker Branch Bridge which crosses one of the lake's numerous coves. Chicot refilled from rainfall to a safe level for fishing and power boat use by the end of March 2011. Much of the lake bottom was exposed from late September 2010 until mid-February 2011 with only the main deeper channel remaining wet with 8 to 10 feet of water. The channel runs from just south of the south end boat launch to the lake spillway and continues to the north-end boat launch. This channel provided suitable fish habitat during the bridge repair.

Vegetation observed in the lake was mostly water hyacinth (*Eichhornia crassipes*) with the greatest amount existing from the middle to the northern end of the lake. Severe amounts of water hyacinth were seen in the area surrounding the north boat launch as well as adjacent to the main channel near the mid-section of the lake. There was a light to moderate fringe of water hyacinth along the shore of the lake starting in the middle section extending into turtle island and conservation cove. A light fringe of water hyacinth could be found in Walker's branch and a heavy fringe was seen along Pine Island. This heavy fringe of water hyacinth in the Pine island area was first noticed during April of 2011 while tagging bass for the Cabela's fishing tournament. At this time, only small patches of water hyacinth were observed elsewhere in the lake.

Light to moderate amounts of water hyacinth were observed in the southern end of the lake on September 21, 2011. Heavy amounts of water primrose (*Ludwigia* spp.) were observed on the southern end of the lake. A light fringe of water hyacinth could be seen in the back of coves located on the southern end of the lake.

A heavy infestation of American lotus (*Nelumbo lutea*) and white water lily (*Nymphaea odorata*) was observed on the shallow flats adjacent to the north boat launch. There was a heavy amount of filamentous algae (*Spirogyra*) in this area as well. Little to no hydrilla (*Hydrilla verticillata*) was found in this area with no hydrilla being found in conservation cove or along the spoil bank canal banks. This area had received a treatment of Sonar fluridone herbicide during the spring of 2010. Submerged vegetation was found in the end of the conservation cove, southern naiad (*Najas guadalupensis*) in light amounts. A very light amount of duckweed (*Lemna* spp.) and common salvinia (*Salvinia minima*) was seen in the lake. **NO GIANT SALVINIA OBSERVED.**

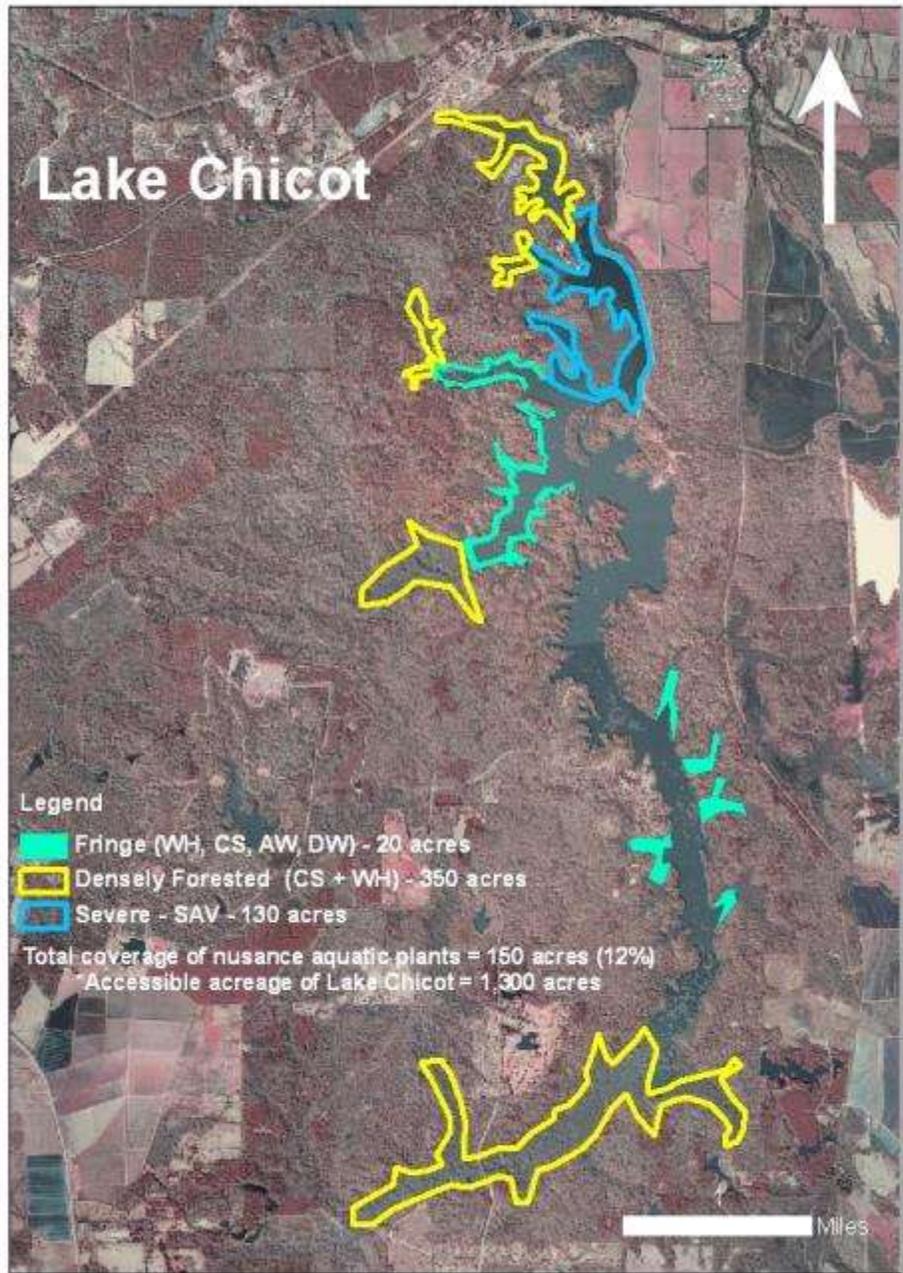
Chicot Lake Vegetation Typemap

Water hyacinth (*Eichhornia crassipes*) was the predominant species of floating vegetation. Other floating plants observed were duckweed (*Lemna spp.*) and common salvinia (*Salvinia minima*). Floating vegetation was not the main problem, although small pockets and fringes were scattered throughout the lake and within some coves. These small infestations are treated regularly throughout the growing season by District 6 spray crews.

A severe infestation of submerged and emergent aquatic vegetation was observed in the northern part of the lake adjacent to the boat launch (~130 acres). This area received a Sonar treatment in the spring of 2012. The predominant species of submerged aquatic vegetation (SAV) were coontail (*Ceratophyllum demersum*), fanwort (*Cabomba caroliniana*), southern naiad (*Najas guadalupensis*), and hydrilla (*Hydrilla verticillata*). The predominant emergent species were American lotus (*Nelumbo lutea*), alligator weed (*Alternanthera philoxeroides*), and white water lily (*Nymphaea odorata*).

*Hydrilla was observed in trace amounts. The bulk of SAV was composed of native species.

Walker Branch and Turtle Island were relatively clear of nuisance aquatic vegetation.

Several coves as well as the very north and south of the lake had moderate-to-severe infestations of a variety of nuisance aquatic vegetation. However, these areas are densely forested, shallow, and considered inaccessible.

An estimated total of 150 acres of nuisance aquatic vegetation was observed. The estimated total of accessible acreage is 1,300 acres. An estimated 12% of Chicot Lake is infested with nuisance aquatic vegetation (mostly SAV).

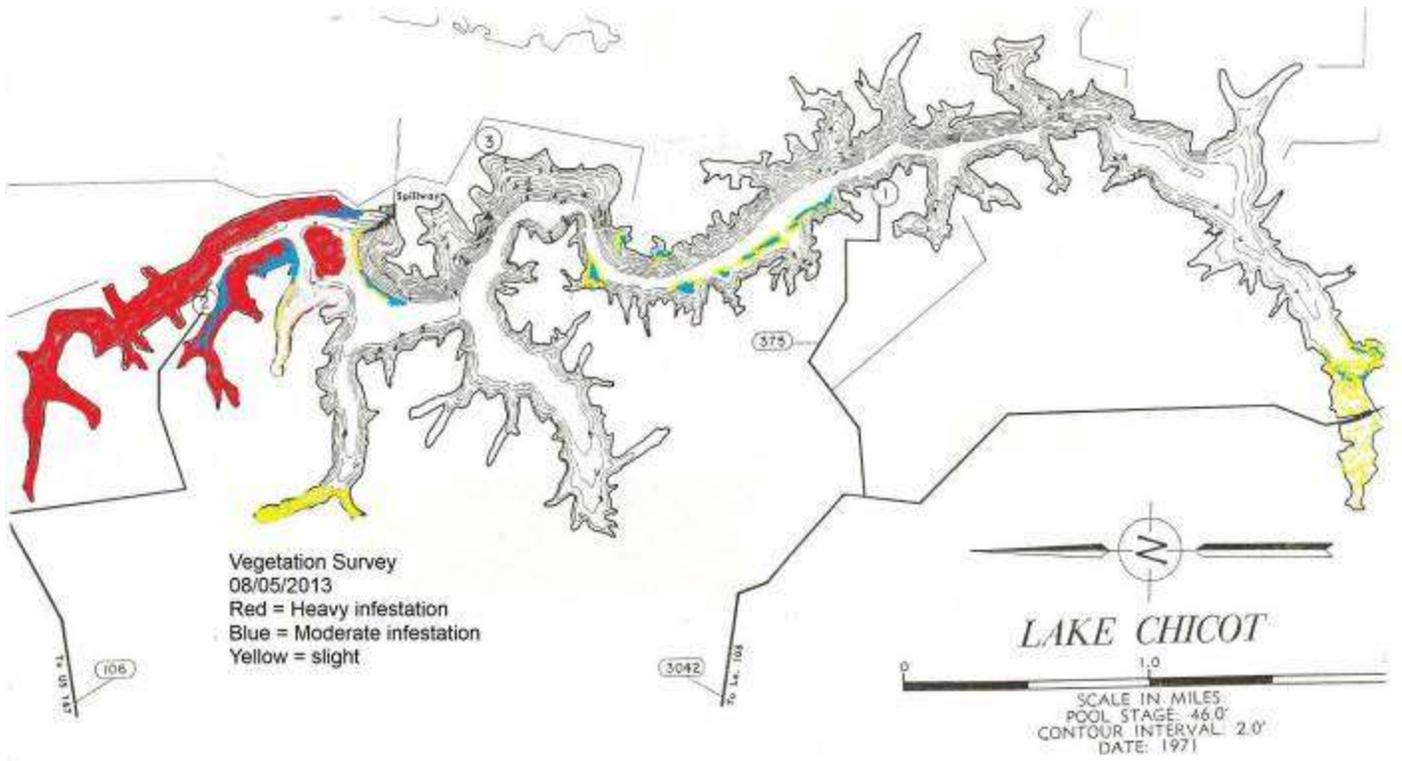
Chicot Vegetation Type Map

Common salvinia (*Salvinia minima*) was the predominant species of floating vegetation. Other floating plants observed were water hyacinth (*Eichhornia crassipes*) and duckweed (*Lemna spp.*). Floating vegetation was not the main problem, although small pockets and fringes were scattered throughout the lake and within some coves. These small infestations were treated regularly throughout the growing season by District 6 spray crews.

A severe infestation of submerged and emergent aquatic vegetation was observed in the northern part of the lake adjacent to the boat launch and fishing pier, approximately 150 acres. The predominant species of submerged aquatic vegetation (SAV) were coontail (*Ceratophyllum demersum*), fanwort (*Cabomba caroliniana*), southern naiad (*Najas guadalupensis*), and hydrilla (*Hydrilla verticillata*). The predominant emergent species were American lotus (*Nelumbo lutea*), alligator weed (*Alternanthera philoxeroides*), and white water lily (*Nymphaea odorata*).

*Hydrilla was the dominant species in this area. Native plants made up the remaining submerged plants.

Walker Branch and Turtle Island were relatively clear of nuisance aquatic vegetation.

Several coves, as well as the very north and south ends of the lake, had moderate to severe infestations of a variety of nuisance aquatic vegetation. However, these areas were densely forested, shallow, and considered inaccessible.

An estimated total of 175 acres of nuisance aquatic vegetation was observed. The estimated total of accessible acreage is 1,350 acres. An estimated 14% of Chicot Lake was infested with nuisance aquatic vegetation (mostly SAV).

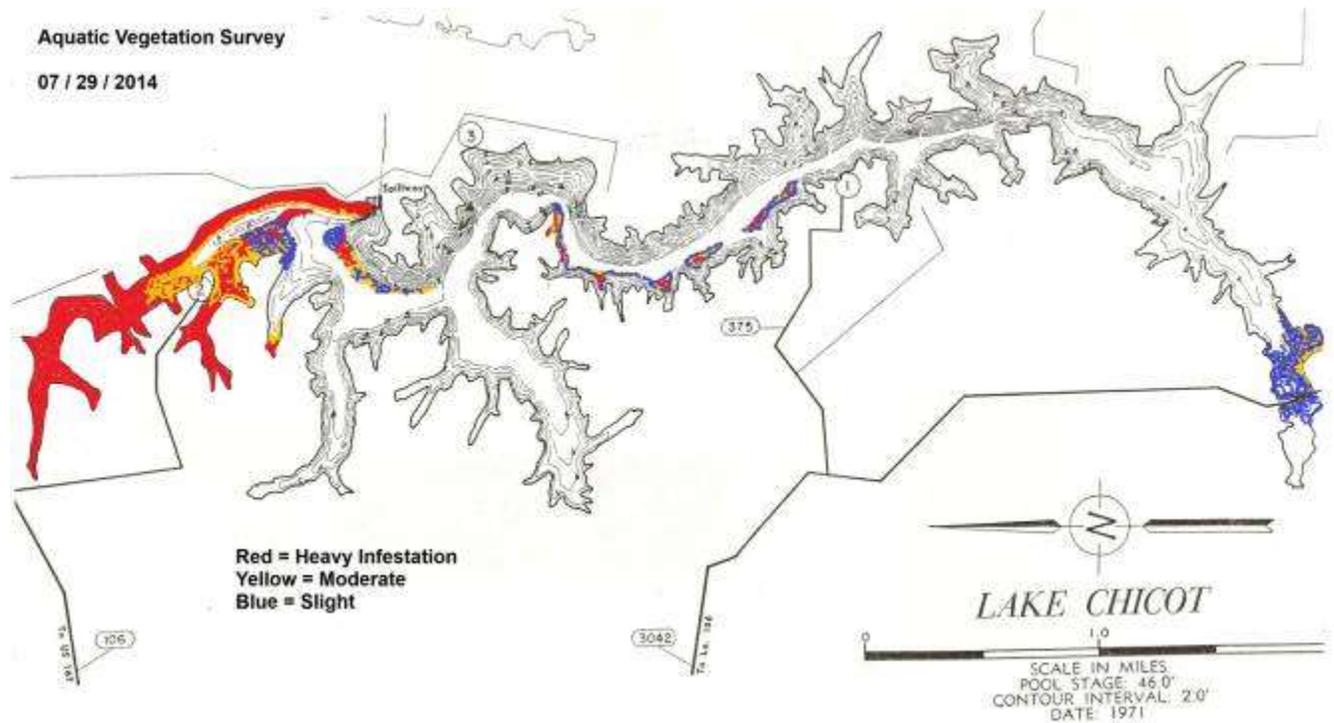
Chicot Vegetation Type Map

The north area of Chicot Lake in the vicinity of the North boat launch, spillway levee from the north boat launch to the spillway structure, center portion of ski-lake and north fishing pier continued to be plagued by *Hydrilla verticillata*. A significant amount of American Lotus also exists within this area. These areas were treated with a limited amount of fluridone pellets in April of 2014. On the date of this survey, a slight reduction in hydrilla was seen within the treated areas. The lotus stand was just as thick as it was last year at the time of survey. The cold winter of 2013 appears to have had little effect upon the lotus. Six hundred grass carp were stocked into Chicot Lake at the north boat launch in October of 2013. The problem areas of hydrilla in Chicot Lake do not appear to have grown in aerial coverage with little to no hydrilla experienced outside of this defined vicinity. Conservation cove, Turtle Island Cove and Walker's Branch were free of hydrilla infestations. An increase of native submerged vegetation was found in areas bordering the hydrilla laden area. Submerged vegetation seen occupying these areas were coontail and fanwort. No bladderwort was observed. Proceeding south out of the north flats, hydrilla occurrence diminished quickly except for a small patch in the area of the lake near the spillway. No hydrilla was observed south of Area 2 boat launch.

A significant amount of water primrose, alligator weed, swamp smartweed and taro continued to exist upon the shallow spoil bank area of the mid lake locations between Area 2 boat launch and the south boat launch. This vegetation had been treated twice with glyphosate during the spring and summer and appeared to be under control. Not all of this vegetation was eradicated since it is a popular fishing location and does provide successful fish cover. This area requires continual upkeep but, has proven manageable so far.

Primrose, taro and alligator weed were also found in moderate to heavy amounts on the western bank of the spoil mounds separating Turtle Island Cove from the spillway canal. This area has had continual maintenance by the herbicide spray crew, receiving treatments a couple of times per year, but has proven to be manageable and does offer good crappie fishing opportunities. Minimal amounts of primrose and alligator weed were seen in the terminal south end of Chicot Lake.

Little to no common salvinia was observed. What was seen was a light fringe of common salvinia throughout the lake, with no specific location holding large amounts. Salvinia was seen beneath the clumps of giant cutgrass found on many of the bank points of the lake. The cutgrass appears to have thinned some due to this past year's very cold winter weather with most clumps being comprised of new growth rather than older brownish colored cutgrass typical of plants carried over from last summer. The cold winter more than likely was responsible for the common salvinia reduction. This was quite a difference from past years in which common salvinia was seen blanketing the lake surface. A reduction in common salvinia was seen throughout all District 6 lakes this year. NO GIANT SALVINIA OBSERVED.

A heavy amount of filamentous algae was observed in the hydrilla beds on the north flats and within the terminal end of Conservation Cove. These locations are both close to campground areas. The cove adjacent to the south end pier has also had a problem with algal growth in years past, but was free of any problem vegetation on the day of survey.

A partial de-watering of Chicot Lake was begun on Sep. 2, 2014. Water levels were dropped slowly to facilitate the stranding of embanked and shallow water vegetation. The spillway gates were closed in September and the lake allowed re-filling by late December. The spillway gates at Chicot Lake open at the bottom and allow for the gradual removal of poor quality water typically found within the bottom portions of the lake.

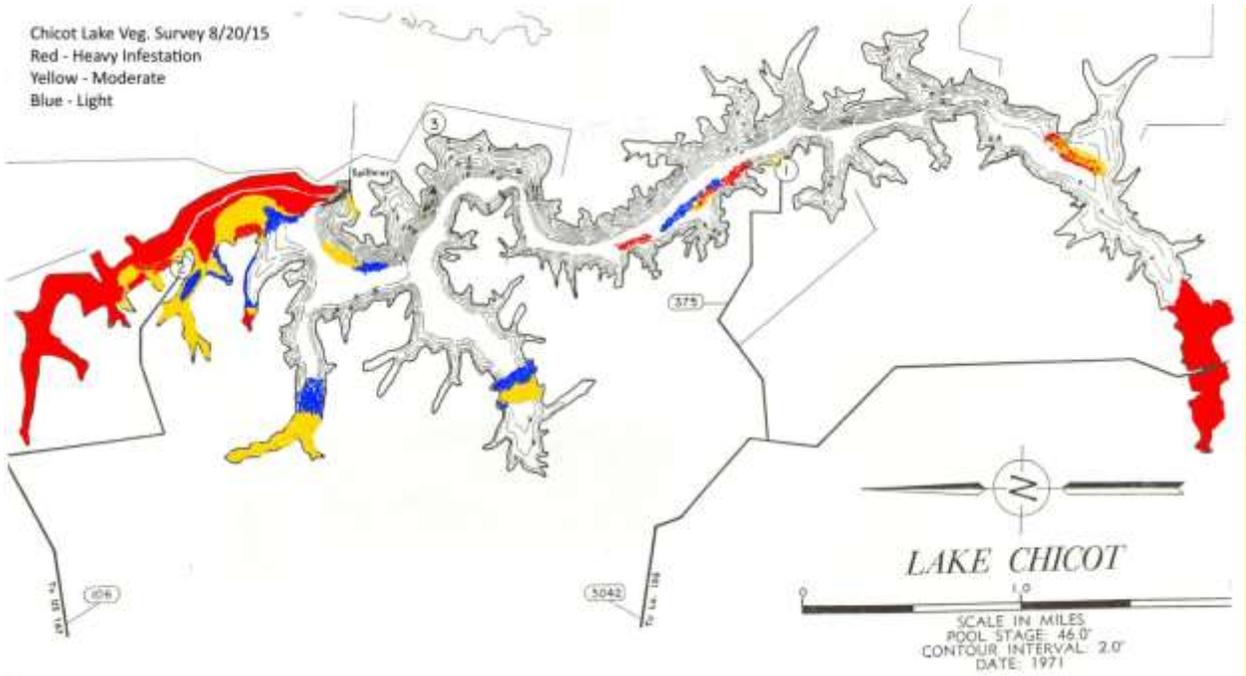
Chicot Lake Veg. Survey 8/20/15
Red - Heavy Infestation
Yellow - Moderate
Blue - Light

A survey of aquatic vegetation conducted on Chicot Lake revealed a moderate to heavy infestation of vegetation on the north end and southern tip of the lake. A very light infestation was observed in the remainder of the system. Water level in the lake on the day of the survey was five inches below pool.

The north area of Chicot lake in the vicinity of the North boat launch, spillway structure, center portion of ski lake, and north fishing pier flats continue to be heavily infested with submerged vegetation consisting of hydrilla (*Hydrilla verticillata*), fanwort (*Cabomba caroliniana*), coontail (*Ceratophyllum demersum*), and light patches of bladderwort (*Utricularia* spp.). Some light to moderate areas of filamentous algae were also observed in this area. A significant amount of American Lotus (*Nelumbo lutea*) also exists from the spillway structure to the flats near the north boat launch.

Light to moderate amounts of submerged vegetation, hydrilla, fanwort, water milfoil (*Myriophyllum verticillata*), and coontail, were observed in conservation cove and in the wooded area just north of the mouth of conservation cove. A light fringe of common salvinia (*Salvinia minima*), water hyacinth (*Eichhornia crassipes*), and alligator weed (*Alternanthera philoxeroides*) was seen in conservation cove. The shallow end of the cove was heavily infested with aquatic vegetation. A significant amount of common salvinia with very light patches of Giant Salvinia was observed in the wooded area. Giant salvinia was also seen in the vegetative fringe of conservation cove. **This is the first discovery of giant salvinia in Chicot Lake to this date.**

Turtle island cove and Walker's branch contain light amounts of hydrilla, fanwort and coontail. A moderate amount of submerged vegetation and filamentous algae was observed in the open water area near the bridge in walker's branch. Dominate submerged species found in this area were fanwort and coontail. No bladderwort observed. Primrose, taro (*Colocasia esculenta*) and alligator weed are also found in moderate to heavy amounts on the western bank of the spoil mounds separating Turtle island cove from the spillway canal (boat channel). This area near the spoil mounds is lightly treated annually. Being this is a popular fishing location, not all of this vegetation is eradicated. It provides fish cover and fishing success.

As you move south towards the vicinity of the Area 2 boat launch the occurrence of submerged vegetation quickly diminishes. Very light patches of submerged vegetation were only observed in the shallow terminal ends of some small coves off the main lake. Area 2 boat launch was mostly free of vegetation with only light patches of hydrilla being visible. No hydrilla was observed south of Area 2 boat launch except for a light fringe near the south boat launch. Light to moderate patches of common salvinia were also seen near the south boat launch.

A moderate amount of water primrose (*Ludwigia* spp), alligator weed, swamp smartweed (*Polygonum hydropiperoides*) and taro continue to exist upon the shallow spoil bank area of the mid lake between Area 2 boat launch and the south boat launch. This vegetation is also lightly treated annually to keep it under control. Not all of this vegetation is eradicated since it is a popular fishing location and does provide successful fish cover.

Light to moderate patches of primrose, water hyacinth, and alligator weed were seen in the terminal south end of Chicot Lake in the Blue Springs area and near the Indian Hills bridge. A significant amount of duckweed was also observed near the Indian Hills bridge.

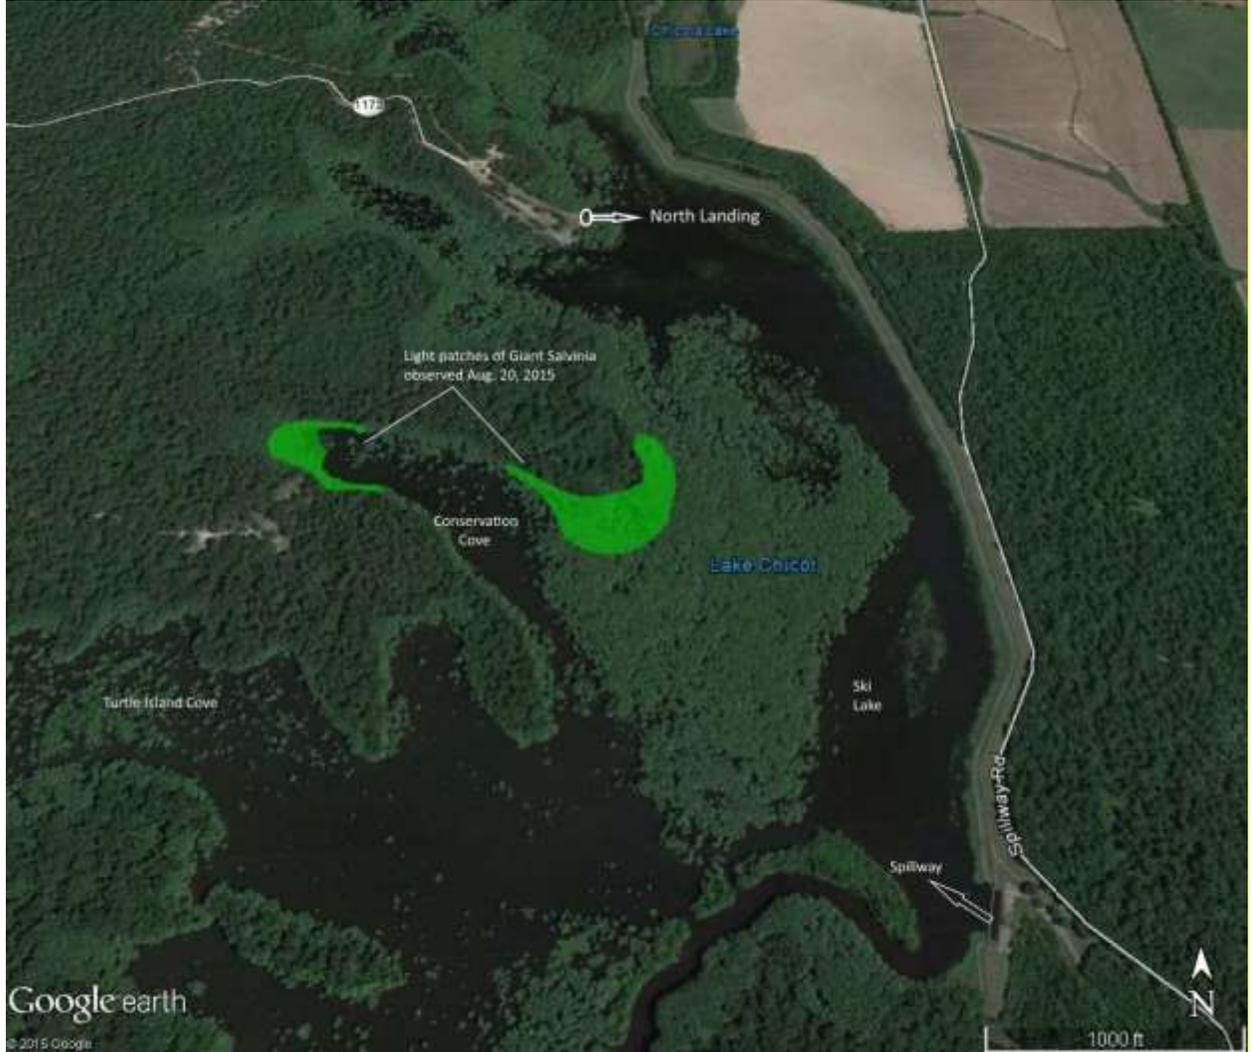
Map of where Giant Salvinia was observed

Unfortunately, GIANT SALVINIA has made its way into Chicot Lake!
