# **LOUISIANA DEPARTMENT OF WILDLIFE & FISHERIES**

**WATERBODY MANAGEMENT PLAN SERIES**

**COCODRIE LAKE**

**AQUATIC VEGETATION TYPE MAPS  
AND NARRATIVES – 2016**

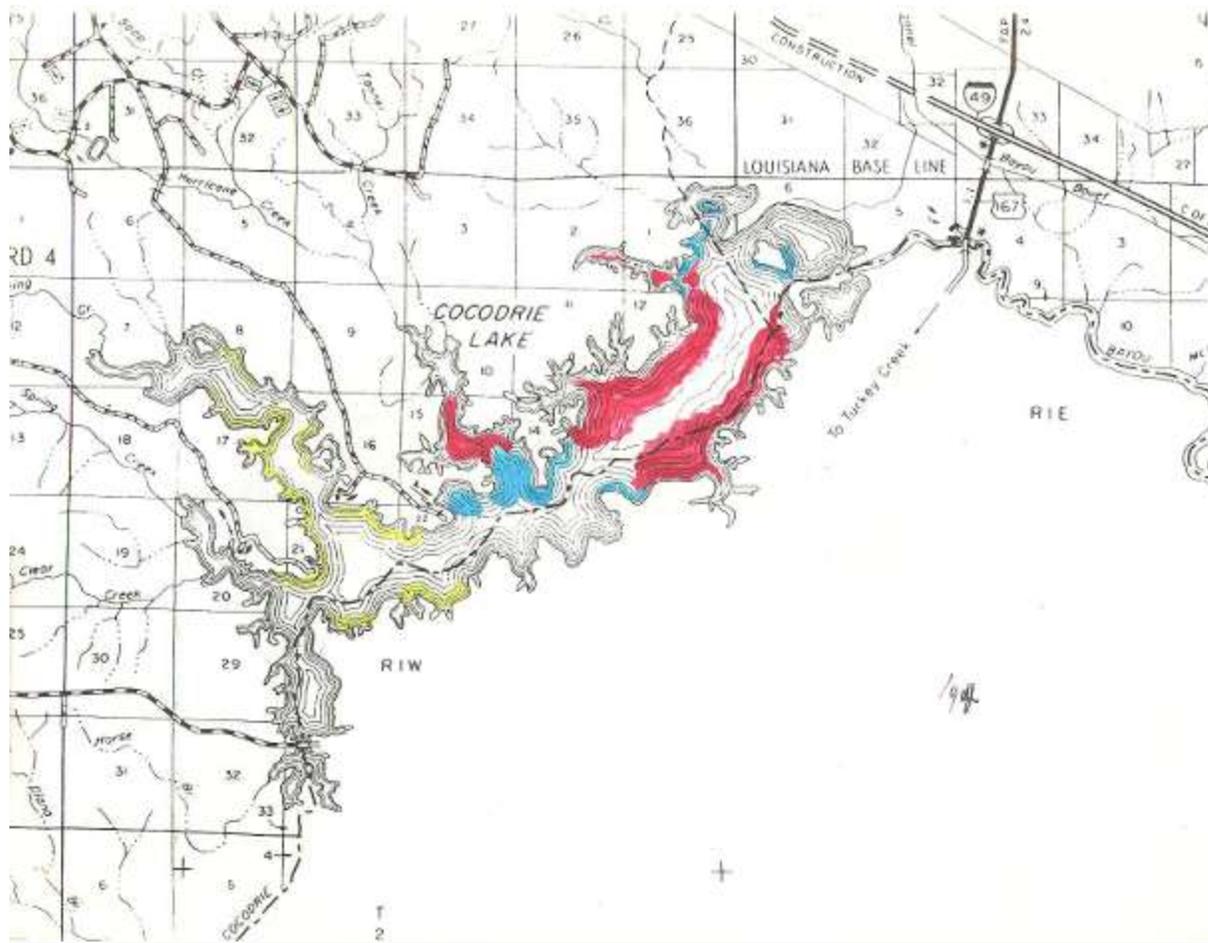
COCODRIE LAKE TYPESMAP  
8/21/94

A survey was made of Cocodrie Lake in Rapides and Evangeline parishes on September 21st to evaluate aquatic weed infestations. The major boat lanes and most of the shoreline areas were open to boating and fishing. Problems were found in the shallow water bay and cypress-tupelo swamp areas.

The cypress-tupelo flooded sections on the west end of Cocodrie Lake had a severe infestation of water hyacinth. In this part of the lake, duck hunters seemed to be affected most by the dense growth of plants. Hyacinth also lined the channel from Johnson's Landing to the dam along Hwy. 147.

The bay waters on the north side of Cocodrie Lake had a moderate to severe infestation of osagea, coontail, and bladderwort restricting boating and fishing in those areas.

In summary, a significant portion of Cocodrie Lake was open to water related recreation. The major hyacinth problems were in remote sections of the swamp where water depths ranged two to three feet and the bottom was littered with tree stumps, limbs, and other debris making travel by conventional boat almost impossible. Submerged weed problems were light along the shoreline and no water hyacinth plants were found in the eastern one-half of Cocodrie Lake.

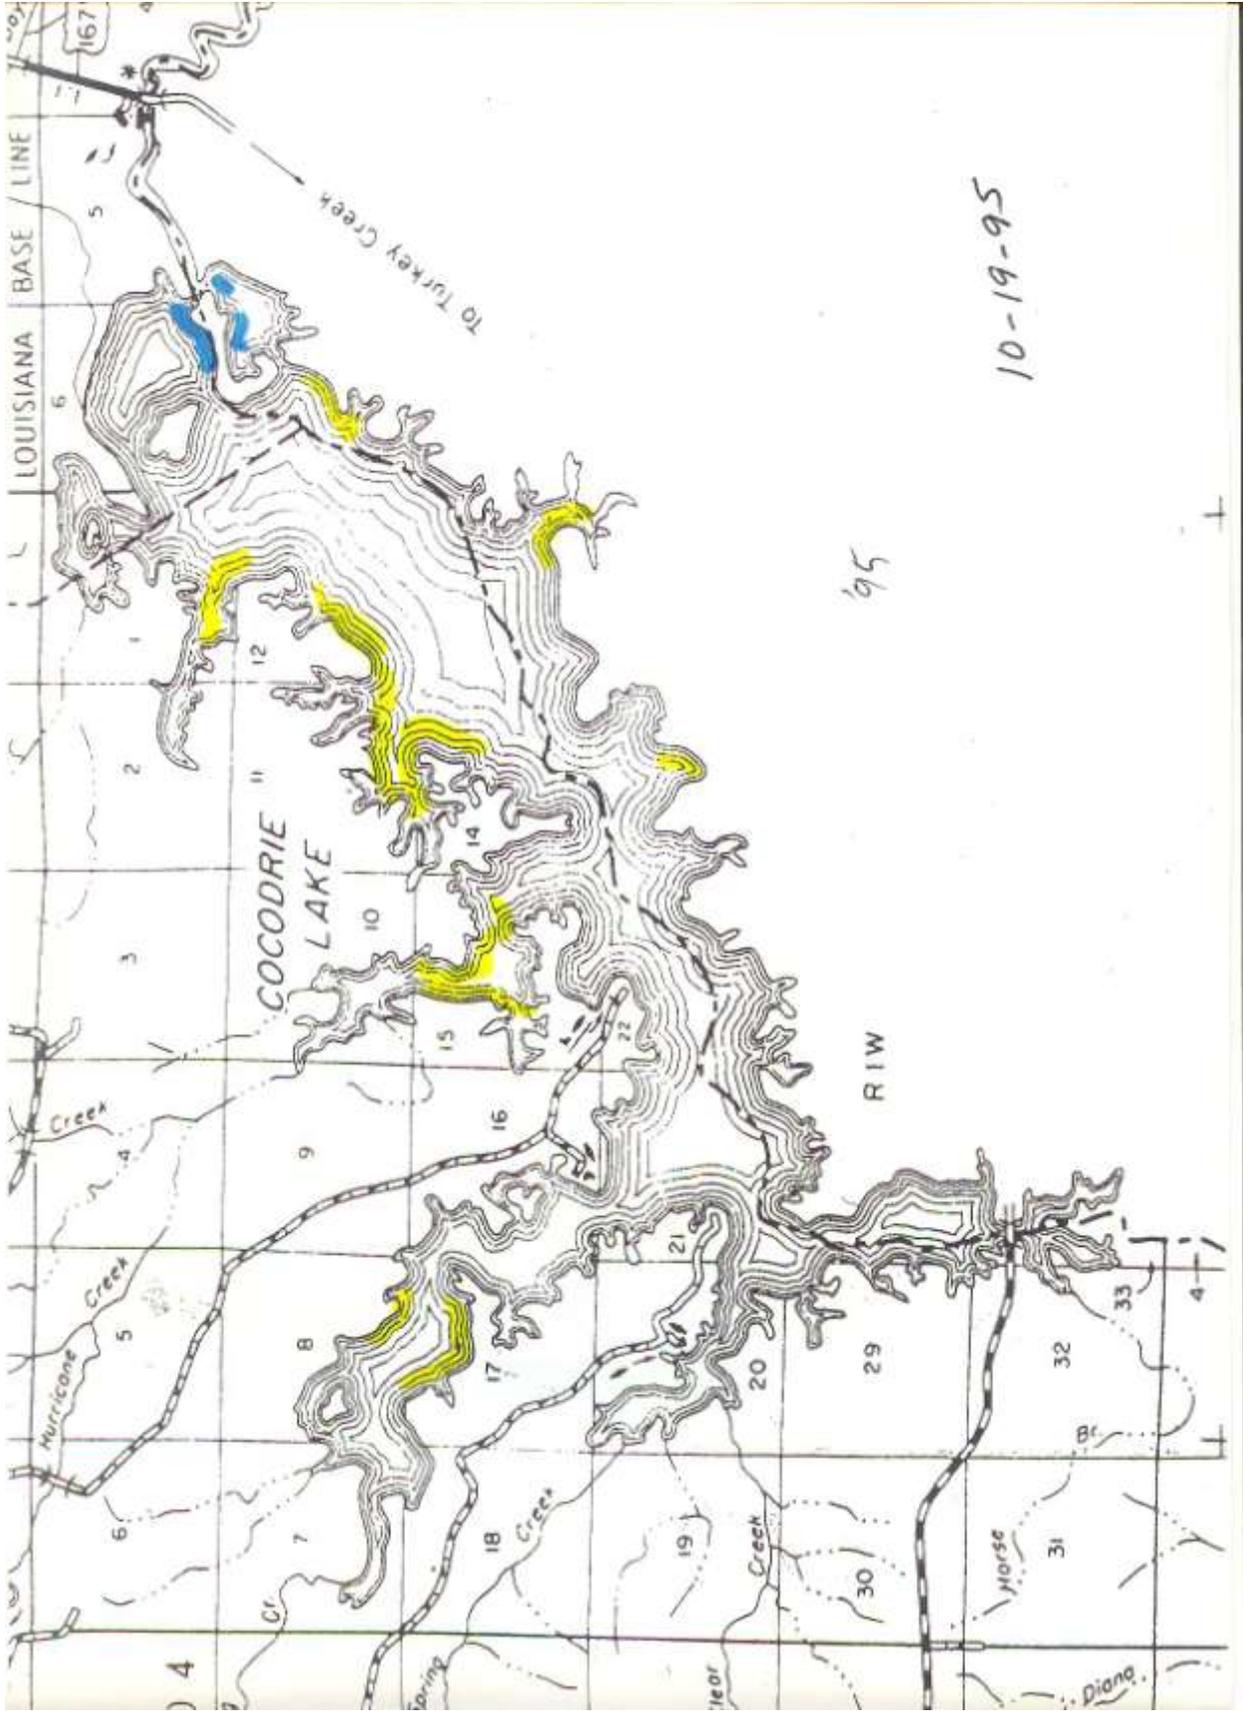
COCODRIS LAKE TYPEMAP  
October 19, 1995

Cocodris Lake was surveyed October 18, 1995. No serious water weed problems existed in Cocodris Lake at the time of this visit. Water weed problems were dramatically improved over the 1994 survey period.

In April of 1995 there was an unusually high water situation in Cocodris Lake. This may have been a significant factor in reducing the overall weed problems.

During this survey, all coves and backwater areas were completely accessible by boat and a number of fishermen were taking advantage of the improved conditions. Free floating coontail and bladderwort sprigs were observed from time to time with an occasional patch of coontail several yards in diameter. The infestation of submergents was very light and at no time posed a problem to water recreation activities.

Water hyacinth were not present in the main body of the lake. These plants were found in the backwater areas along the old channel of Cocodris bayou where it leaves the lake. Water hyacinth was the dominant aquatic weed, but these plants were restricted to shallow backwater areas which were unmanageable. One interesting observation was the high population of weevils found on these plants. All of the water hyacinth plants had a very large number of feeding spots on the leaves and at the base of each leaf. These weakened plants had browned out leaves apparently caused from a secondary fungal infection.

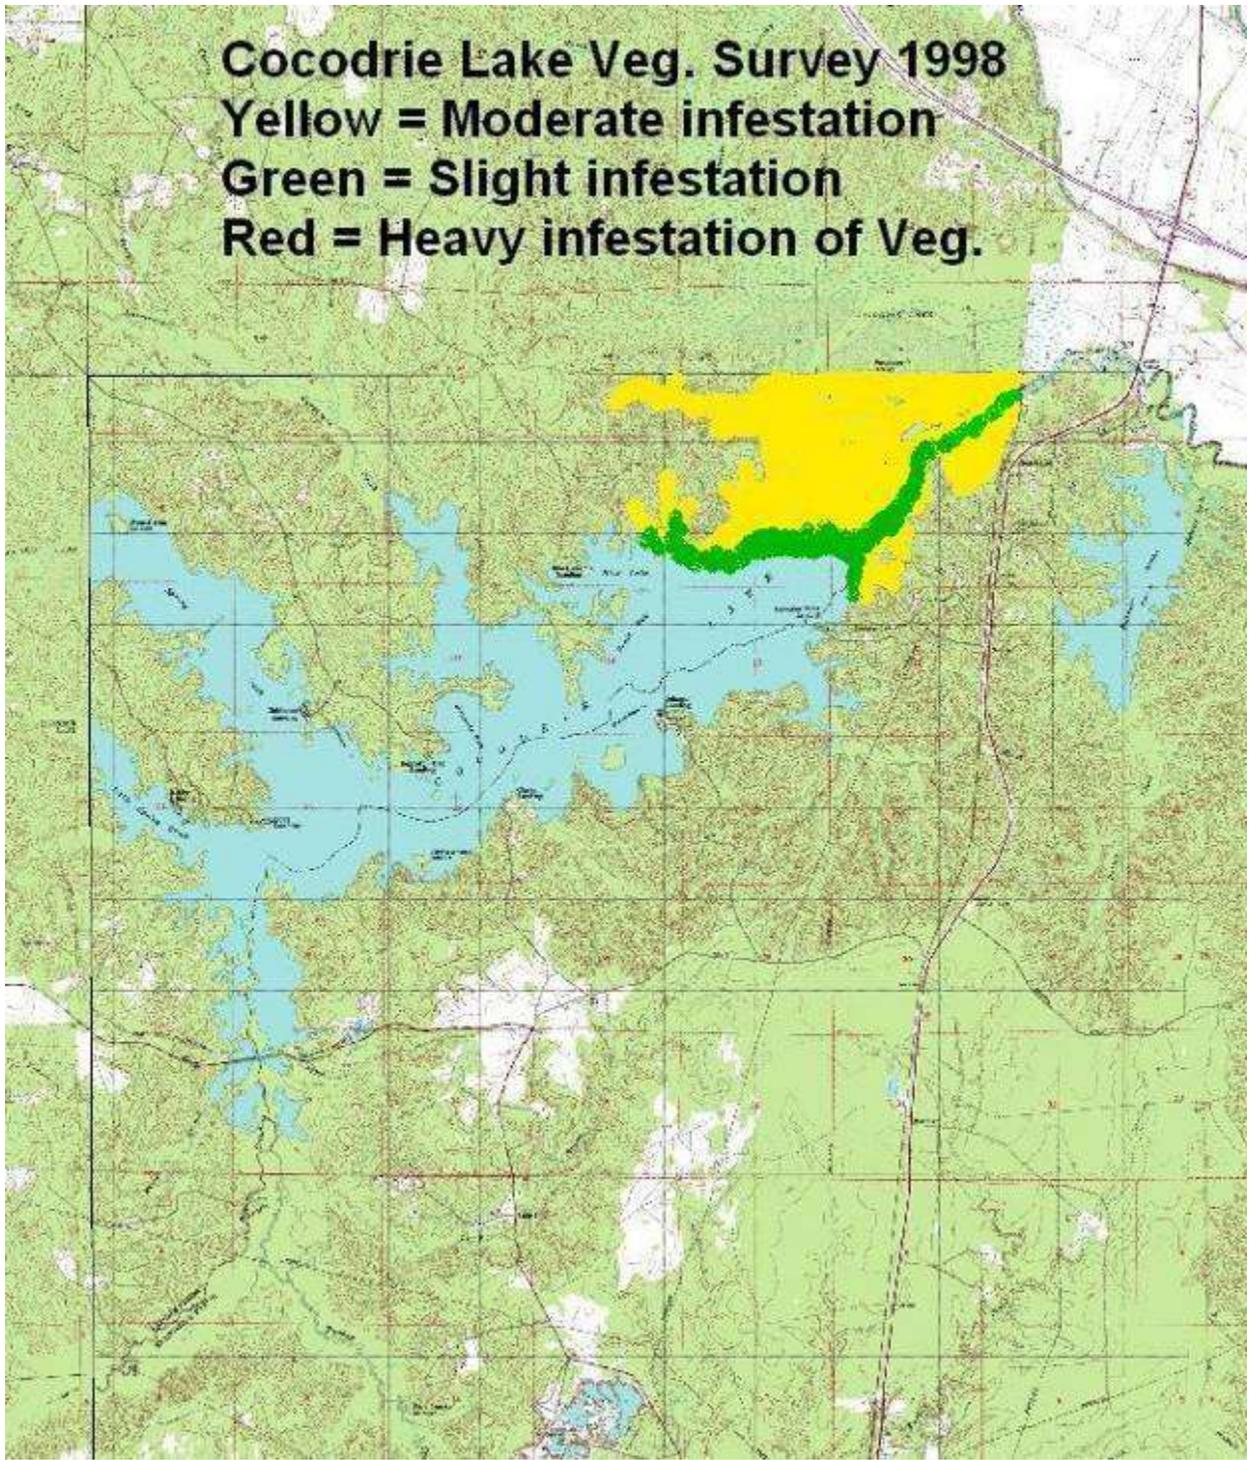
**Cocodrie Lake Veg. Survey 1998**  
**Yellow = Moderate infestation**  
**Green = Slight infestation**  
**Red = Heavy infestation of Veg.**

The southwestern 3/4ths (upper end) of the lake was in excellent condition and no floating aquatic plants were observed during the survey in this area. The waters around Clark's landing, Buck's landing, Bennetts Bay, and the main body of the lake were all problem free. Smartweed, buttonbush, and a few marginal aquatic grasses were found around the lake margin and in shallow backwater areas. Occasionally, a spring or two of coontail or bladderwort could be seen floating near the surface. No submerged aquatics were brought to the surface in this area as a result of random drag sample efforts.

The northeastern 1/4th (lower end) of the lake supported a moderate infestation of water hyacinth, *Eichhornia crassipes*, and salvinia, *Salvinia rotundifolia*. These plants were found in the area of flooded tupelo gum and cypress on both sides of the channel leading to the dam. Infestations of coontail, cabomba, and bladderwort were light in this section of the lake.

In summary, approximately 75% of Cocodrie lake was free of aquatic plant growth. The major aquatic plant problem was water hyacinth which was found only in the lower end of the lake in tree studded areas difficult to reach by boat. The salvinia infestation was also confined to the lower end of the lake. Salvinia was widely scattered in this area and is currently not causing a problem. Submergent weeds were the least abundant of all aquatic vegetation in the entire lake and posed no problems.

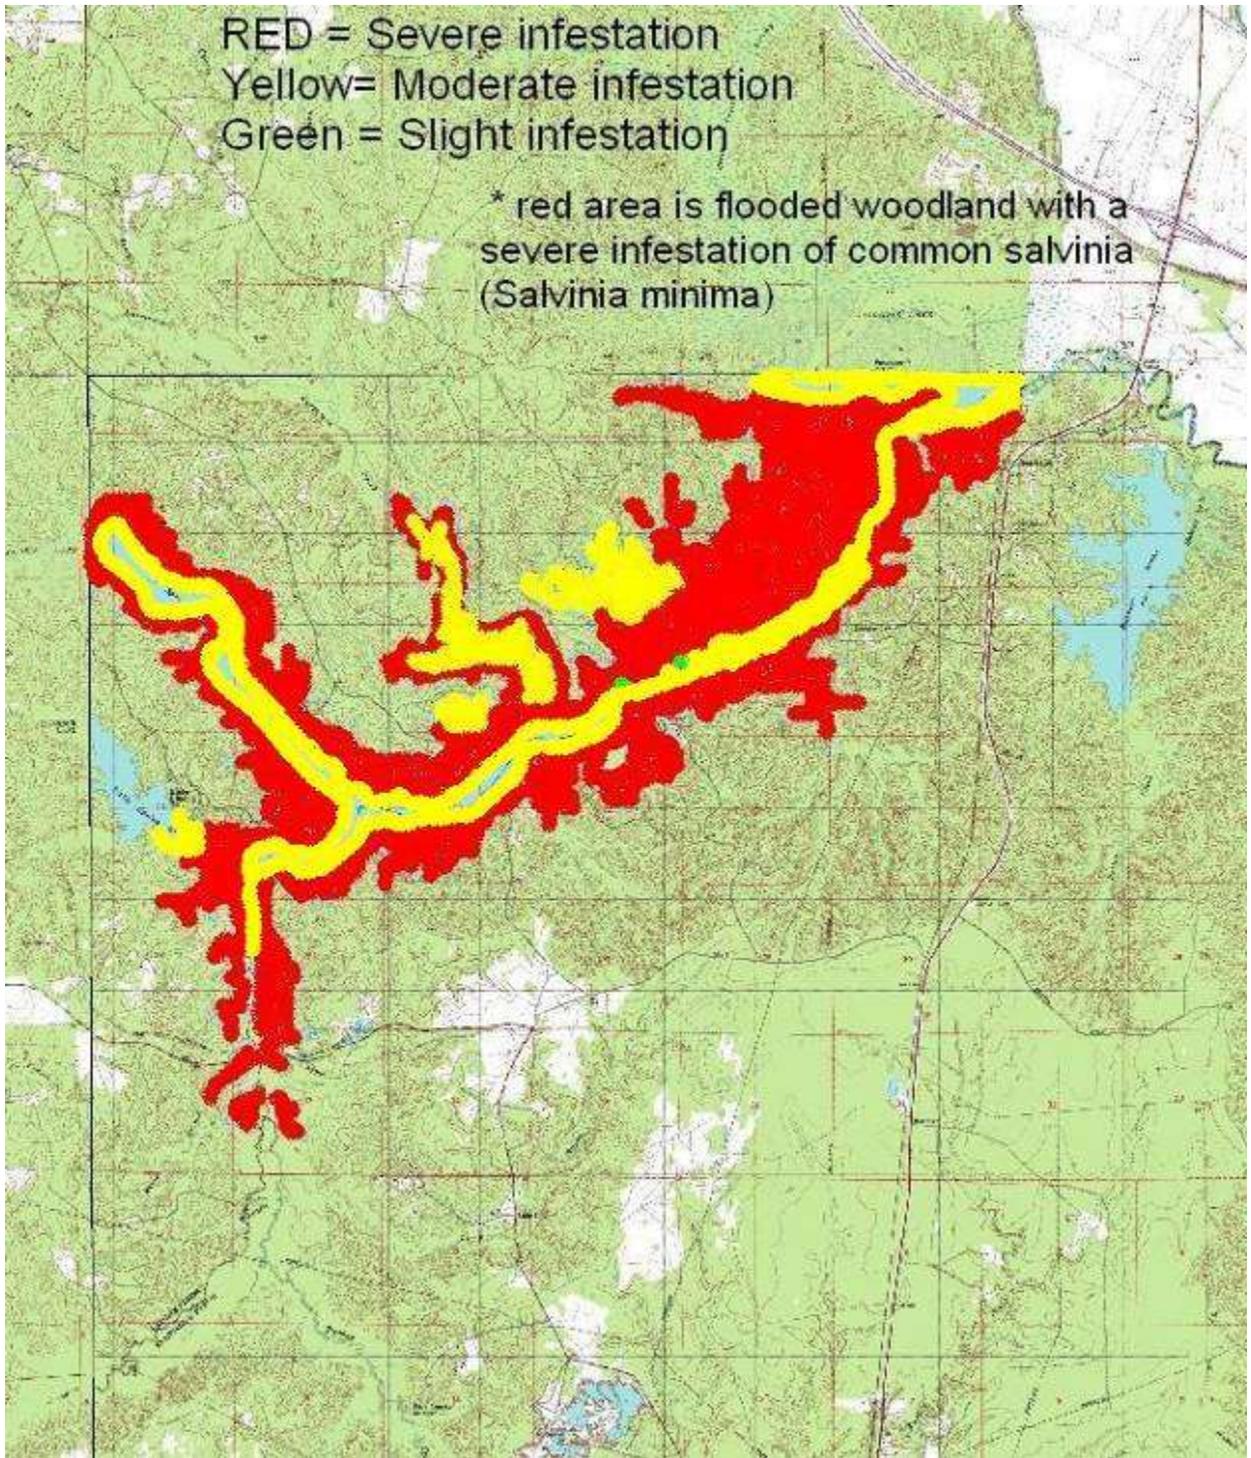
**2005 Aquatic Vegetation Survey  
Cocodrie Lake Sep. 23**

Cocodrie Lake is close to completely covered with common salvinia (*Salvinia minima*) this year. Areas of the lake where common salvinia are not found include the center of the main channel and center locations of Bennett's bay and blue hole. All flooded woodland areas of the lake contain copious amounts of common salvinia and is marked red on the attached map. Other vegetation observed include Common bladderwort (*Utricularia vulgaris*), Cabomba (*Cabomba caroliniana*), Coontail (*Ceratophyllum demersum*), Parrot feather (*Myriophyllum brasiliensis*), Primrose (*Ludwigia* spp.) and White water lily (*Nymphaea odorata*). This vegetation is found in the large shallow coves surrounding the deeper center channel and is marked yellow on the attached map. Small amounts of water-milfoil (*Myriophyllum spicatum*) were seen on the edge of the center channel and this is marked green on the attached map.

RED = Severe infestation  
Yellow= Moderate infestation  
Green = Slight infestation

\* red area is flooded woodland with a severe infestation of common salvinia (*Salvinia minima*)

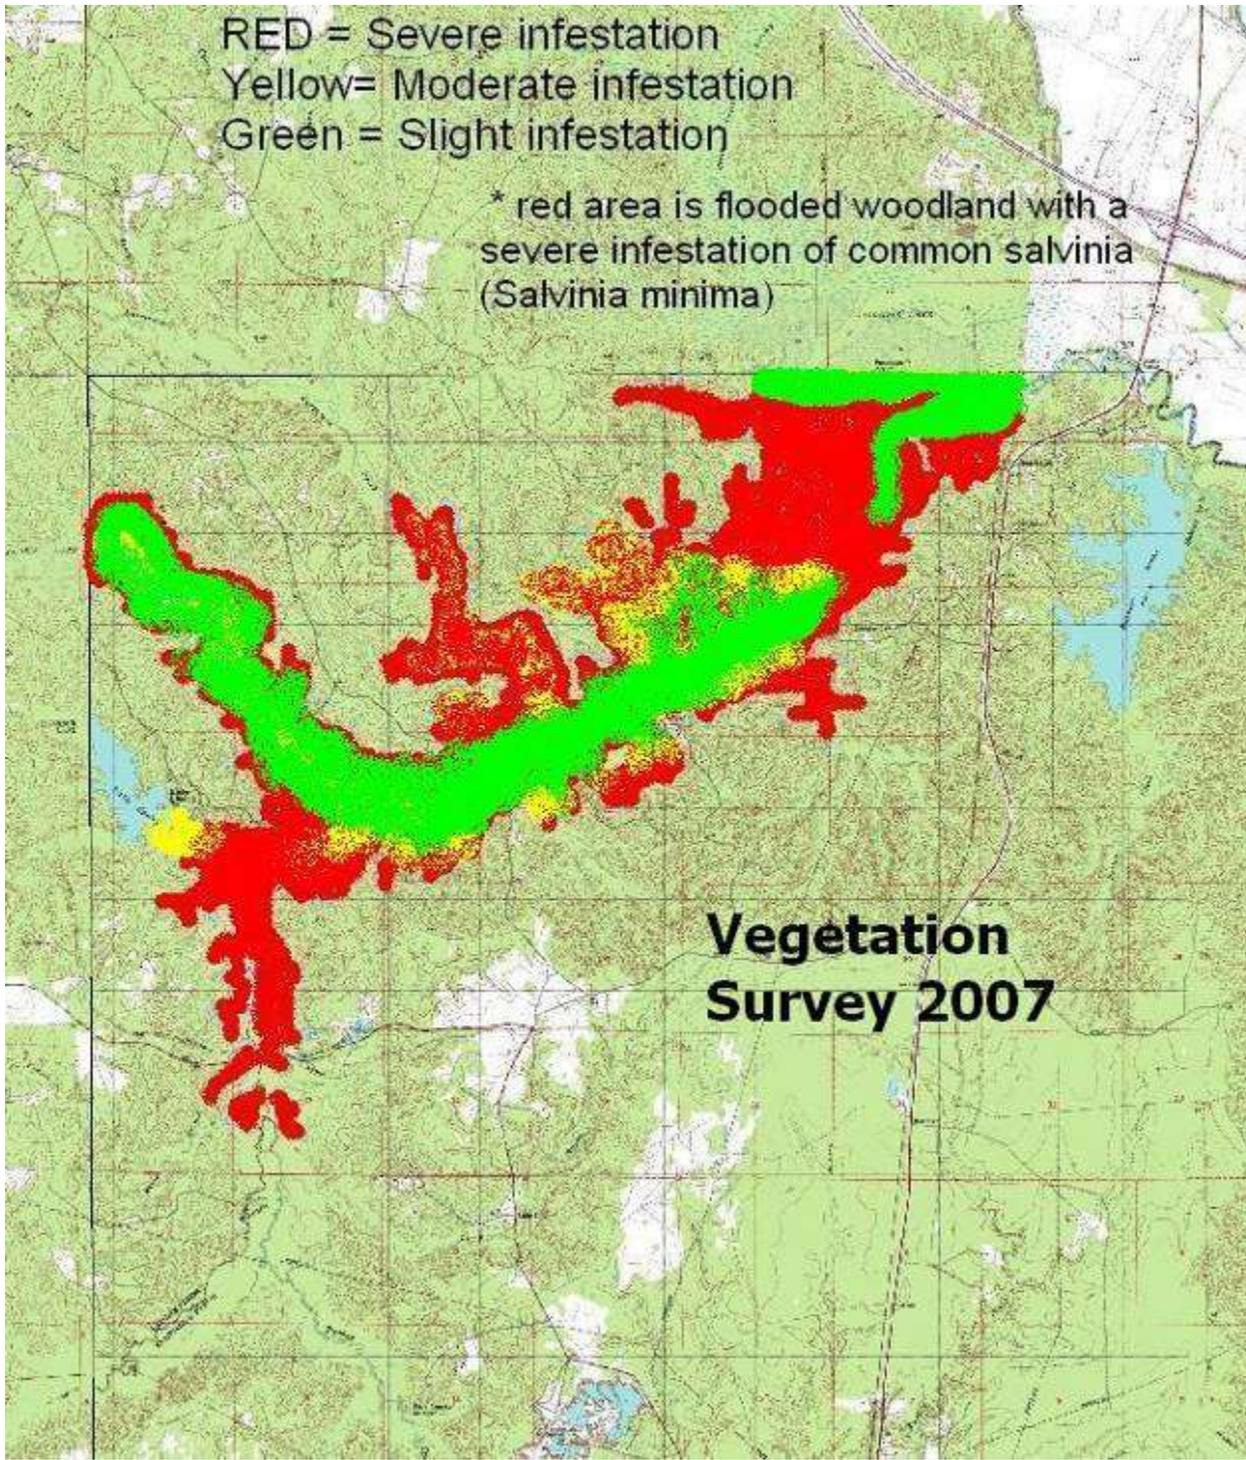
## 2007 Aquatic Vegetation Survey Cocodrie Lake

Cocodrie Lake has less coverage of common salvinia (*Salvinia minima*) this year than the lake displayed in Sep. of 2005. Areas of the lake where common salvinia are not found include the main channel. This is marked in green on the map. Green areas of the map are areas that were treated throughout 06 and 07 with reward. Many of the flooded woodland areas of the lake still contain copious amounts of common salvinia and are marked red on the attached map. The spillway area of the lake displayed slight amounts of vegetation. Other vegetation observed include Common bladderwort (*Utricularia vulgaris*), Cabomba (*Cabomba caroliniana*), Coontail (*Ceratophyllum demersum*), Parrot feather (*Myriophyllum brasiliensis*), Primrose (*Ludwigia* spp.) and White water lily (*Nymphaea odorata*). This vegetation is found in the large shallow coves surrounding the deeper center channel. Coverage by submerged vegetation in these shallow coves is severe and marked in red on the map. Little lake, a deeper cove located on the southwestern edge of the lake has slight to no vegetation.

RED = Severe infestation  
Yellow= Moderate infestation  
Green = Slight infestation

\* red area is flooded woodland with a severe infestation of common salvinia (*Salvinia minima*)

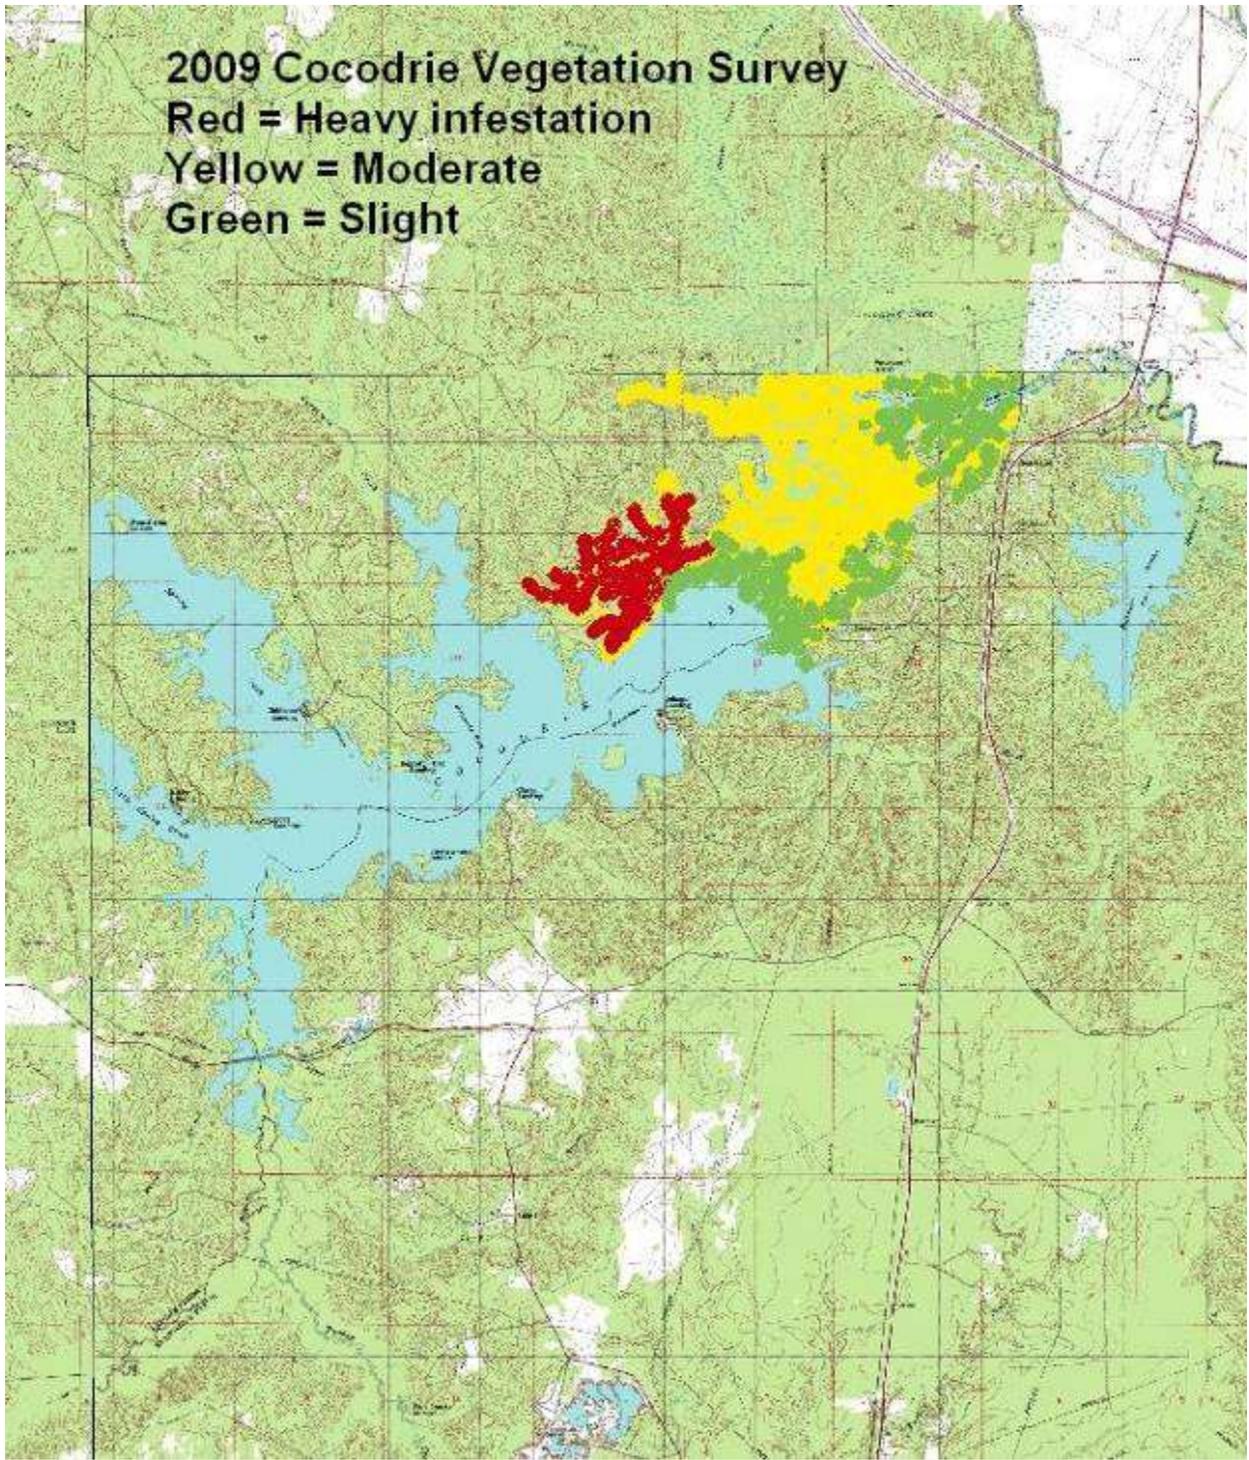
**2009 Cocodrie Vegetation Survey**

Cocodrie Lake is going in the last year of its three year drawdown which began in 2008 to control the spread of common salvinia. A survey was conducted on September 16<sup>th</sup>, 2009 to observe common salvinia. The lake was approximately 4 feet below pool stage. Common Salvinia was observed near the northwest end of the lake, near blue lake, in the channel. Majority of the wooded areas were dry which has reduced the amount of common salvinia. Other areas observed was Bennett's Bay and Little River where no vegetation was discovered. Neal's Bay and Blue Lake had moderate to heavy amounts of common salvinia and light amounts of fanwort and hydrilla. Majority of the common salvinia was in the channel flowing towards the control gate.

**Red = Heavy infestation**

**Yellow = Moderate**

**Green = Slight**

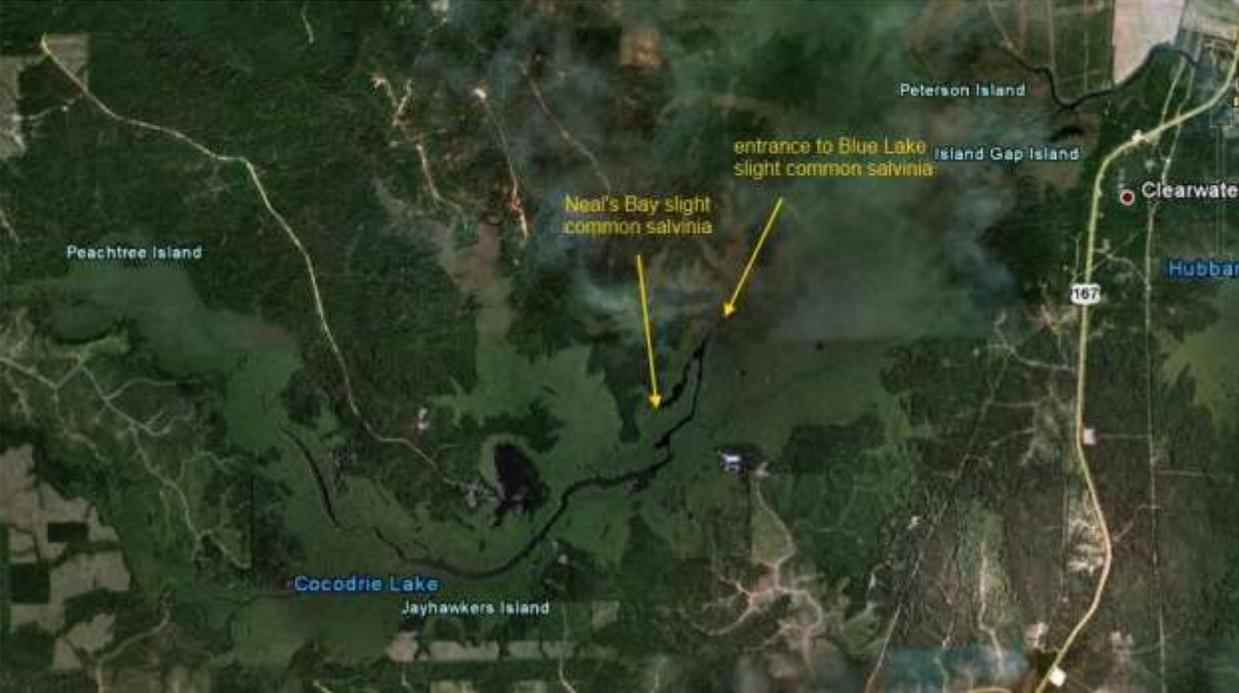
Dissolved oxygen levels were above 3.0 mg/l at the surface throughout the system however these levels were below 2.0 mg/l and often below 1.0 mg/l at any depth greater than 3.0 feet. Water temperatures were above 30 degrees centigrade at surface and pH was found to be above 6.0 at both surface and bottom at all stations recorded. One boat with one person was observed fishing in Bennett bay.

Date	Temp	SpCond	Salinity	Depth	pH	pHmV	Turbidity+	Chlorophyl	d.o. percent	d.o. mg/l	
08/16/11	29.67	0.063	0.03	3.087	6.93	3.9	269.4	46.8	5.00	0.38	bennet
08/16/11	31.87	0.063	0.03	0.609	6.99	0.3	3.4	17.7	59.20	4.33	
08/16/11	18.06	0.178	0.08	8.868	6.56	23.7	39.9	54.5	4.70	0.45	little lake
08/16/11	29.38	0.094	0.04	0.381	6.74	14.6	0.8	15.0	44.90	3.43	
08/16/11	21.06	0.166	0.08	10.899	6.60	21.7	27.3	56.0	3.80	0.34	fontenot
08/16/11	30.58	0.060	0.03	0.169	6.60	22.7	1.0	15.3	39.20	2.94

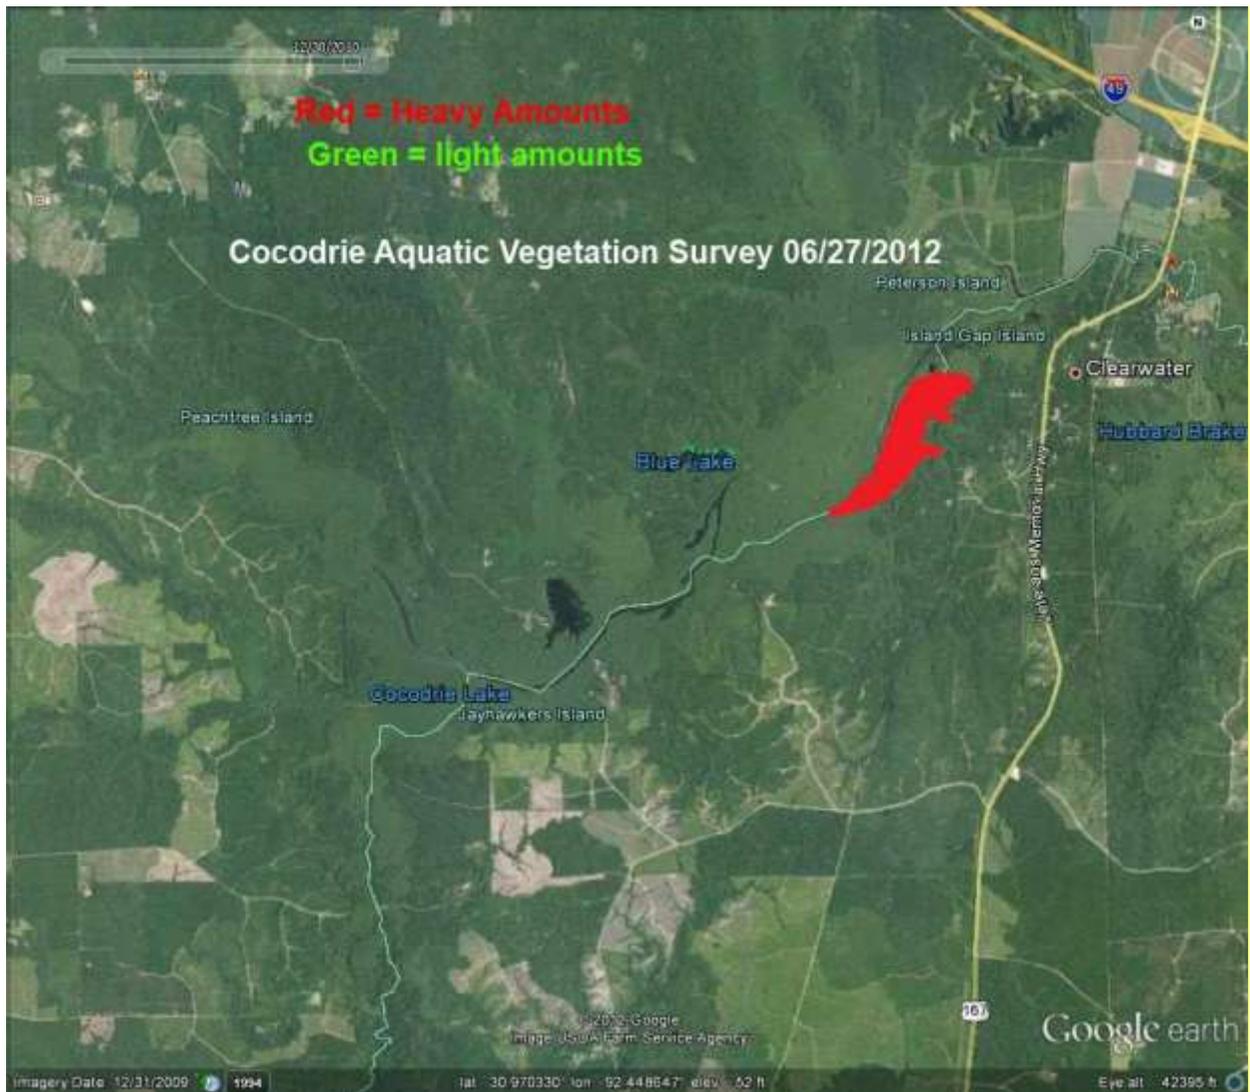
A survey of Bennet's bay revealed little to no aquatic vegetation with only small patches of white lotus observed. A bottom drag for collection of submerged aquatic vegetation rendered no result. Only decaying leaf material was obtained.

NO Giant Salvinia observed.

Date	Temp	SpCond	Salinity	Depth	pH	Turbidity+	Chlorophyl	D.O. mg/l	
06/27/12	20.64	0.100	0.05	11.759	8.82	6.1	65.6	1.48	fotenot ba
06/27/12	27.40	0.055	0.02	0.236	7.74	0.2	13.9	2.78	f bay
06/27/12	27.33	0.055	0.02	0.654	7.58	0.2	14.5	2.88	f bay
06/27/12	28.42	0.051	0.02	3.411	7.15	8.5	21.3	3.10	bennet
06/27/12	29.43	0.051	0.02	0.371	7.02	5.2	20.9	4.26	bennet
06/27/12	24.79	0.056	0.03	5.402	6.99	15.1	14.2	1.40	blue hole
06/27/12	26.85	0.054	0.02	0.666	6.80	0.6	13.3	2.24	blue hole
06/27/12	25.67	0.055	0.02	11.895	6.76	14.8	8.1	0.93	spillway
06/27/12	28.46	0.050	0.02	0.370	6.63	0.1	11.1	2.36	spillway
