LOUISIANA DEPARTMENT OF WILDLIFE & FISHERIES

WATERBODY MANAGEMENT PLAN SERIES

LAKE MARTIN

LAKE HISTORY & MANAGEMENT ISSUES

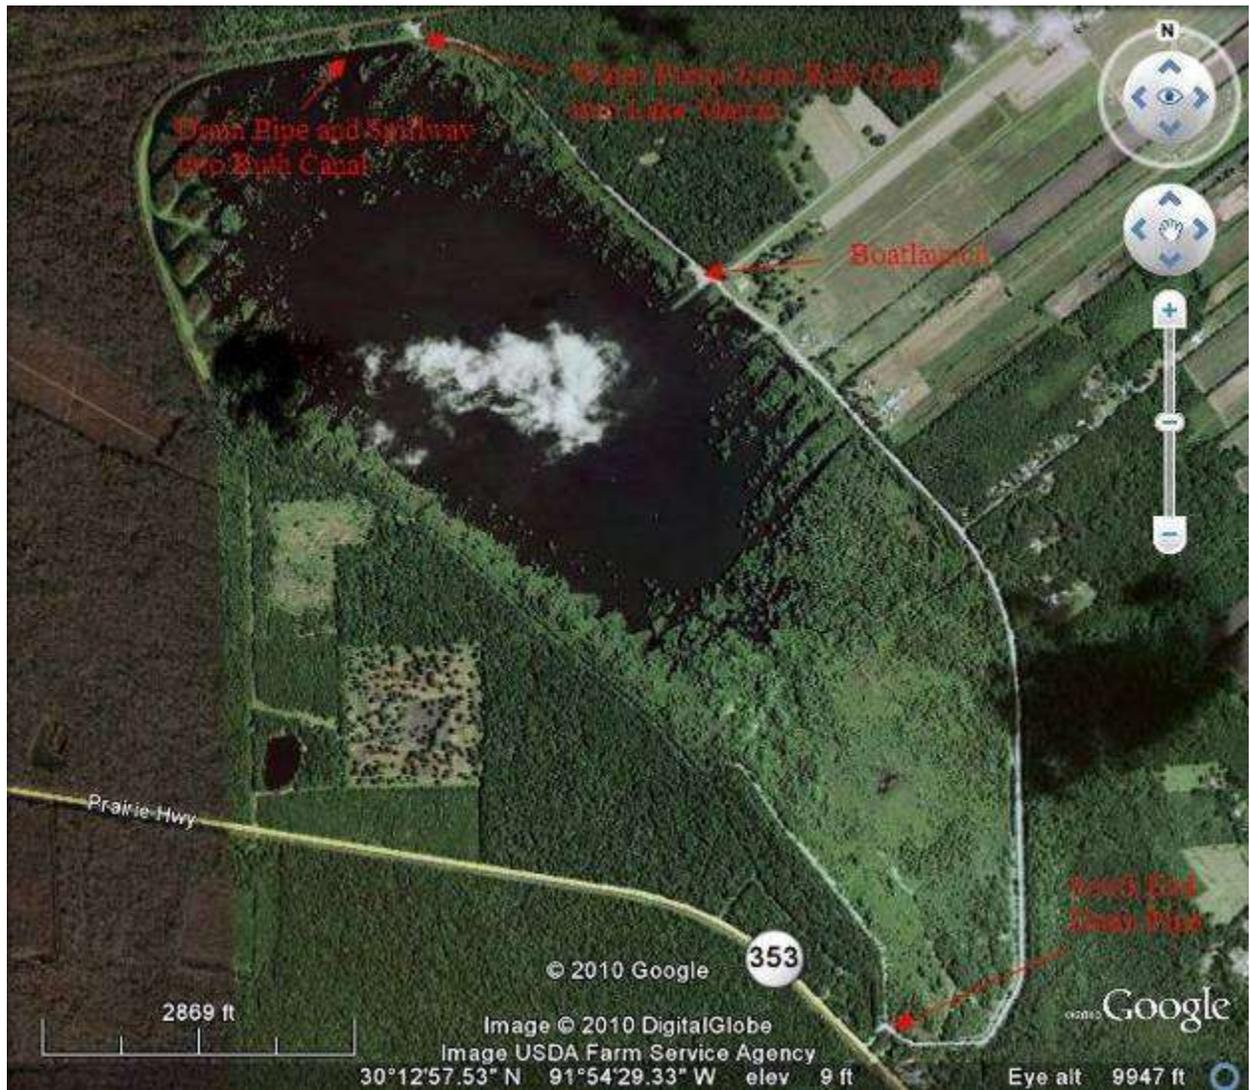
APPENDIX I

Map of Lake Martin depicting water control structures, pumping station, spillway and Boat Ramp.

Map with locations of boat ramp ([Appendix I](#)).

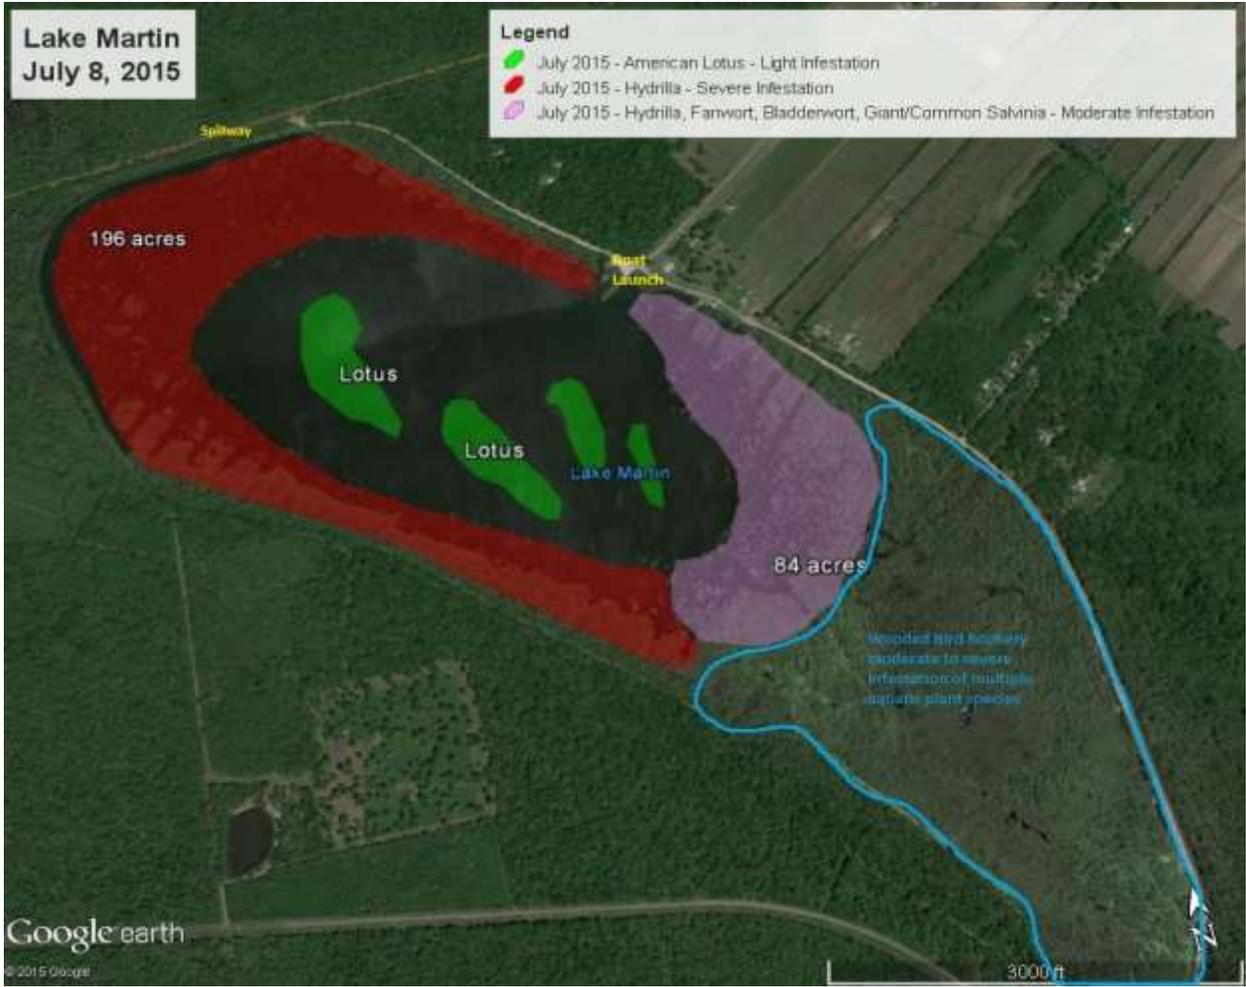
Lake Martin Vegetation Survey July 8, 2015

A survey of the present aquatic vegetation was conducted on Lake Martin on 7/8/2015.

At that time, a moderate to severe infestation of submerged vegetation was observed. Severe amounts of hydrilla were observed in the North/Northwest wooded areas of the lake. Moderate amounts of hydrilla, along with fanwort, bladderwort, and coontail were also observed in the wooded area adjacent to the Bird Rookery. Moderate amounts of common and giant salvinia, along with slight amounts of water hyacinth were observed within the wooded area just north of the Bird Rookery. Slight amounts of American Lotus were observed in the open water in the center of the lake. All in all, aquatic vegetation amounts were low throughout the open water area of the lake. The area known as the Bird Rookery is shallow with an average depth of 2 to 2.5 feet and is thickly vegetated with buttonbush and bald cypress. Mats of sedge, alligator weed, pennywort, and water *primrose* are thriving within the bird rookery area of the lake. Also found in the rookery area, were moderate to severe amounts of hydrilla, fanwort, bladderwort, coontail, pennywort, common/giant salvinia, and water hyacinth.

Aquatic vegetative type mapping has been conducted since 1985. Years in which sampling occurred include: 1986 to 1996 and 2003, 2004, 2005, 2010, 2011 and 2015. ([APPENDIX II](#)).
