LOUISIANA DEPARTMENT OF WILDLIFE AND FISHERIES

**OFFICE OF FISHERIES
INLAND FISHERIES SECTION**

**2018 AQUATIC VEGETATION MANAGEMENT
PLAN**

IVAN LAKE

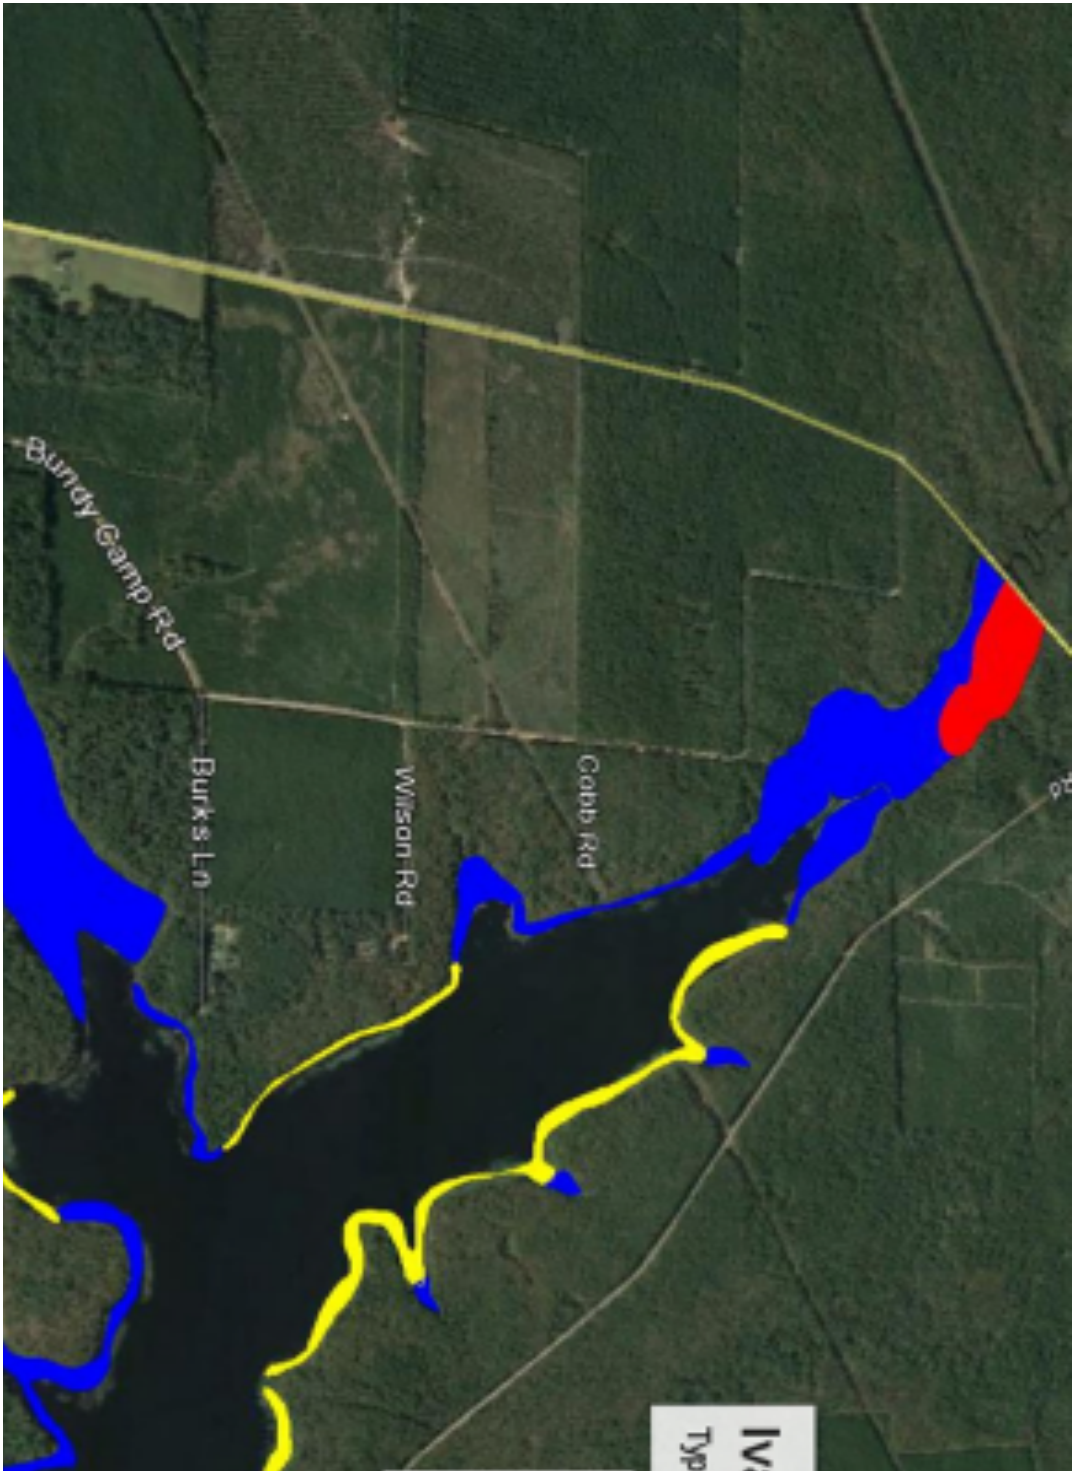
**VEGETATION TYPE MAP
IVAN LAKE
2017**

A vegetation typemap survey was performed by Kevin Houston on August 15, 2017. The lake was around pool stage during the survey.

Aquatic vegetation covered approximately 27% (141 acres) of Ivan Lake. The vast majority of coverage was found in the upper reaches of each arm. American lotus and fragrant water lily account for most of the vegetation present-approximately 100 acres. A fringe of both pad species can be found along any bank; while larger mats can be found in the backs of pockets and the upper ends of creeks. Submerged vegetation can be found in large clusters within open areas of emergent vegetation. Salvinia was observed intermittently around the bank and tertiary mats were found in the backs of coves. Salvinia acreage was estimated at less than 20 acres on the lake.

In Caney Creek, emergent vegetation covered 90% of the surface from markers #45 and #46 upwards to the bridge. Most of the emergent vegetation was fragrant water lily with mixed patches of lotus, watershield, pennywort, primrose, and alligator weed interspersed. Each small cove in the Caney arm had a mat of tertiary salvinia in the upper reaches in addition to the intermittent plants along the bank. Submerged vegetation in Caney Creek was primarily milfoil, fanwort, coontail, and naiad. Only the upper end of Caney Creek was severe as access became limited to the creek channel.

In Phillip's Creek, essentially 100% of the arm west of marker #11 was covered with American lotus and fragrant water lily. Any space that was not shaded by emergent vegetation contained 100% submerged vegetation including coontail and milfoil. The creek channel and portions of the boat road remained open. Although coverage was high, severity was only moderate as all areas were still accessible.

The lower reaches of the lake contain scattered clumps of vegetation including lotus, watershield, and coontail. Mixed patches of emergent plants and marginal plants were providing habitat for giant salvinia.

See 2017 Ivan Lake Vegetation Type Map attached.
