# **LOUISIANA DEPARTMENT OF WILDLIFE & FISHERIES**

**OFFICE OF FISHERIES  
INLAND FISHERIES DIVISION**

**2021 AQUATIC VEGETATION CONTROL PLAN**

**CADDO LAKE**

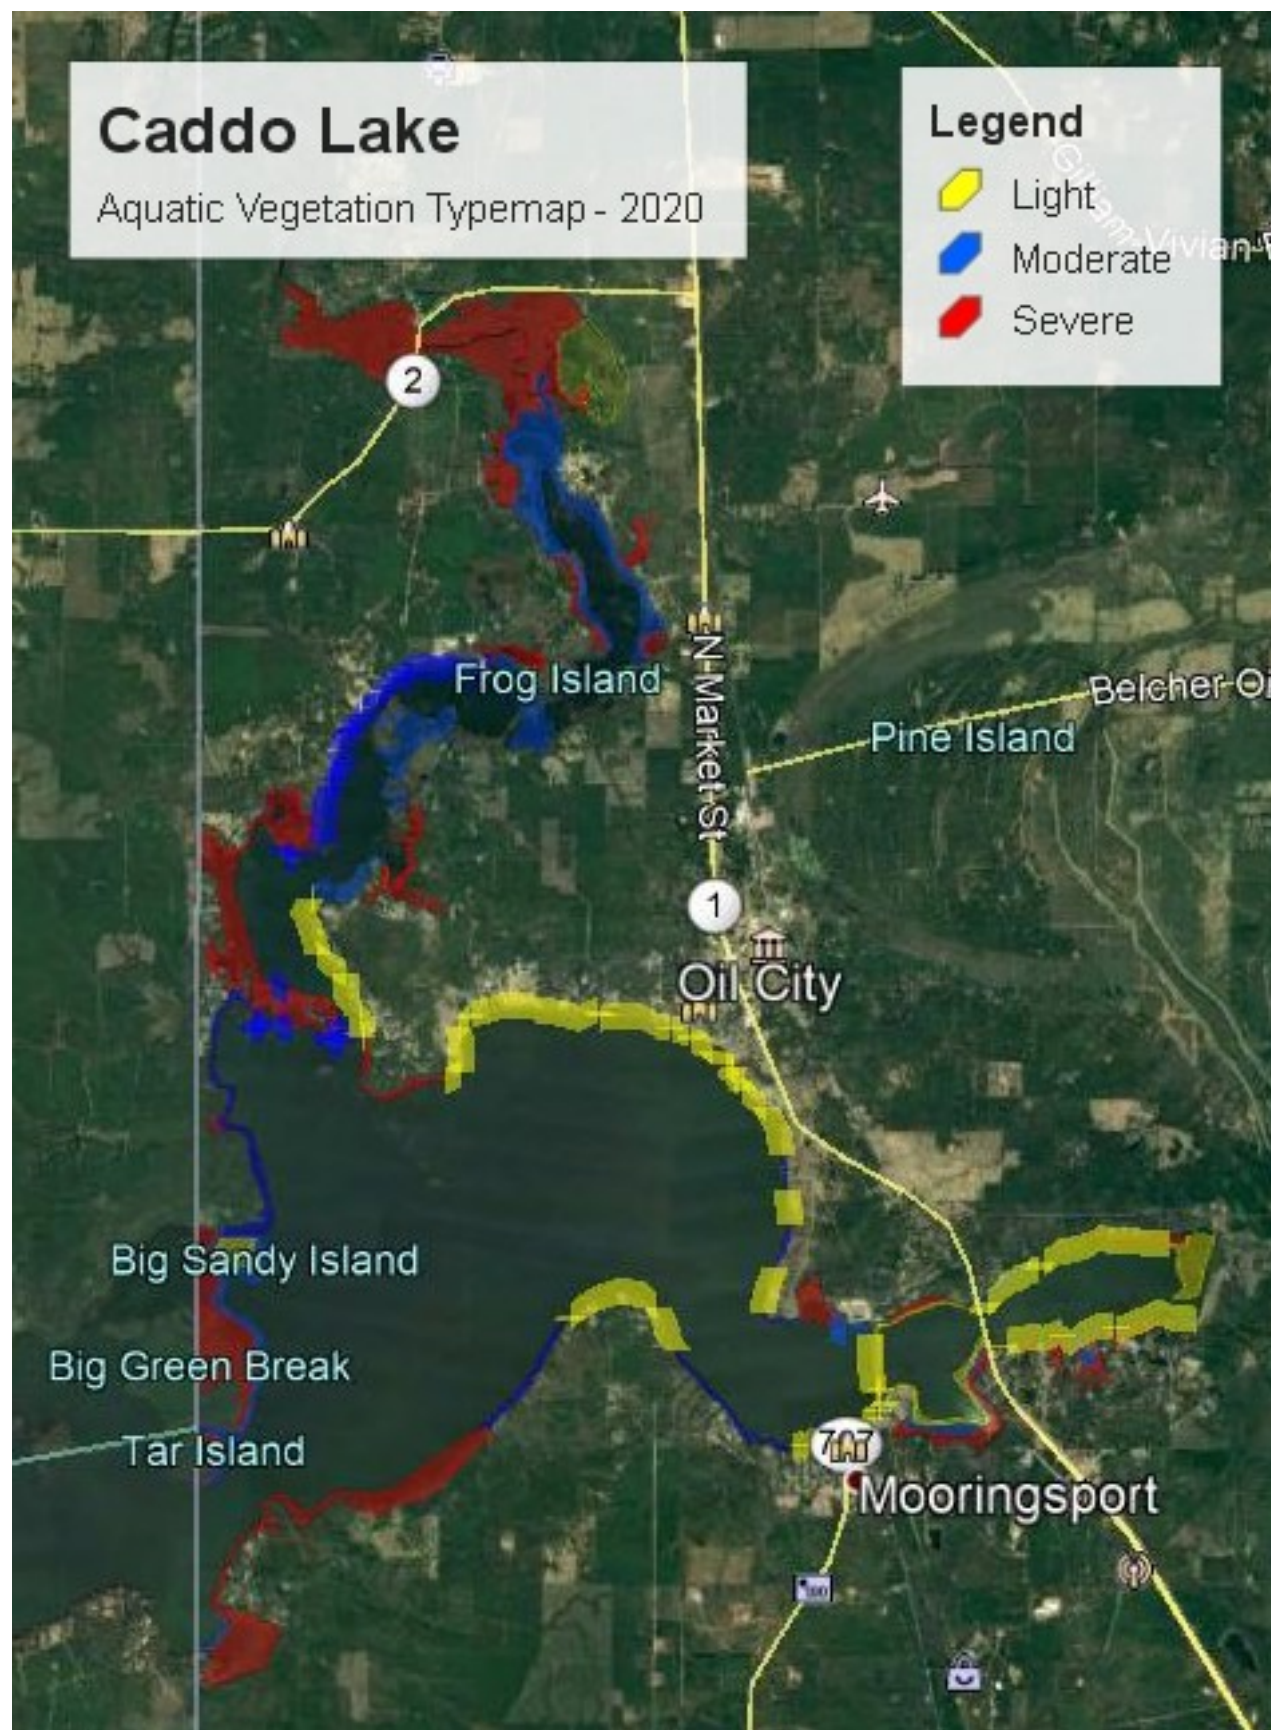
## Aquatic Vegetation Typemap - 2020

Caddo Lake has approximately 2,500 acres on the Louisiana side of the lake, which has some degree of aquatic vegetation coverage. This equates to approximately 22% of the Louisiana side with aquatic vegetation. There was roughly 1200 acres of giant salvinia observed during the survey. The majority of the giant salvinia was found in Jeem's Bayou, the Buzzard's Bay area and the state line area near Big Green Break. In these areas, giant salvinia was commonly interspersed with moderate to severe infestations of American Lotus, spatterdock, alligator weed, and primrose. Salvinia could be found in all stages of growth, including dense mats with terrestrial vegetation on growing on top in many areas. Large mats were occasionally found drifting throughout the lake and scattered along the shoreline. At least a fringe of giant salvinia was present along nearly all of the Louisiana shoreline.

The Buzzard Bay area had significant coverage of American lotus. A few patches of lotus were also found in the Big Green Break area and there were approximately 20 acres located near the power plant.

Crested floating heart was observed for the first time on the Louisiana side of the lake during the 2019 typemap survey. All known infestations on the Louisiana side were treated after discovery. The small patches of crested floating heart not only persist, but expanded their coverage slightly on the east side of Big Green Break and on the south shore line of the lake on the west side of LA Hwy 1. Another patch was found in Jeem's Bayou near Pelican Lodge this year. Total coverage remains at less than 0.1 acres.

The area around the state line had a mixture of aquatic vegetation including hydrilla, spatterdock, primrose, alligator weed, giant salvinia, American lotus and a few small patches of crested floating heart. The majority of the vegetation in this part of the lake was in the Big Green Break area. Coverage ranged from moderate to severe in this area. Coverage increased in the area around Big Sandy Island to the northern shoreline on the west side of Jeem's Bayou from what was observed last year.

Submerged vegetation coverage has changed since last year. Submersed vegetation including hydrilla was found in most shallow areas less than 3 feet deep. Coverage was light to sparse in many of these areas. Hydrilla appeared to be much more widespread than what was noted last year, however it was not observed in thick mats or topped out in any area. Hydrilla was found scattered throughout the shoreline areas on the Louisiana side of the lake, as opposed to last year's survey where it was only observed in two locations. In the area around Big Green Break, submersed vegetation including hydrilla was found out to depths of 6 feet but coverage was not as dense as what was observed last year. Approximately 400 acres of hydrilla was observed during the survey. This is an increase from the hydrilla coverage noted during last year's survey.

No large mats of water hyacinth were found during the survey. It is estimated that there is less than 5 acres present on the lake with only the occasional plant seen mixed with other vegetation.

Giant cutgrass was the most prevalent species of marginal vegetation found around the lake, but it was mostly restricted to the immediate shoreline. Other marginal vegetation included lizard's tail,

wild taro, smartweed, torpedo grass, cattail, spike rush and duck potato.

The aquatic vegetation coverage on the Louisiana side of Caddo Lake is impacting many shoreline residents and users of the lake. Many shoreline property owners are experiencing problems, at least occasional problems, with giant salvinia and quite a few have not been able to access the lake for months. Giant salvinia is affecting boating and fishing access in many areas, especially in Jeem's Bayou. The submersed vegetation coverage changed since the survey conducted last year. Hydrilla was not observed to be topped out or growing in thick mats like was observed in a few areas last year, but was found widely scattered with light to sparse coverage in many of the shallow areas of the lake. American lotus remains a problem in Buzzard Bay. Crested floating heart increased in coverage slightly since last year, despite focused herbicide applications. LDWF crews have treated 796 acres of aquatic vegetation thus far in 2020, the vast majority of this being giant salvinia.
