# **LOUISIANA DEPARTMENT OF WILDLIFE & FISHERIES**

**OFFICE OF FISHERIES  
INLAND FISHERIES SECTION**

**2024 AQUATIC VEGETATION CONTROL PLAN**

**CLEAR-SMITHPORT LAKE  
DESOTO PARISH**

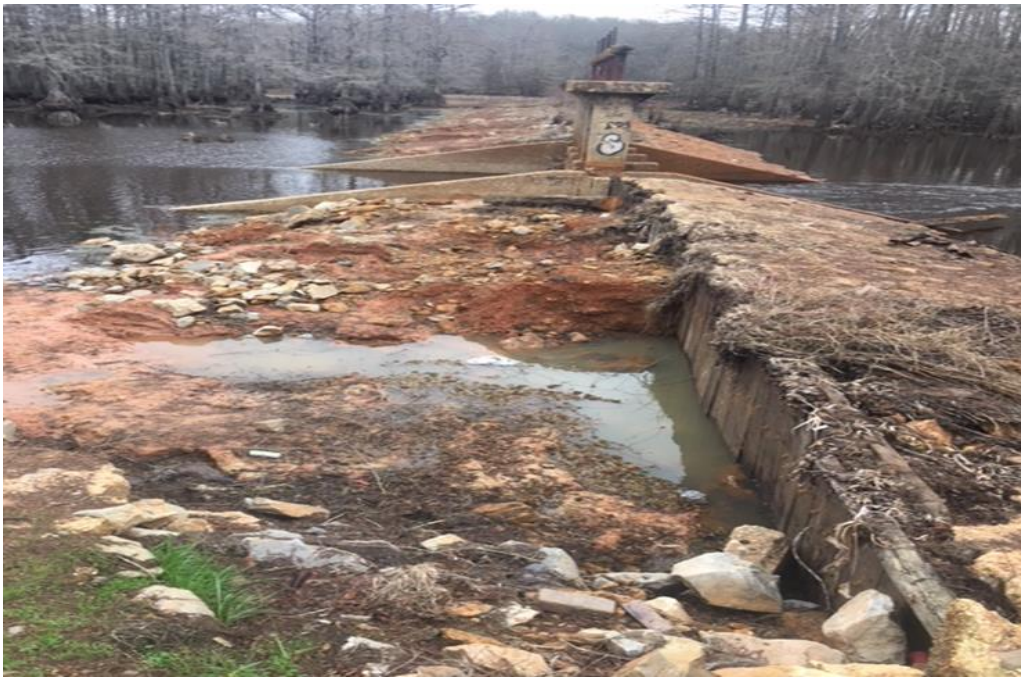
Figure 1. Clear-Smithport Lake Spillway showing severe erosion along face of the spillway following the 2016 floods.

In July 2014, some minor repairs to the sluice gates by LDOTD and LDWF personnel allowed the gates to operate. The east gate required no repair. The two middle gates were reconnected to the lift stems. The west gate has a gear problem in the west side paired gearbox. In March 2016, historic area-wide flooding created a backflow of water upstream from Bayou Pierre and over the Clear-Smithport Lake Dam. Following the first of a series of three yearly drawdowns in 2016 for vegetation management, severe erosion was found along both the upstream and downstream sides of the spillway. A photograph of the spillway during the drawdown and after the March 2016 floods appears in Figure 1

| 08-18-2016 | 12-01-2016 | Weed Control | Good | West Gate is still in need of repair and whole structure severely eroded following flooding in March 2016. |

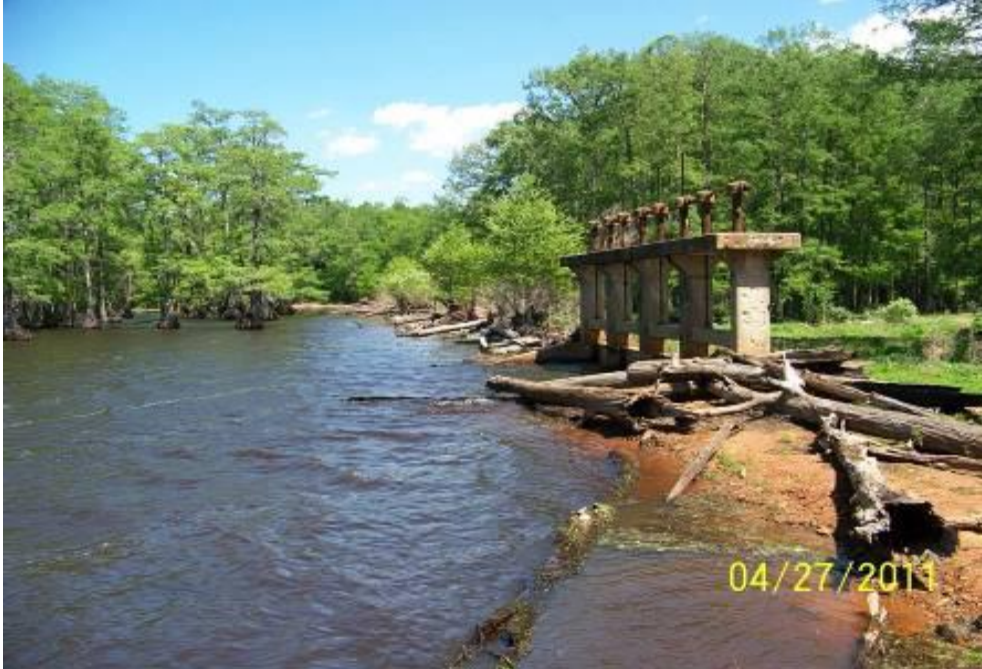
3. Type of control structure –Smithport Lake Dam is an 1,800-foot earthen embankment with a 28-foot wide crown. The dam includes a 600-foot wide spillway made of wooden sheet piles with horizontal wooden crest boards. A photograph of the Smithport Lake Dam control structure appears in Figure 2.

Figure 2. Smithport Lake Dam control structure
