LOUISIANA DEPARTMENT OF WILDLIFE AND FISHERIES

2021 AQUATIC VEGETATION CONTROL PLAN

SPANISH LAKE

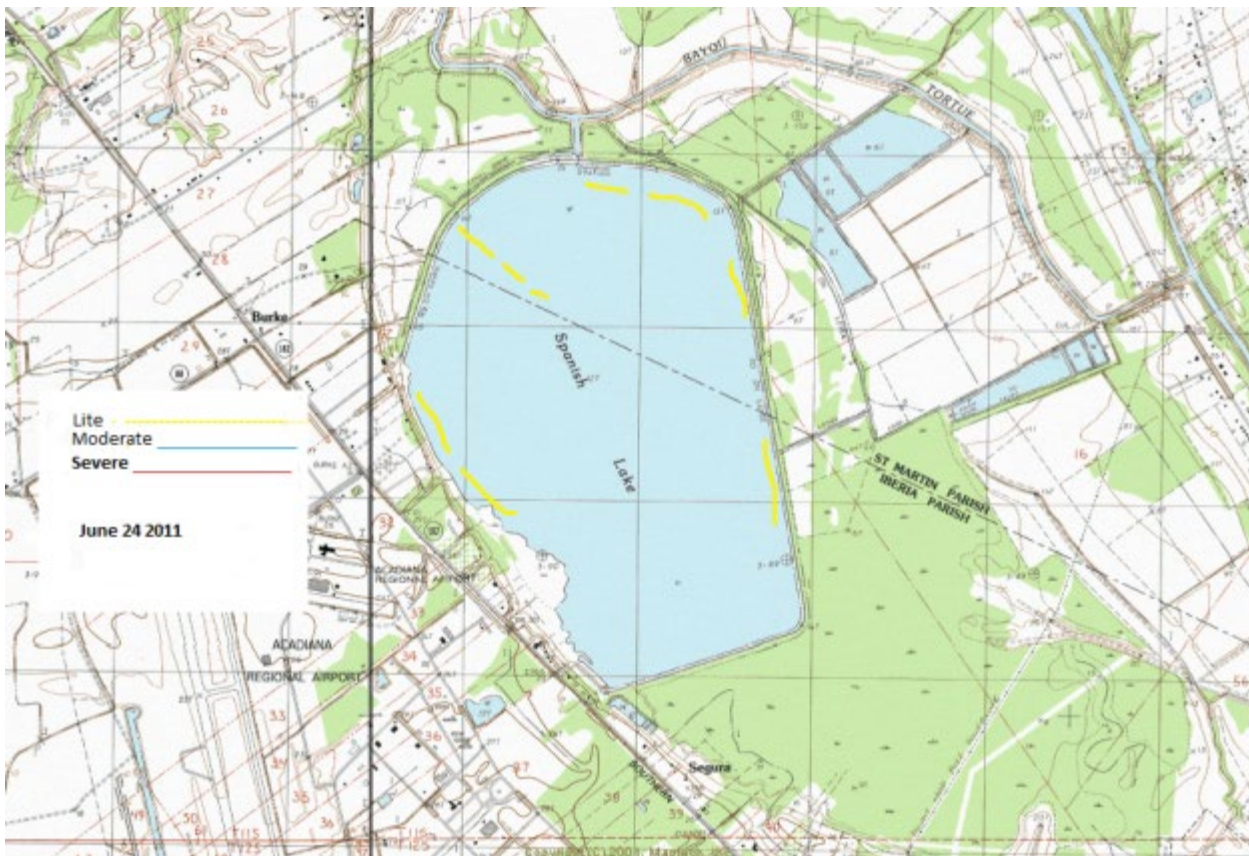
Typemaps:

Spanish Lake Vegetation Survey 6-24-2011 - Martin Plonsky

A survey of aquatic vegetation found in Spanish Lake resulted in the conclusion that there is little to no aquatic vegetation in the lake. Very thin amounts of water hyacinth were observed near the boat launch and on the shoreline of the breakwater islands on the eastern side of the lake. The lake water was saturated (“bloom” condition) with planktonic algae and water ph was above 8.0. Small bunches of iris were seen growing along the eastern bank of the lake. Average water depth was 2 feet. The vegetation survey was conducted on the same day we investigated the report of a fish kill at the lake. No dead fish were observed.
