LOUISIANA DEPARTMENT OF WILDLIFE & FISHERIES

**OFFICE OF FISHERIES
INLAND FISHERIES SECTION**

ANACOCO LAKE

**AQUATIC VEGETATION TYPE MAPS
AND NARRATIVES**

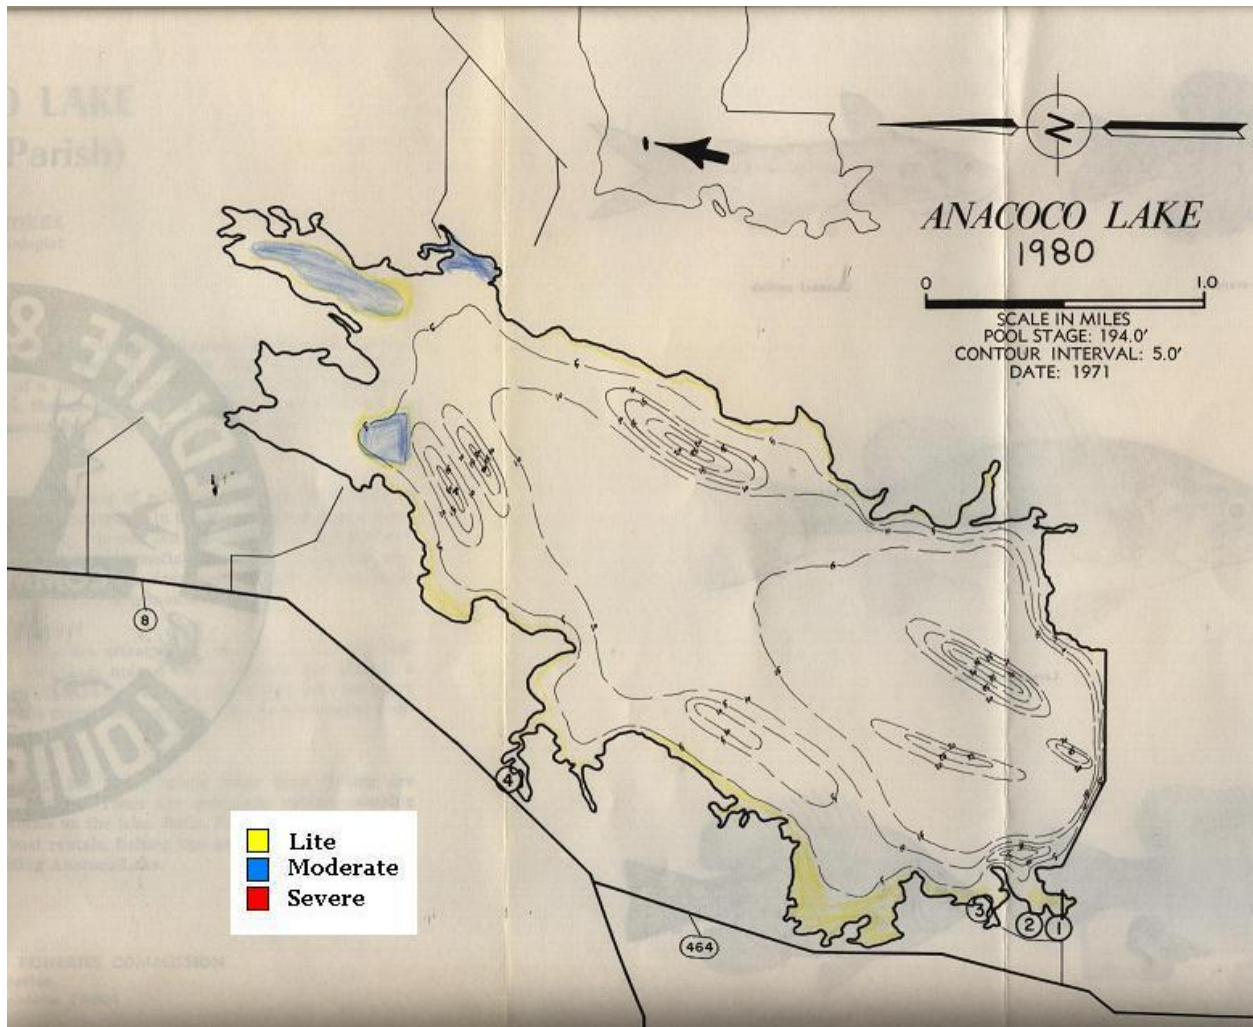
ANACOCO LAKE 1980

- Moderate infestation in two areas of Coontail and Cabomba
- Light infestation of Bladderwort
- Marginal infestation of Bidens and Primrose

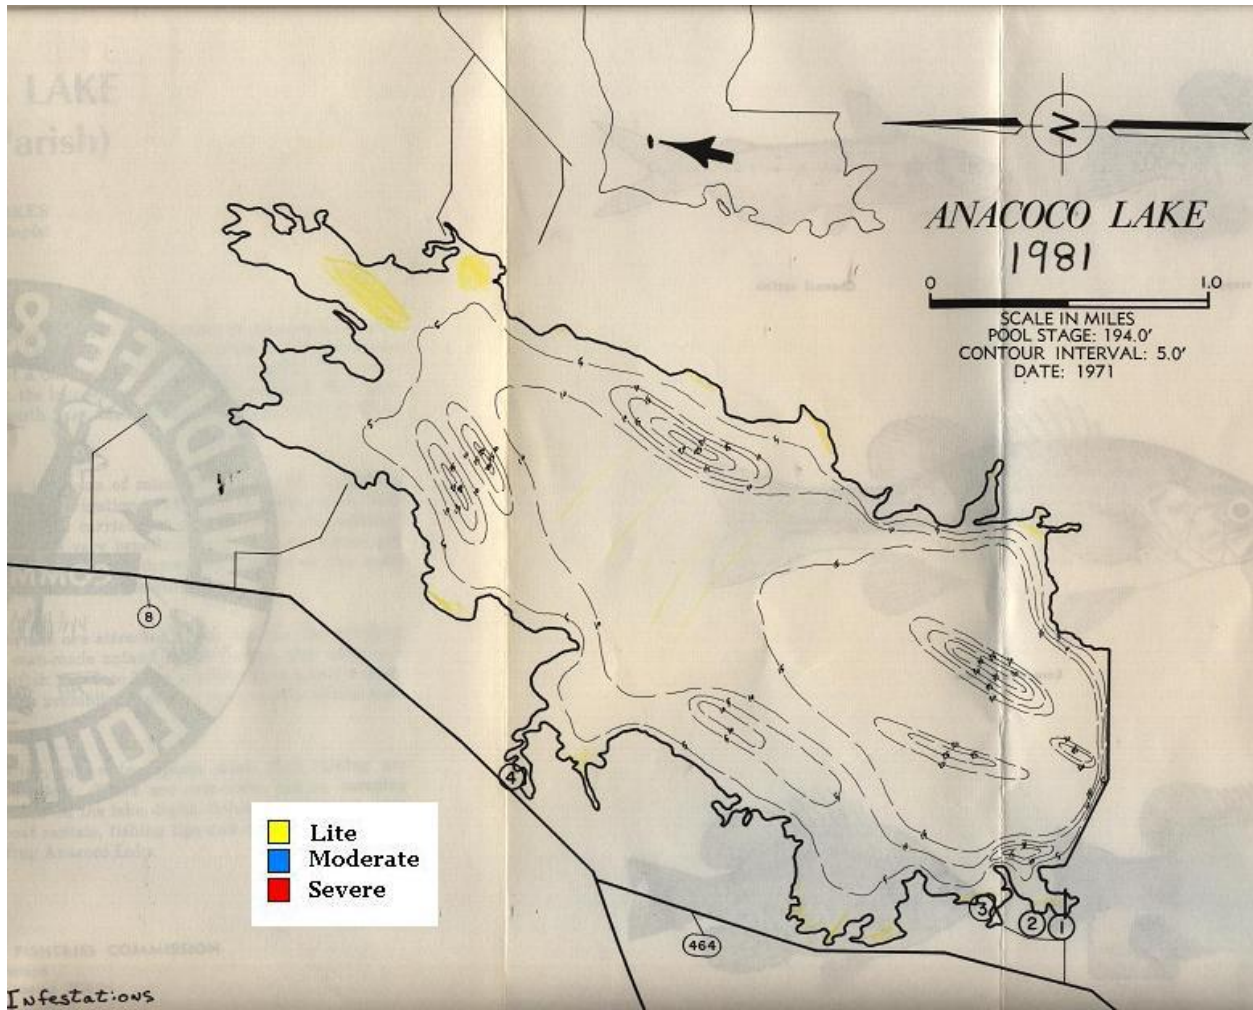
ANACOCO LAKE 1981

- Light infestation of Bladderwort, Coontail, and Chara
- Marginal fringe of Bidens and Primrose greatly reduced from 1980

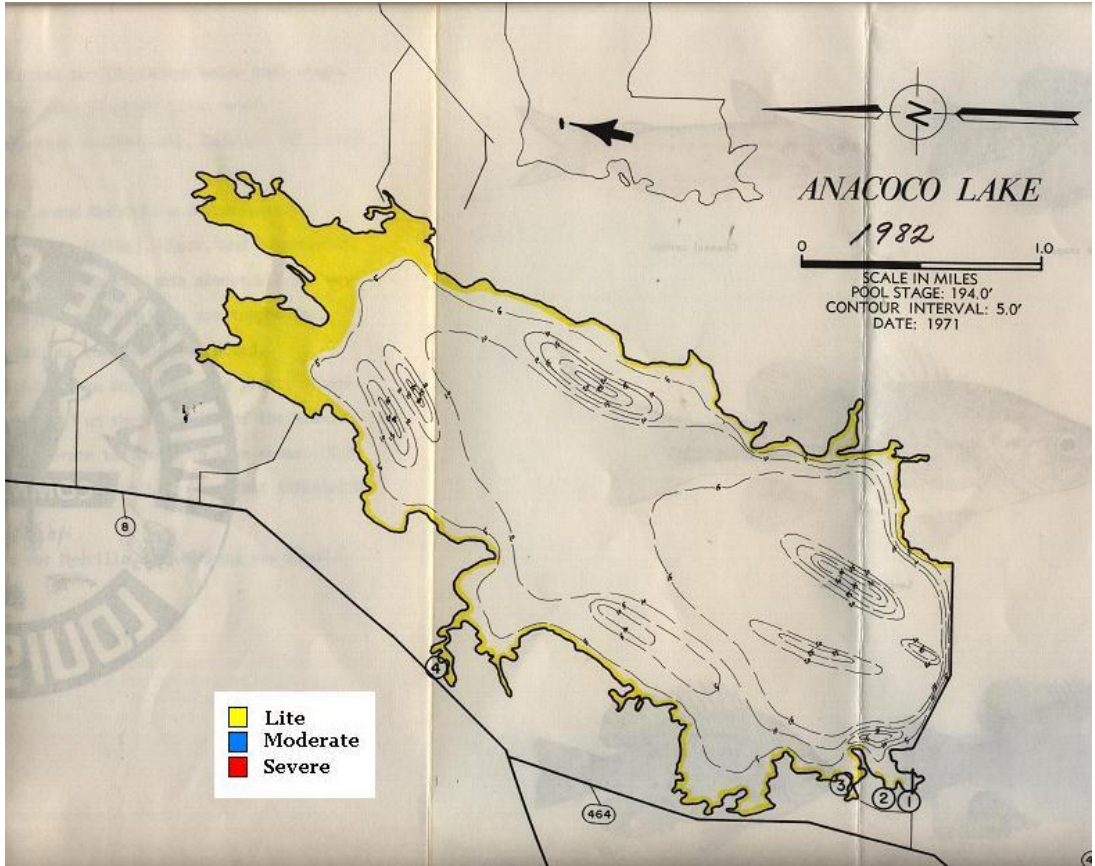
ANACOCO LAKE
1982

Anacoco Lake has a high infestation of submersed plants almost all the way around the lake. The infestation is very light and no plants are topped out.

The marginal plants are more of a problem than any other type plant. There is a buttonbush infestation in the upper end and on the west side of the lake.

The infestation of buttonbush ranges from moderate to severe in some areas. The primrose infestations range from moderate to severe with the severest infestation being in the upper end.

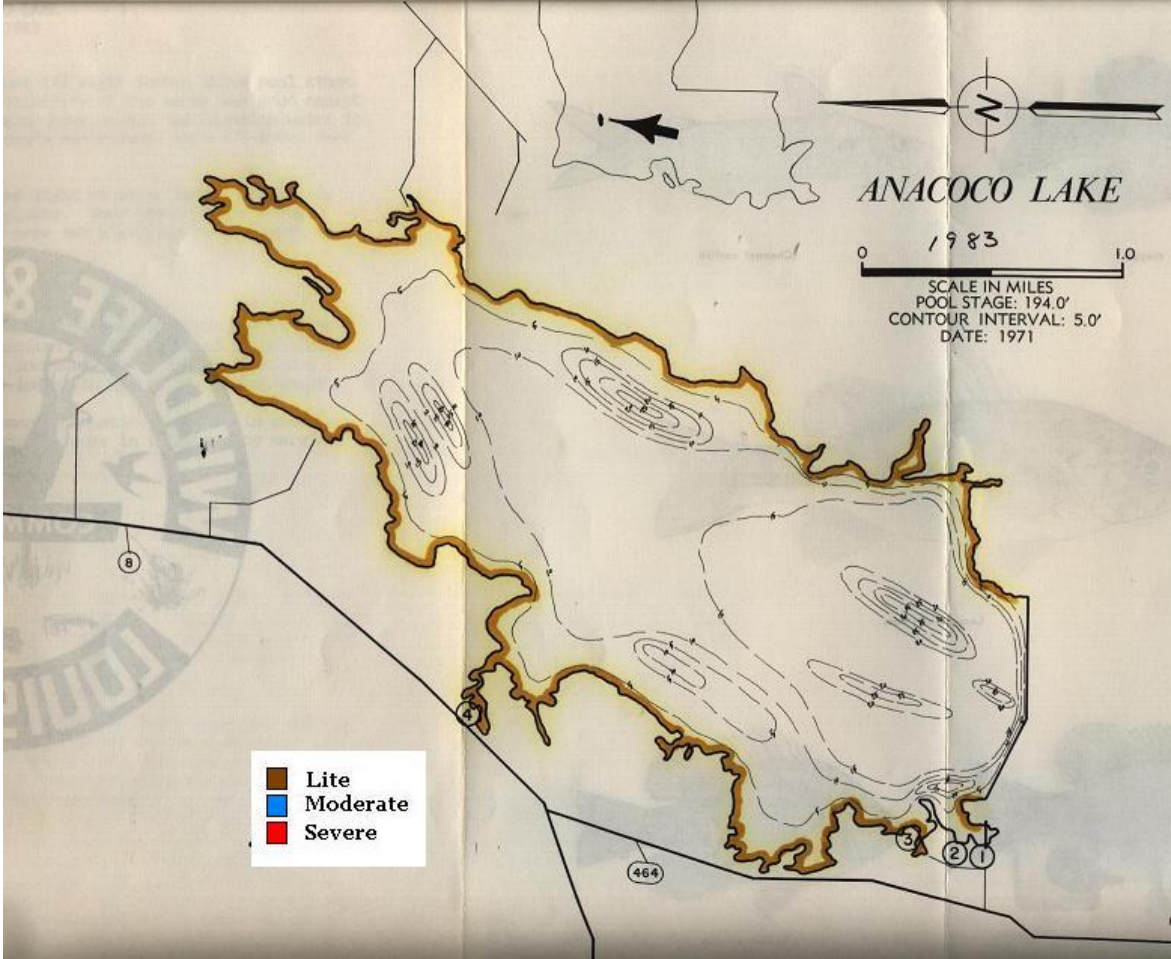
ANACOCO LAKE
1983

All infestations of submersed plants were light to very light. Eleocharis and Filamentous algae were the primary plants. Some spots of Utricularia were present in the upper end, but they were not significant. Potamogeton and Hydrochloa were also noted in small amounts.

The marginal plants noted were Cephalanthus, Hydrolea, Ludwigia, Polygonum and Saururus. Button bush is still a problem on the upper end of Anacoco Lake, but there does not seem to be any increase in the amount of plants from last year. Water primrose has not increased enough to be a nuisance.

In summary, Anacoco Lake, as far as submersed aquatic plants is in good condition. There has been no significant increase in submersed or marginal plants since last year.

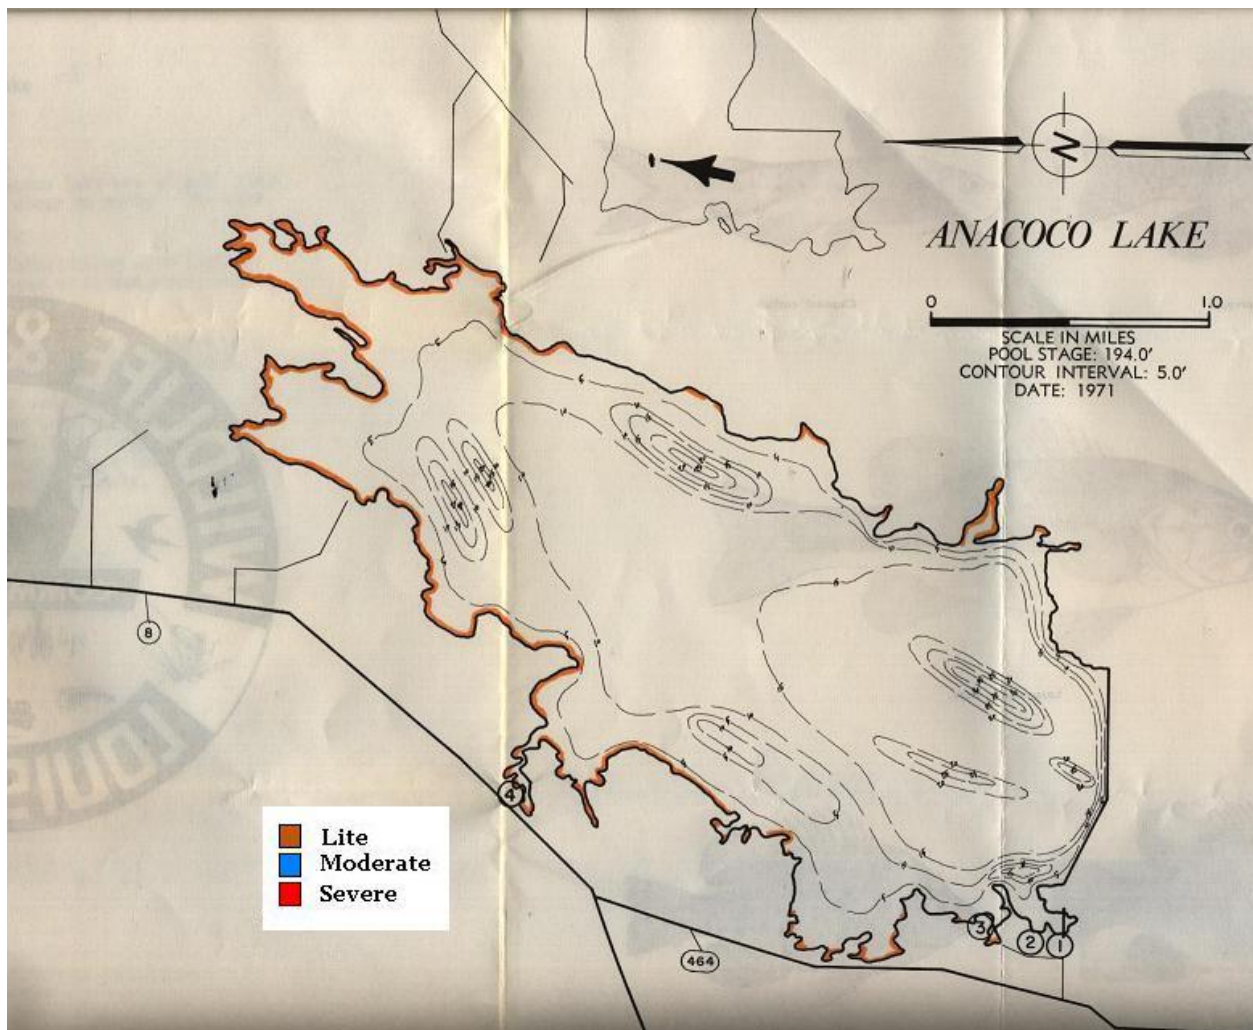
ANACOCO LAKE 1984

The submersed aquatic plant infestations were light. The light infestations were comprised of Potamogeton, Najas, Hydrochloa, Chara and filamentous algae.

In summary Anacoco lake is in very good condition. The lake has no submersed aquatic plant problem. The button bush problem in Anacoco Lake has not gotten any better, although there seems to be no increase since last year. All other marginal plants are in tolerable amounts.

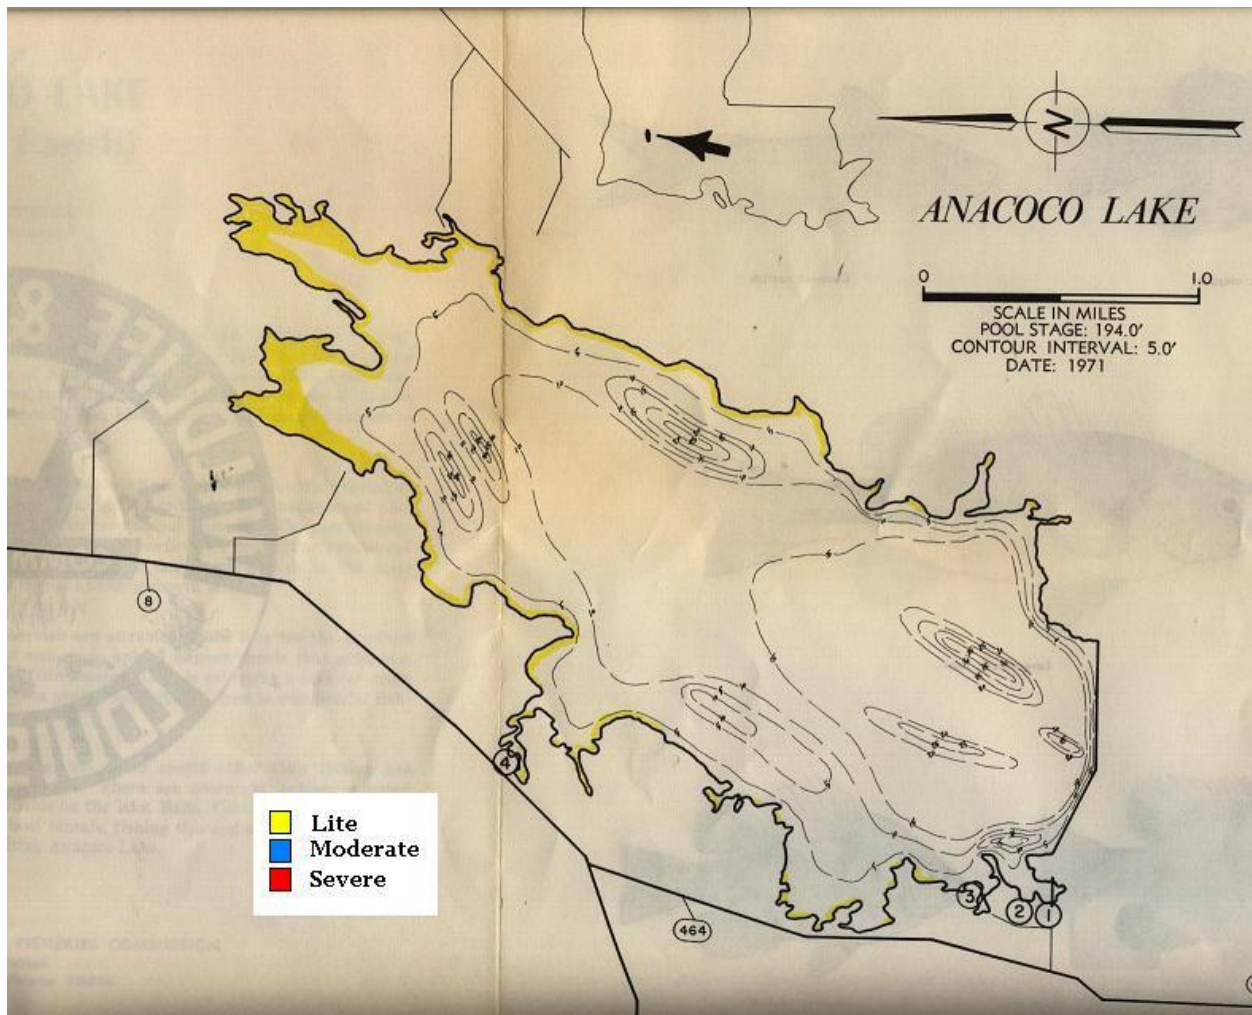
ANACOCO LAKE 1988

In summary Anacoco Lake is in good condition. There has been no significant increase in plants this growing season. Button willow is still a problem in the upper end of the lake, but there has been no increase.

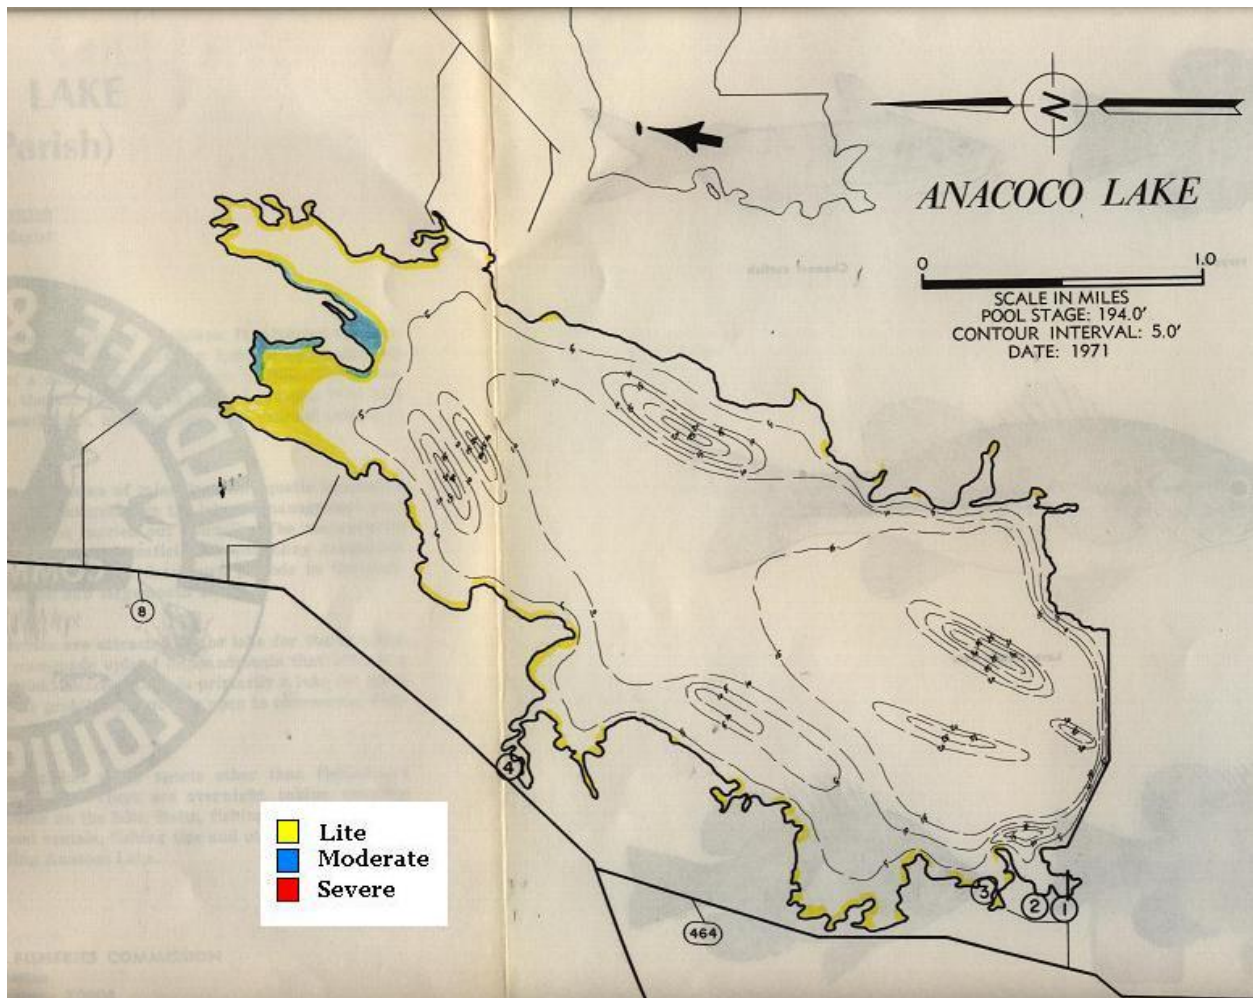
ANACOCO LAKE 1989

The dominant submersed aquatic plant in the upper half of Anacoco Lake was *Utricularia*. The secondary aquatic plants noted were *Ceratophyllum demersum* and southern naiad (*Najas*). Also noted were *Chara* in one area. All infestations were very light in all areas.

The dominant submersed aquatic plant in the lower half of Anacoco Lake was Southern Naiad (*Najas*). Some small fragments of *Utricularia* were also noted in one or two coves.

The buttonbush (*Cephalanthus*) in Anacoco Lake's upper end has not increased to any noticeable extent. Submersed aquatic plants have not increased since last growing season. Early summer rains may have had some effect on submersed plants because of higher water levels.

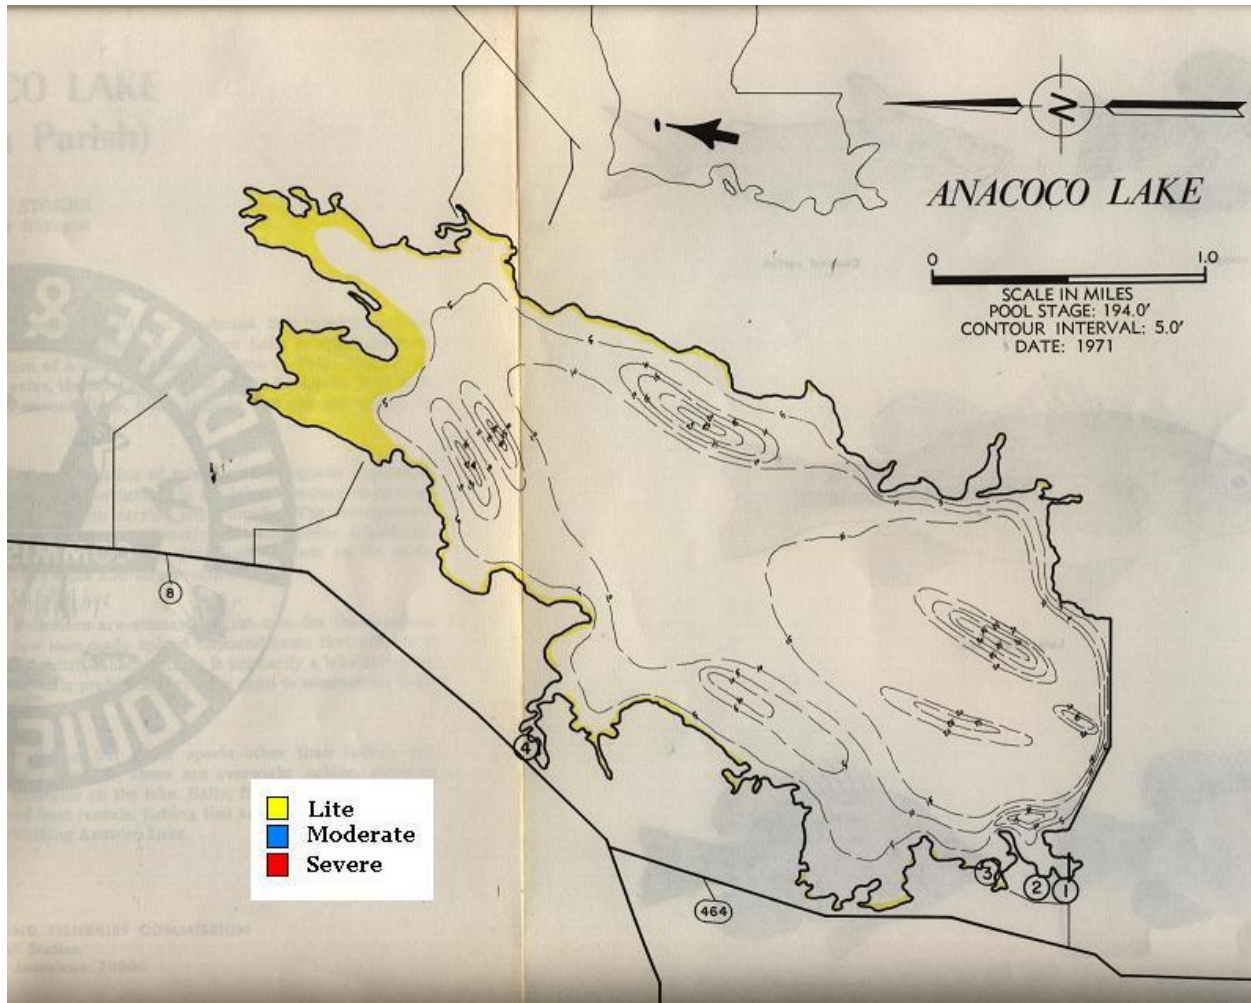
ANACOCO LAKE

In summary Anacoco Lake has mainly light infestation of *Utricularia spp.* and *Najas spp.*, one area of moderate infestation in the upper end was composed of *Utricularia*.

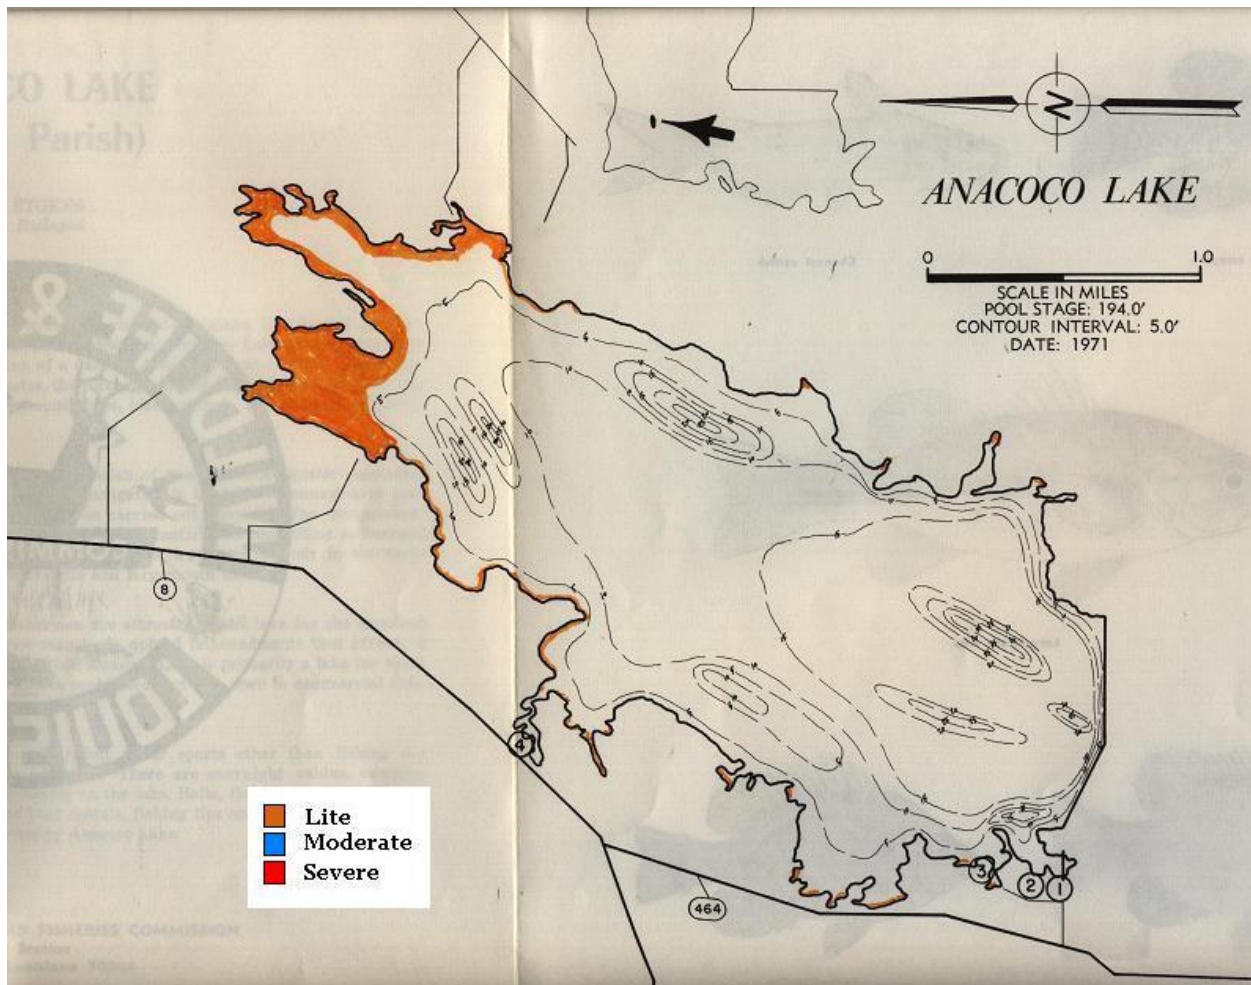
ANACOCO LAKE 1992

The primary aquatic plant noted was *Utricularia*. The secondary plant noted was *Potamogeton*, coontail, *Cabomba* and Southern Naiad.

Most infestations of aquatic plants in Anacoco Lake was confined to the upper end and was light and growing in depths out to 5' feet in some areas.

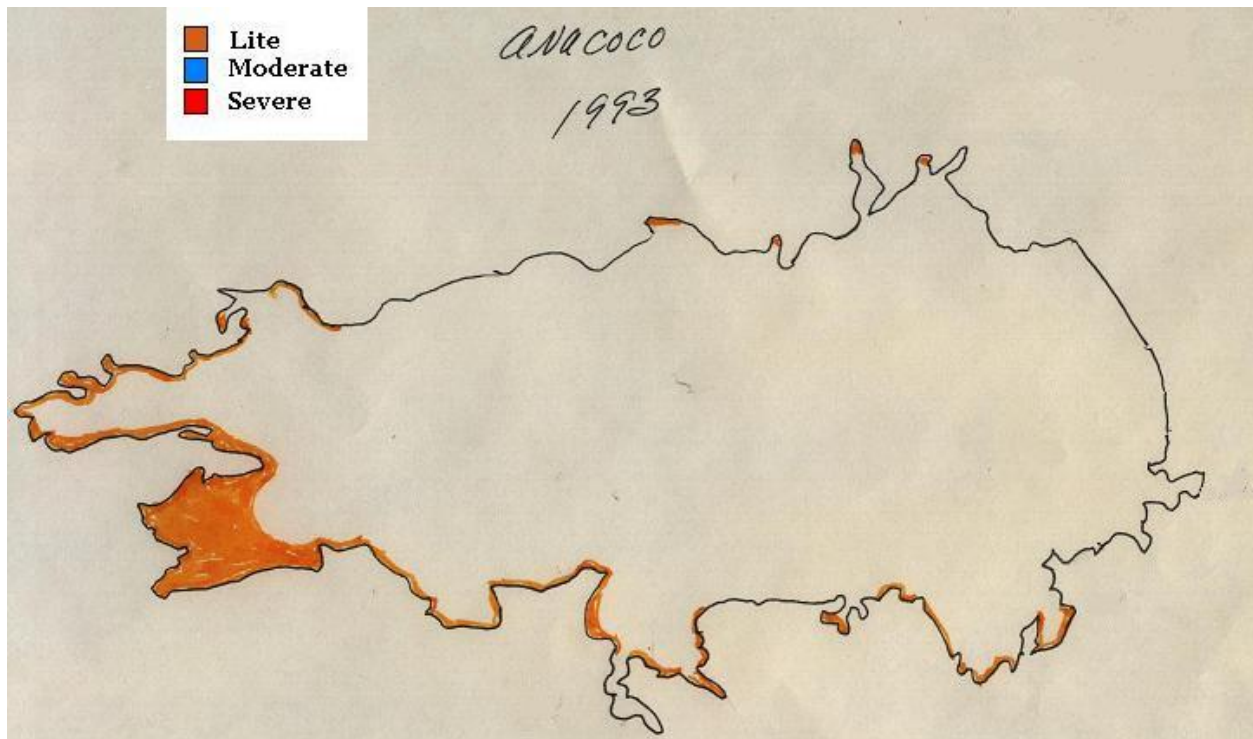
ANACOCO LAKE
1993

The primary aquatic plant noted was *Utricularia*. The secondary plants were Southern naiad and *Potamogeton*, *Cabomba* and coontail was also noted in the upper end. Most infestations were light and growing out to 5' feet in some areas.

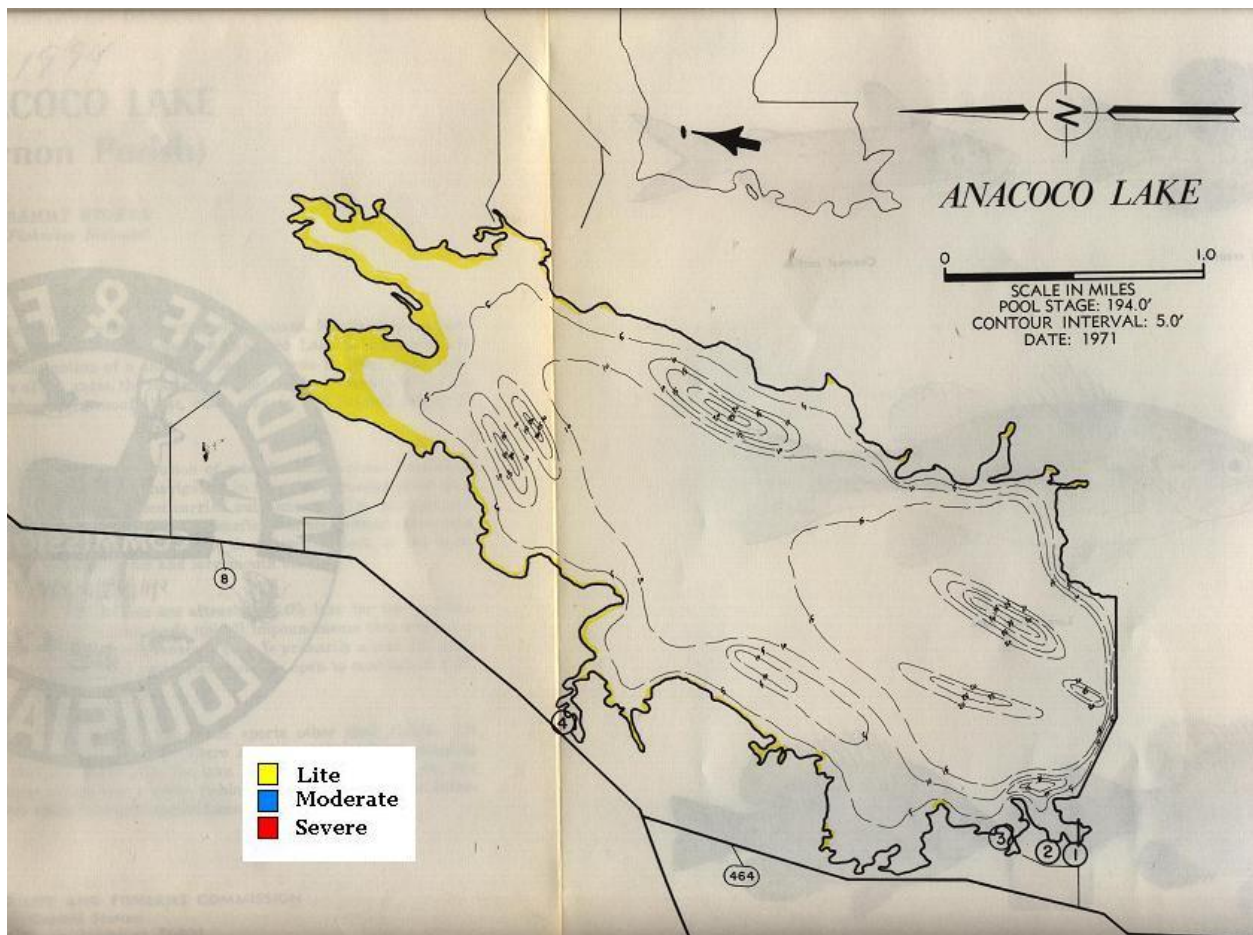
ANACOCO LAKE 1994

The submersed aquatic plants in Anacoco Lake were light in all areas. Most infestations were composed of southern naiad and Potamogeton. A fragment of Cabomba was noted also some Utricularia was noted in the extreme upper end.

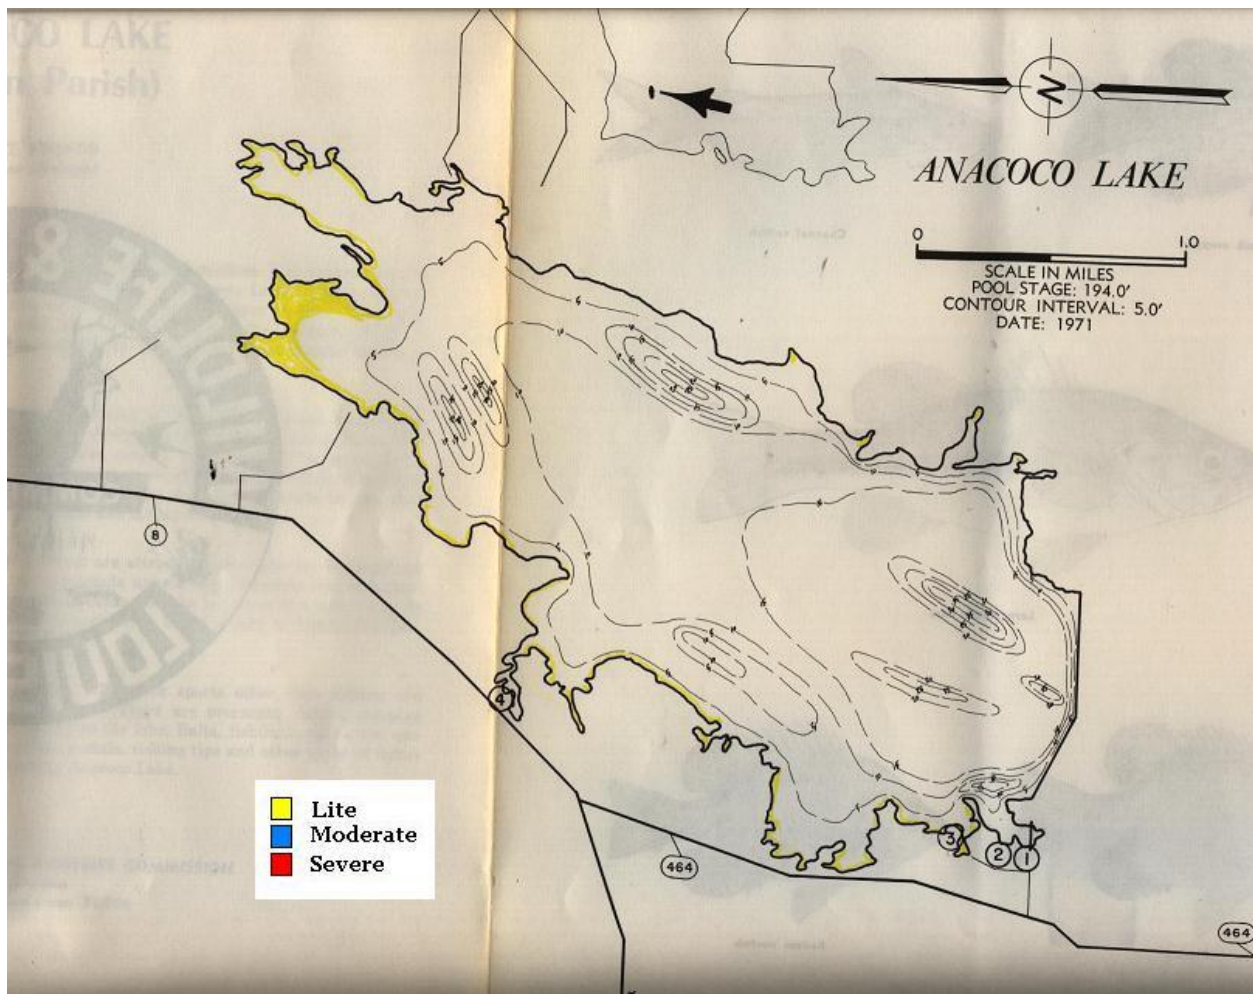
ANACOCO LAKE
1998
Melvin Bagwell

The aquatic plants surveyed were bladderwort, pondweed, Chara, and filamentous algae. The emerged plants surveyed were Bacopa, smartweed, bulrush, and alligatorweed.

The distribution of aquatic plants was light to very light in all areas. The total infested area was an estimated 10%.

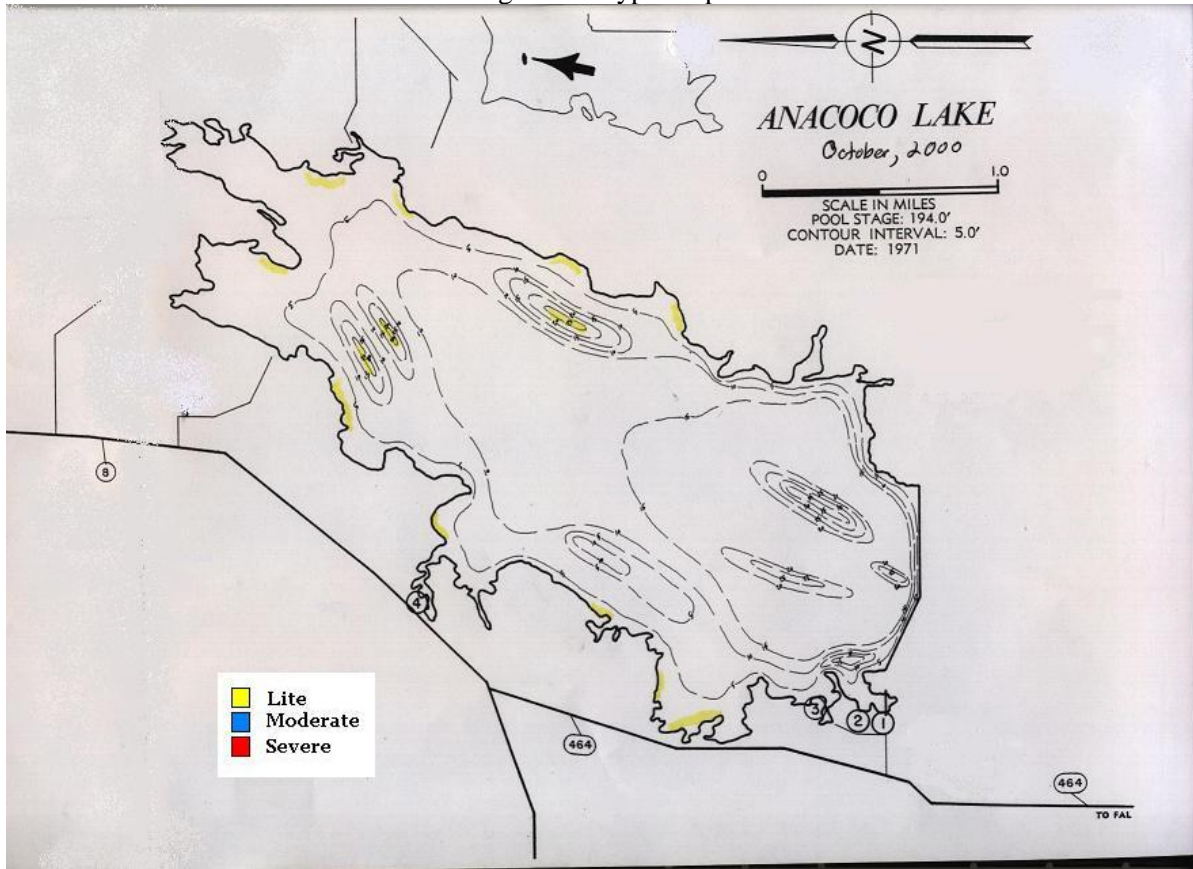
Vegetative Type Map 2000

However, aquatic plant growth was present and consisted mostly of *Potamogeton spp.*, *Najas spp.*, *Hydrochloa spp.*, and *Nymphaea odorata*. These plants were found in several locations of the lake where water was less than 18 inches deep. The infestations were very minor and only worthy of mention at this point in time. We observed no floating aquatic plants. Marginal aquatic plants such as *Ludwigia spp.*, *Polygonum spp.*, and *Alternanthera philoxeroides*, were very rare.

Salix nigra (willow) was beginning to establish itself in the lakebed during drawdown. When the lake returned to pool stage, some of this willow growth was not completely inundated. This willow growth may require herbicide treatment if it continues to grow under partially flooded conditions.

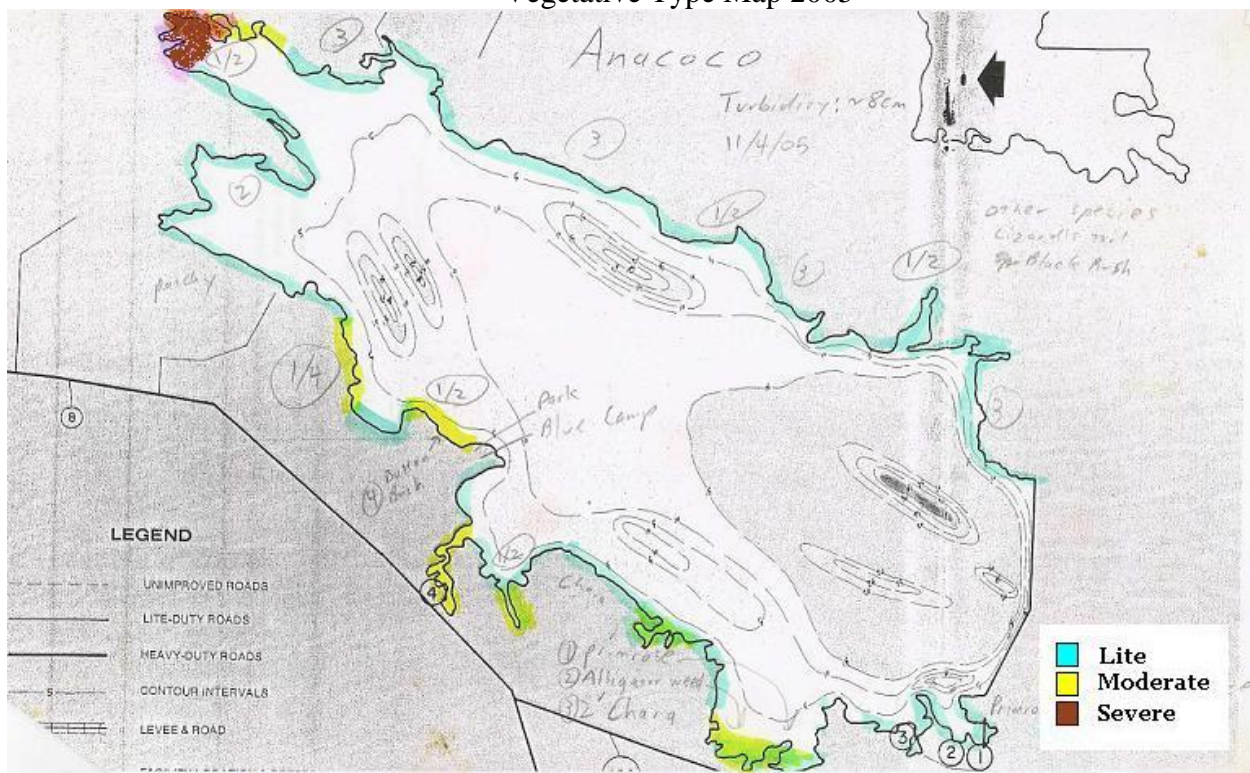
Vegetative Type Map 2005

Primroses (*Ludwigia peploides*) were the most abundant vegetation observed during the survey with light to moderate amounts along most of the shoreline and one heavy infestation at the northern tip of the lake. Alligatorweed (*Alternanthera philoxeroides*) was also present in lesser amounts in the same areas.

Light amounts of muskgrass (*Chara spp.*) were found along most of the 2' contour of the lake with this being the only submersed aquatic observed.

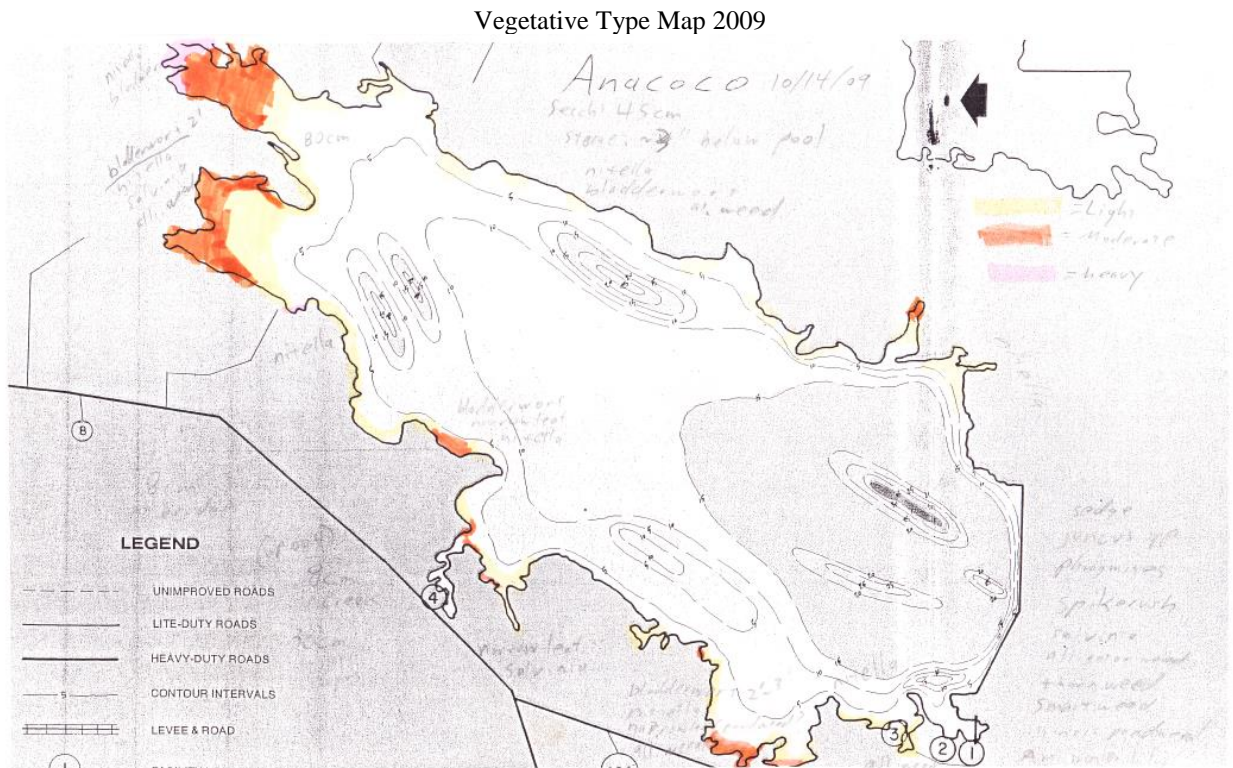
Common salvinia (*Salvinia minima*) was more abundant than last year with light to moderate infestations observed in coves along the western and northern shores of the lake.

Other plants present in trace to light amounts were water lily (*Nymphaea odorata*), common reed (*Phragmites australis*), water sedge (*Cyperus* spp.), rushes (*Juncus* spp.), spikerush (*Eleocharis* spp.), smartweed (*Polygonum hydropiperoides*), Primrose (*Ludwigia peploides*), Illinois pondweed (*Potamogeton illinoensis*), and variable leaf pondweed (*Potamogeton diversifolia*).

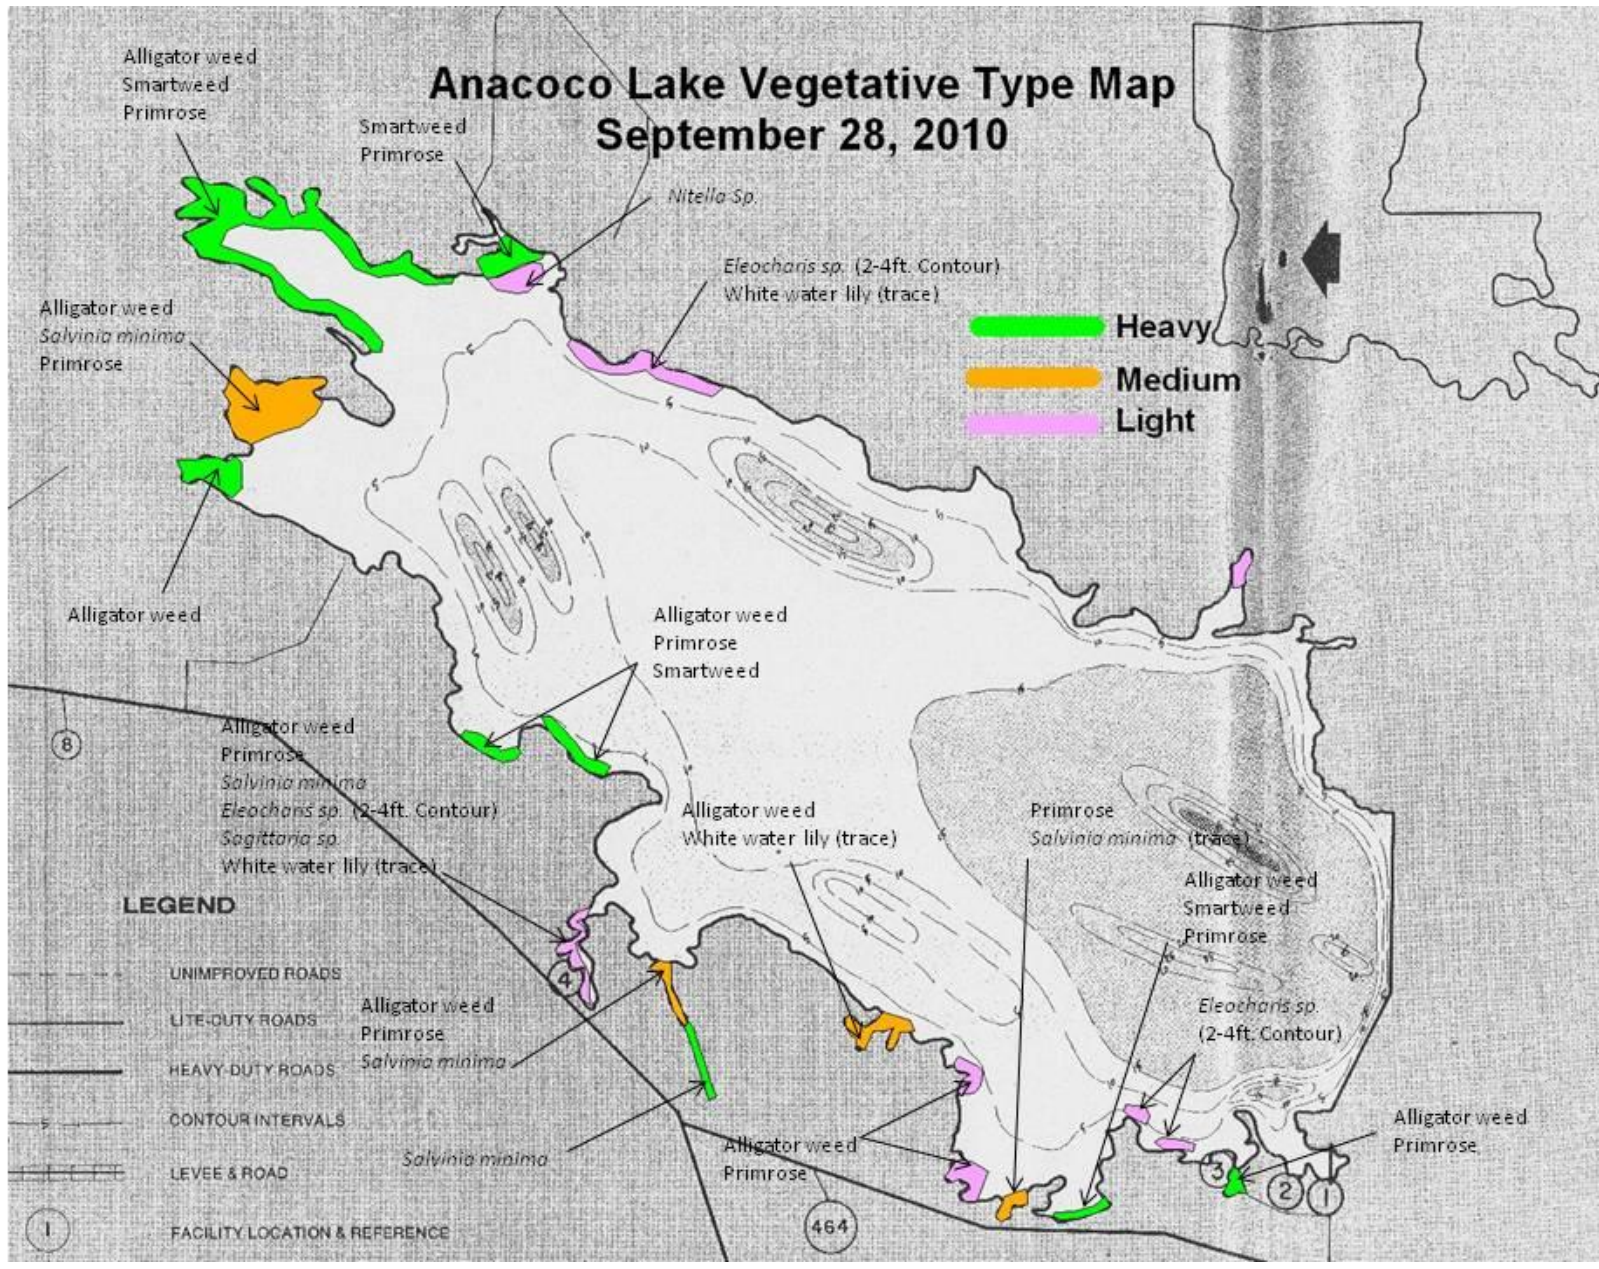
Anacoco Lake Vegetative Type Map

Areas of observed occurrence were designated as "Heavy", "Medium", or "Light". Most areas classified as "Heavy" were observed in the protected shallow-water areas located within coves and bays or canals found along the lake. Predominant species associated with these areas were emergent Alligatorweed (*Alternanthera philoxeroides*), Primrose (*Ludwigia spp.*), and Smartweed (*Polygonum spp.*). Additionally, these three species were found in light to moderate amounts intermittently along shoreline of the entire lake.

Common salvinia (*Salvinia minima*) was found in medium to heavy amounts in only in two small areas. One of these areas is a small dead-end canal near Brown-Ridder Loop Road, on the east side of the lake, and the other is a cove located on the north side of the lake.

- Alligator weed
- Primrose
- Salvinia minima*

- Primrose
- Salvinia minima* (trace)
- Alligator weed
- Smartweed
- Primrose
- Eleocharis sp.* (2-4ft. Contour)

As a whole, aquatic vegetation is not negatively impacting fisheries habitat or angler access on Anacoco Lake. We will continue to monitor common salvinia and alligatorweed levels and recommend treatments if infestations become significant. Water quality issues continue to plague this lake, making establishment of beneficial submerged aquatic vegetation difficult.

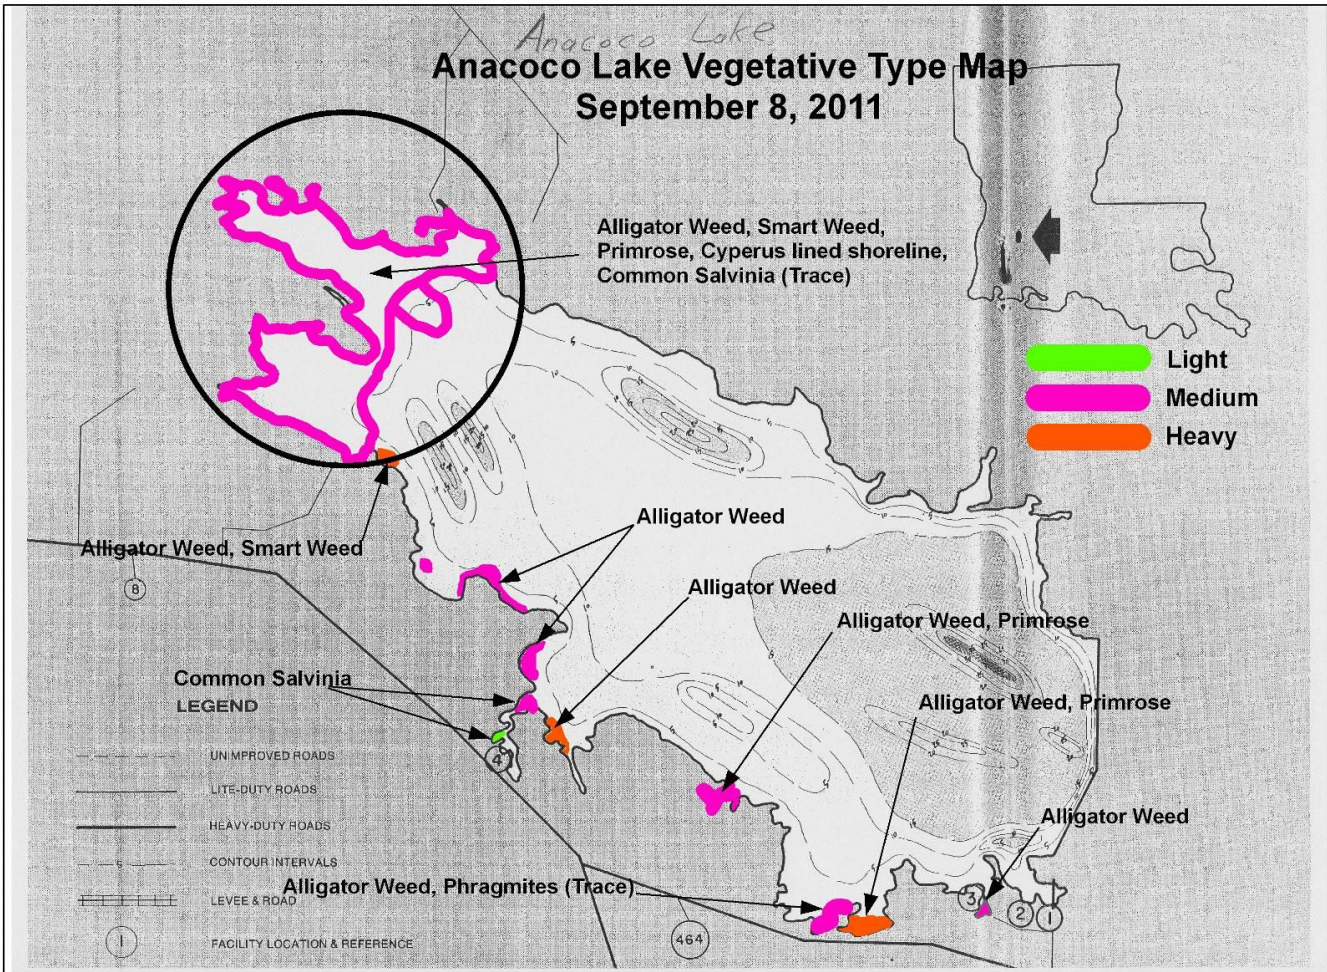
Anacoco Lake
Anacoco Lake Vegetative Type Map
 September 8, 2011

Areas of observed occurrence were designated as "Heavy", "Medium", or "Light". Very few areas of the lake were identified as having aquatic vegetation present. Because of the extreme drought conditions and extended period of low water, most of the vegetation present was observed along the exposed edges of the shoreline in "Medium" amounts. Predominant species associated with these areas were emergent Alligatorweed (*Alternanthera philoxeroides*), Primrose (*Ludwigia spp.*), and Smartweed (*Polygonum spp.*). "Heavy" aquatic vegetation was identified in only two small areas on the lake. Vegetation in these areas consisted mostly of Alligatorweed and Smartweed with a moderate amount of Common salvinia at the location near Sandy Creek. Common salvinia was also identified in trace amounts in the flats on the northern portions of the lake as well as flat sedges (*Cyperus spp.*).

Due to the severe turbidity and poor clarity no submerged aquatic species were observed during the survey.

As a whole, aquatic vegetation is not negatively impacting fisheries habitat or angler access on Anacoco Lake. We will continue to monitor common salvinia and alligatorweed levels and recommend treatments if infestations become significant. Water quality issues continue to plague this lake, making establishment of beneficial submerged aquatic vegetation difficult.
