LOUISIANA DEPARTMENT OF WILDLIFE & FISHERIES

**OFFICE OF FISHERIES
INLAND FISHERIES SECTION**

ANACOCO LAKE

**AQUATIC VEGETATION TYPE MAPS
AND NARRATIVES**

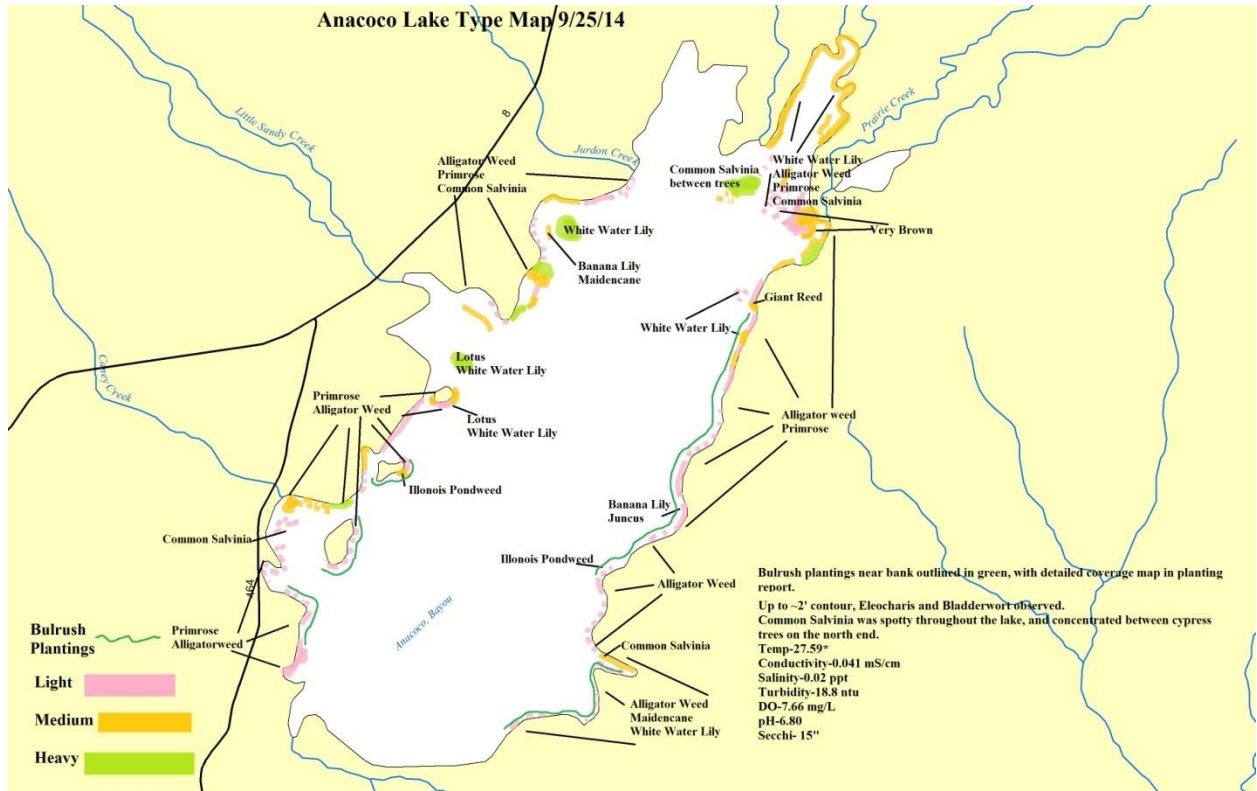
Anacoco Lake Type Map 9/25/14

Plant densities were designated as "Low," "Medium," and "High." The heaviest densities of plants were in the northern portions of the lake, and most notably in the northeastern end, though earlier spray efforts have been effective in the areas that are perennial problems. The most common species of concern in these areas were alligator weed (*Alternanthera philoxeroides*) and primrose (*Ludwigia spp.*). These two species made up the majority of plants in heavily infested areas. Common salvinia (*Salvinia minima*) was observed sheltered in a southeastern cove and in the cypress trees on the northern end of the lake. *Phragmites spp.* was observed in one small stand on the eastern end of the lake.

Much of the 2'-4' contour of the lake was occupied by light to medium densities of spikerush (*Eleocharis spp.*), pondweed (*Potamogeton spp.*), and stonewort (*Nitella spp.*). In the winter and spring of 2013, LDWF planted bulrush (*Schoenoplectus californicus*), white water lily (*Nymphaea odorata*), and tape grass (*Vallisneria americana*) throughout the lake. So far, bulrush survival has been high, water lilies were observed mostly in the northern and western portions of the lake with a few large stands present, and no surviving tape grass was observed.

Alligator weed is a substantial problem in the northeastern portion of the lake, and any spray efforts should be concentrated on these areas. Overall, much of the lake is problem-free in regards to nuisance plants.

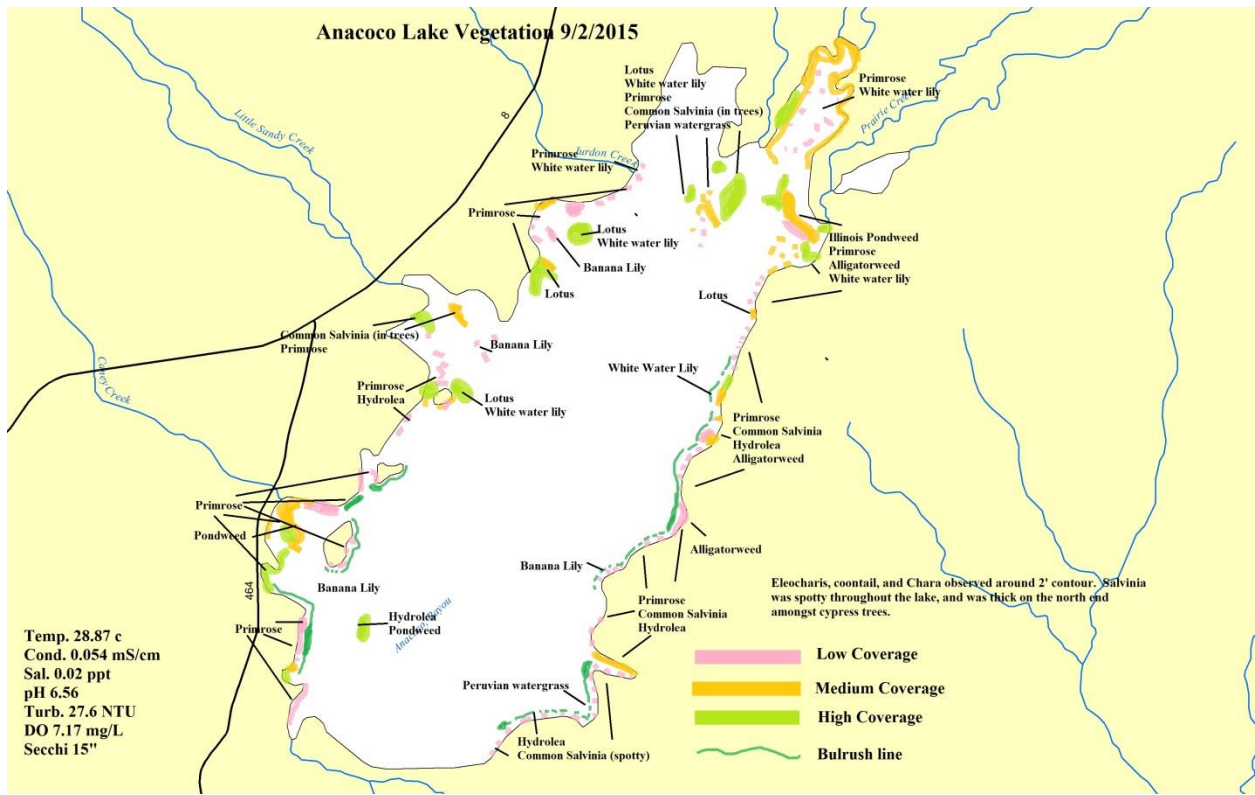
Anacoco Lake Vegetation 9/2/2015

Plant densities were designated as “Low,” “Medium,” and “High.” The heaviest densities of plants were in the northern portions of the lake, and most notably in the northeastern end, though earlier spray efforts have been effective in the areas that are perennial problems. The most common species of concern in these areas were alligator weed (*Alternanthera philoxeroides*) and primrose (*Ludwigia* spp.). These two species made up the majority of plants in heavily infested areas. Common salvinia (*Salvinia minima*) was observed sheltered in a southeastern cove and in the cypress trees on the northern end of the lake. *Phragmites* spp. was observed in one small stand on the eastern end of the lake.

Much of the 2'-4' contour of the lake was occupied by light to medium densities of spikerush (*Eleocharis* spp.), pondweed (*Potamogeton* spp.), coontail (*Ceratophyllum demersum*) and stonewort (*Nitella* spp.). In the winter and spring of 2013, LDWF planted bulrush (*Schoenoplectus californicus*), white water lily (*Nymphaea odorata*), and tape grass (*Vallisneria americana*) throughout the lake. So far, bulrush survival has been high, water lilies were observed mostly in the northern and western portions of the lake with a few large stands present, and no surviving tape grass was observed.

Alligator weed and primrose is a substantial problem in the northeastern portion of the lake, and any spray efforts should be concentrated on these areas. Overall, much of the lake is problem-free in regards to nuisance plants.

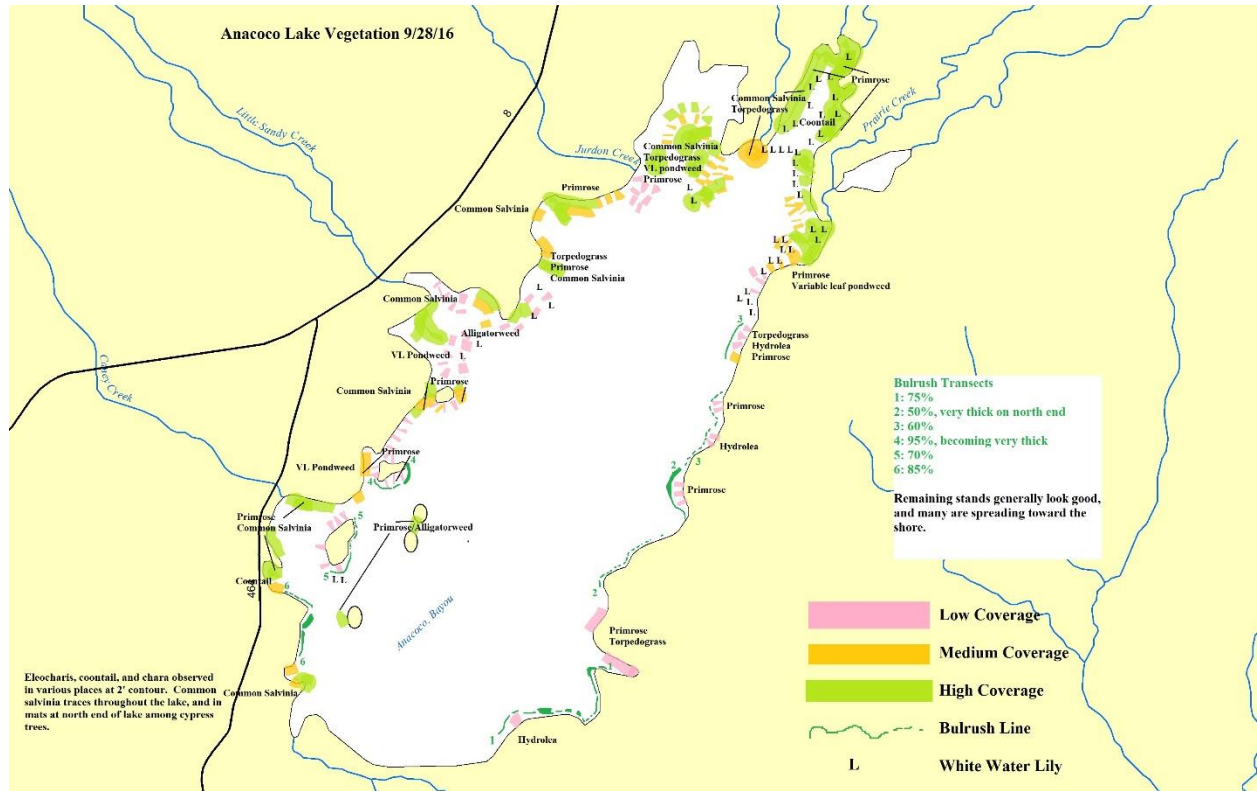
Anacoco Lake Vegetation 9/28/16

Plant densities were designated as “Low,” “Medium,” and “High.” The heaviest densities of plants were in the northern portions of the lake, and most notably in the northeastern end, though earlier spray efforts have been effective in the areas that are perennial problems. The most common species of concern in these areas were alligator weed (*Alternanthera philoxeroides*) and primrose (*Ludwigia sp.*). These two species made up the majority of plants in heavily infested areas. Common salvinia (*Salvinia minima*) was observed sheltered in a southeastern cove and in the cypress trees on the northern and western ends of the lake.

Much of the 2'-4' contour of the lake was occupied by light to medium densities of spikerush (*Eleocharis sp.*), pondweed (*Potamogeton sp.*), coontail (*Ceratophyllum demersum*) and stonewort (*Nitella sp.*). In the winter and spring of 2013, LDWF planted bulrush (*Schoenoplectus californicus*), white water lily (*Nymphaea odorata*), and tape grass (*Vallisneria americana*) throughout the lake. So far, bulrush survival has been high, water lilies were observed mostly in the northern and western portions of the lake with a few large stands present, and no surviving tape grass was observed.

Alligatorweed and primrose is a substantial problem in the northeastern portion of the lake, and any spray efforts should be concentrated on these areas. Common salvinia is a constant problem in cypress swamps and is being addressed with spray efforts. Overall, much of the lake is problem-free in regards to nuisance plants.

Eleocharis, coontail, and chara observed in various places at 2' contour. Common salvinia traces throughout the lake, and in mats at north end of lake among cypress trees.

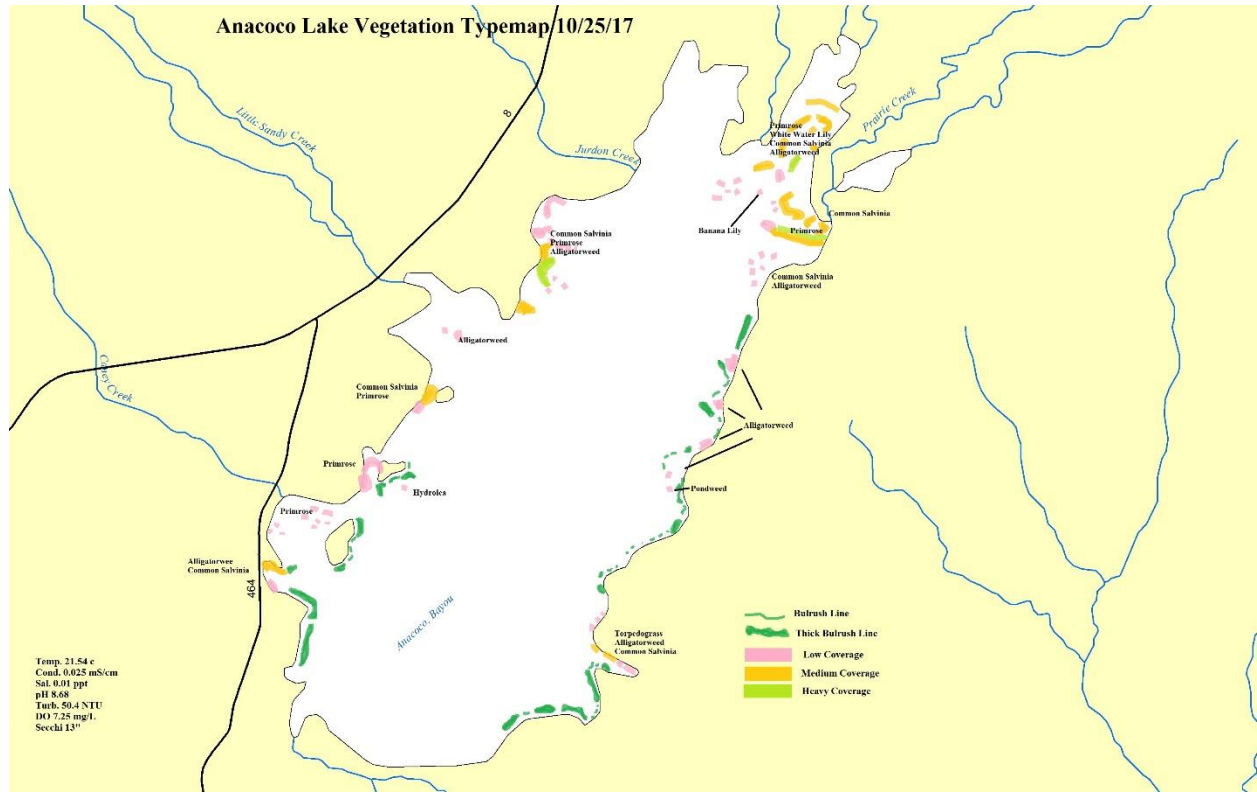
Anacoco Lake Vegetation Typemap/10/25/17

Plant densities were designated as “Low,” “Medium,” and “High.” The heaviest densities of plants were in the northern portions of the lake, and most notably in the northeastern end, though earlier spray efforts have been effective in the areas that are perennial problems. The most common species of concern in these areas were alligator weed (*Alternanthera philoxeroides*) and primrose (*Ludwigia sp.*). These two species made up the majority of plants in more infested areas. Common salvinia (*Salvinia minima*) was observed scattered in low densities, windblown throughout the lake and amongst other vegetation.

Some of the 2’-4’ contour of the lake was occupied by light densities of spikerush (*Eleocharis sp.*), pondweed (*Potamogeton sp.*), coontail (*Ceratophyllum demersum*) and stonewort (*Nitella sp.*). In the winter and spring of 2013, LDWF planted bulrush (*Schoenoplectus californicus*), white water lily (*Nymphaea odorata*), and tape grass (*Vallisneria americana*) throughout the lake. So far, bulrush survival has been high with expansion from existing stands, but there has been no dispersal by seed noted. Water lilies have been observed mostly in the northern and western portions of the lake with a few large stands present, but were rarely seen this year. No surviving tape grass has been observed.

Densities of aquatic weeds were the lowest observed in recent years. There were very few areas of “high” density, and much of the lake was devoid of vegetation. This is most likely due to combined spray efforts and multiple high-water events this year. Very few white water lilies were observed, most likely due to the high water, too. The only observed increases in aquatic vegetation were in the stands of bulrush, where they are expanding noticeably. Overall, Anacoco Lake has very few aquatic weed issues at the time of the survey.

Temp. 21.54 c
 Cond. 0.025 mS/cm
 Sal. 0.01 ppt
 pH 8.68
 Turb. 50.4 NTU
 DO 7.25 mg/l
 Secchi 13"

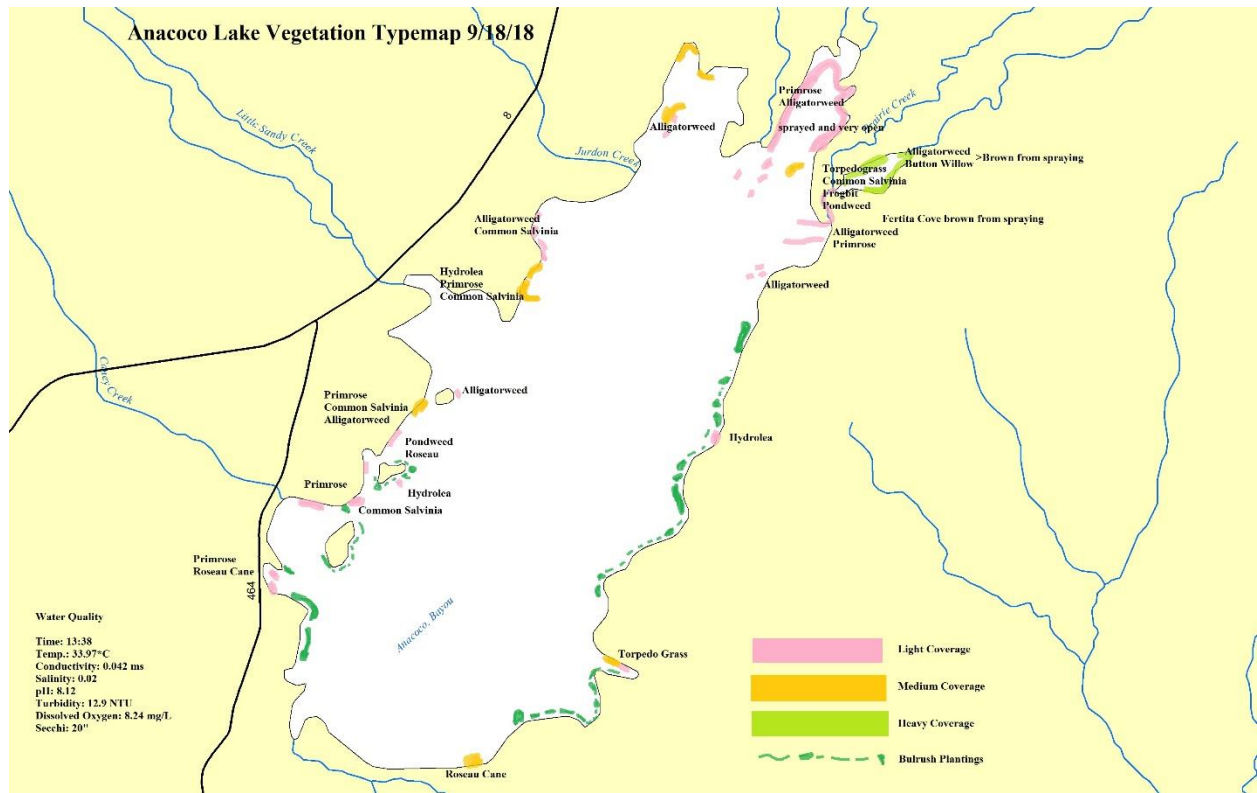
Anacoco Lake Vegetation Typemap 9/18/18

Plant densities were designated as “Low,” “Medium,” and “High.” The heaviest densities of plants were in the northern portions of the lake, and most notably in the northeastern end, though earlier spray efforts have been effective in the areas that are perennial problems. The most common species of concern in these areas were alligator weed (*Alternanthera philoxeroides*) and primrose (*Ludwigia sp.*). These two species made up the majority of plants in more infested areas. Common salvinia (*Salvinia minima*) was observed scattered in low densities. Sources of Salvinia are in the cypress trees in the northern portions of the lake, but densities are currently relatively low in those areas.

Some of the 2'-4' contour of the lake was occupied by light densities of spikerush (*Eleocharis sp.*), pondweed (*Potamogeton sp.*), coontail (*Ceratophyllum demersum*) and stonewort (*Nitella sp.*). In the winter and spring of 2013, LDWF planted bulrush (*Schoenoplectus californicus*), white water lily (*Nymphaea odorata*), and tape grass (*Vallisneria americana*) throughout the lake. So far, bulrush survival has been high with expansion from existing stands, but there has been no dispersal by seed noted. White water lilies have been observed in the past mostly in the northern and western portions of the lake with a few large stands present, but not seen at all this year. No surviving tape grass has been observed.

Densities of aquatic weeds were even lower than the previous year's survey, and are the lowest in many years. There were very few areas of “high” density, and much of the lake was devoid of problem vegetation. This is most likely due to combined spray efforts and multiple high-water events of last year, followed by an extremely hard winter. Stands of bulrush were affected by the freeze, but no significant losses were observed. Water clarity is improved over last year. Overall, Anacoco Lake has very few aquatic weed issues at the time of the survey.
