# LOUISIANA DEPARTMENT OF WILDLIFE & FISHERIES

WATERBODY MANAGEMENT PLAN SERIES

**BUNDICK LAKE**

AQUATIC VEGETATION TYPE MAPS  
AND NARRATIVES

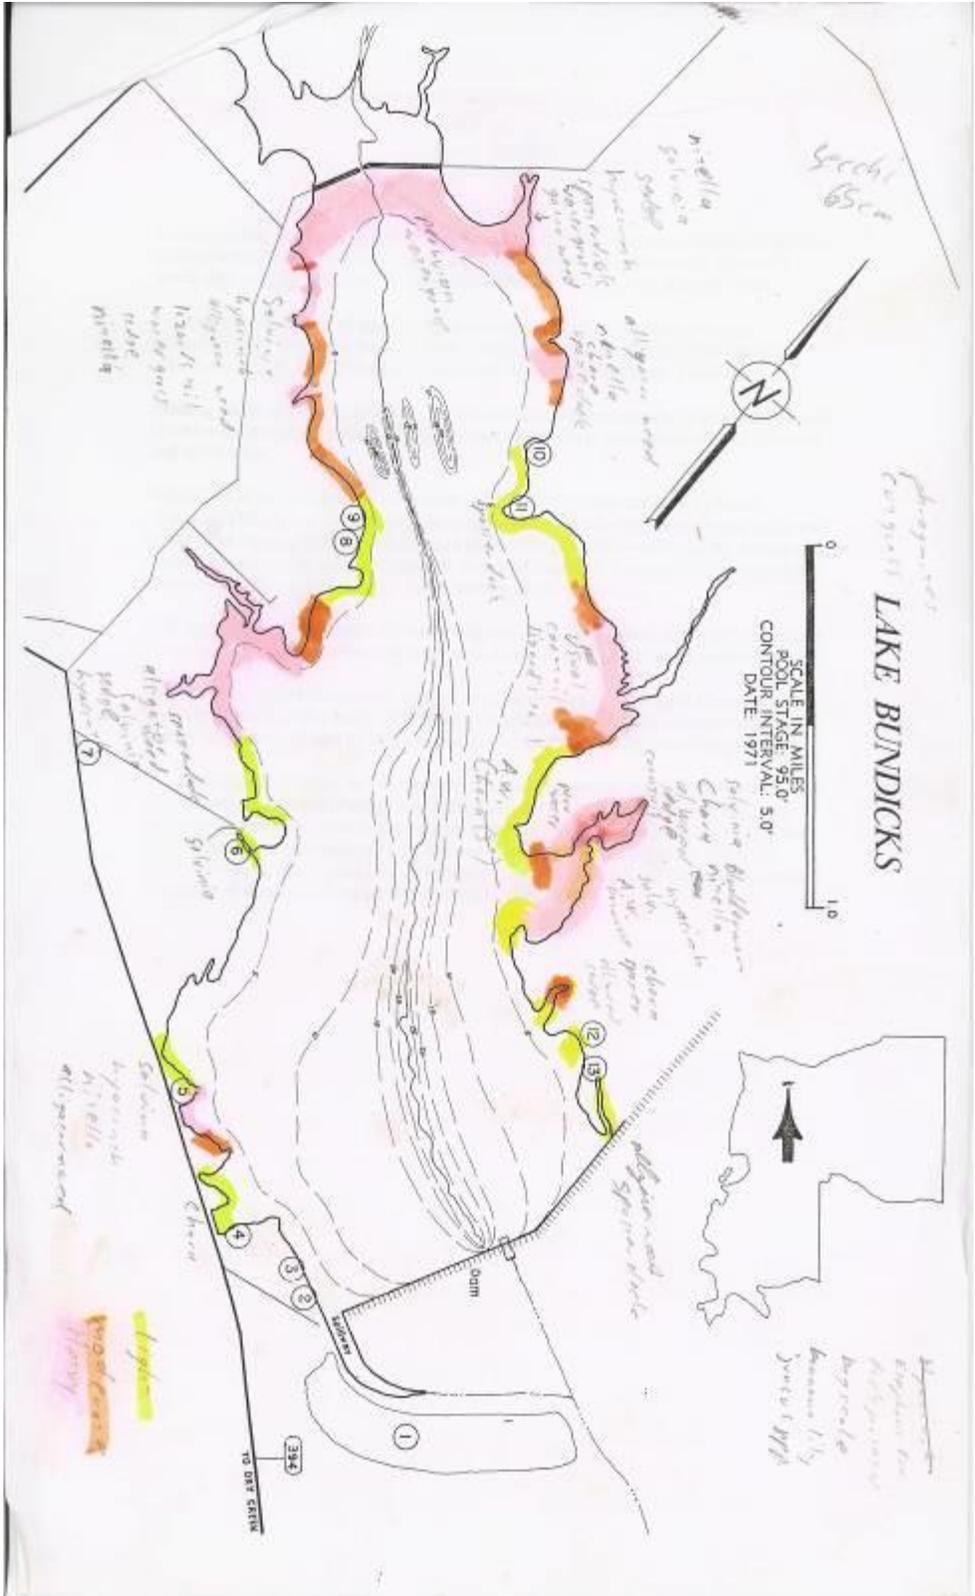
Bundick Lake, in Beauregard Parish, was surveyed for the presence of aquatic vegetation on September 25, 2007. On the day of the survey the water was relatively clear with secchi disk reading of 65 cm. Water levels in the lake were at pool stage (95' MSL).

The heaviest infestation of aquatic vegetation was alligatorweed (*Alternanthera philoxeroides*). This plant was observed in light amounts along most of the shoreline with heavy infestations in shallow coves, especially on the north end of the lake.

Floating plants observed included common salvinia (*Salvinia minima*) and water hyacinth (*Eichhornia crassipes*) present in light to heavy amounts in some coves and on the north end of the lake.

Submersed aquatic plants that were observed on the Bundick Lake survey in light to heavy amounts included stonewort (*Nitella spp.*) and muskgrass (*Chara spp.*). These plants were found in the two to four foot contour with some heavy infestations in the shallow coves on the northern and eastern end of the lake. Moderate to heavy infestations of coontail (*Ceratophyllum demersum*) were present in coves on the eastern shore of the lake.

Spatterdock (*Nuphar luteum*) and water sedge (*Cyperus spp.*) were observed along much of the shoreline, and moderate amounts were found in most of the coves around the lake.

Peruvian water grass (*Luziola peruviana*) was still present in the Baptist Cove along the east side of the lake in a heavy infestation. Of particular note, light amounts were also observed on the north end of the lake, present for the first time outside of Baptist cove.

Other plants observed in trace to light amounts were maidencane (*Panicum hemitomon*), smartweed (*Polygonum hydropiperoides*), duck potato (*Sagittaria spp.*), bagscale (*Sacciolepis striata*), giant cutgrass (*Zizaniopsis miliacea*), elephant ear (*Taro spp.*), lizard's tail (*Saururus cernus*), banana lily (*Nymphoides aquatica*), spikerush (*Eliocharis spp.*), water grass (*Luziola fluitans*), and common reed (*Phragmites australis*) with most of these occurring on the north end of the lake.

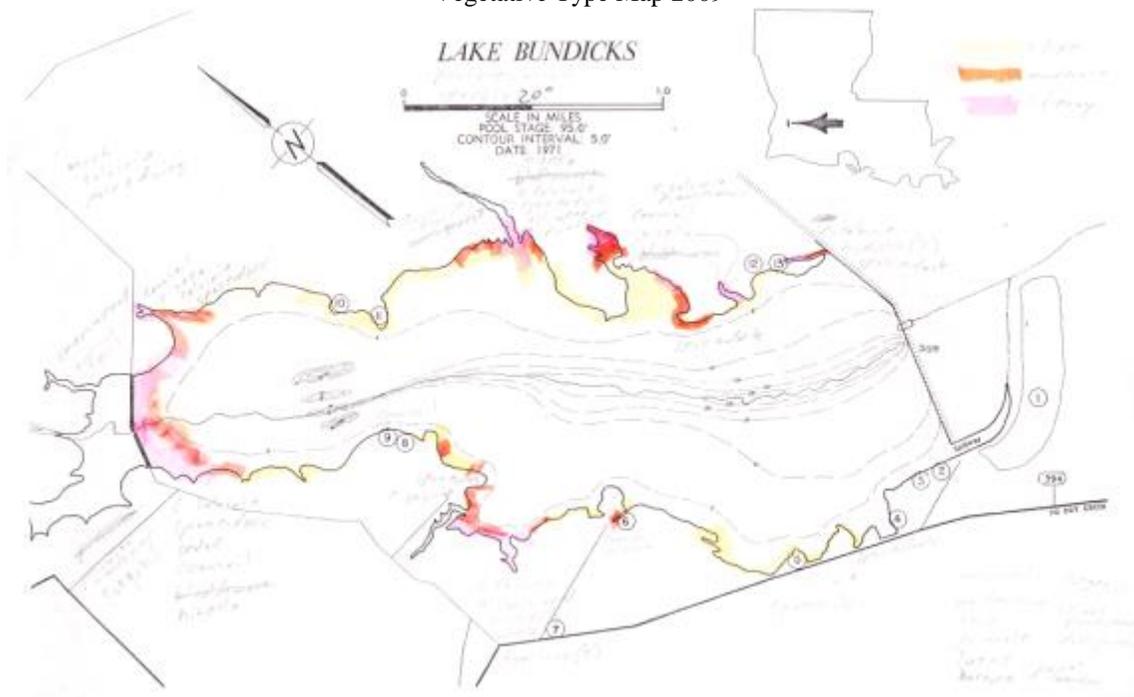
## Vegetative Type Map 2009

The most common aquatic vegetation observed were common salvinia (*Salvinia minima*) and spatterdock (*Nuphar luteum*). Heavy infestations of salvinia occurred on the north end of the lake with light to moderate infestations on the western shoreline. Much of the salvinia in the Hopewell bridge area appeared to be dying from district spray efforts. Spatterdock was present in light amounts around most of the lake with moderate to heavy amounts on the northern part of the lake.

Stonewort (*Nitella spp.*) and coontail (*Ceratophyllum demersum*) were the predominant submersed aquatic plants observed. Stonewort was present in light to moderate amounts in the 2' to 3' contour with some heavy accumulations on the northern and eastern shores of the lake. Light to moderate amounts of coontail were present along the 2' to 5' contour except for the southwestern quarter of the lake.

Emerald plants alligatorweed (*Alternanthera philoxeroides*) and American cupscale grass (*Sacciolepis striata*) were present in light amounts with one heavy infestation of each on opposite shores of the lake and some heavy infestations of cupscale grass in the northern section. Efforts to control Peruvian water grass (*Luziola peruviana*) and alligatorweed continued to be successful as we observed continuing reductions of both from last year.

Other plants observed in trace to light aggregations were maidencane (*Panicum hemitomon*), water sedge (*Cyperus spp.*), smartweed (*Polygonum hydropiperoides*), duck potato (*Sagittaria spp.*), giant cutgrass (*Zizaniopsis miliacea*), southern cutgrass (*Leersia spp.*), elephant ear (*Taro spp.*), primrose (*Ludwigia spp.*), American lotus (*Nelumbo lutea*), bacopa (*Bacopa spp.*), Illinois pondweed (*Potamogeton illinoensis*), parrot feather (*Myriophyllum aquaticum*), hydrilla (*Hydrilla verticillata*), banana lily (*Nymphoides aquatica*), and water hyacinth (*Eichhornia crassipes*), with most of these occurring on the northern half of the lake.

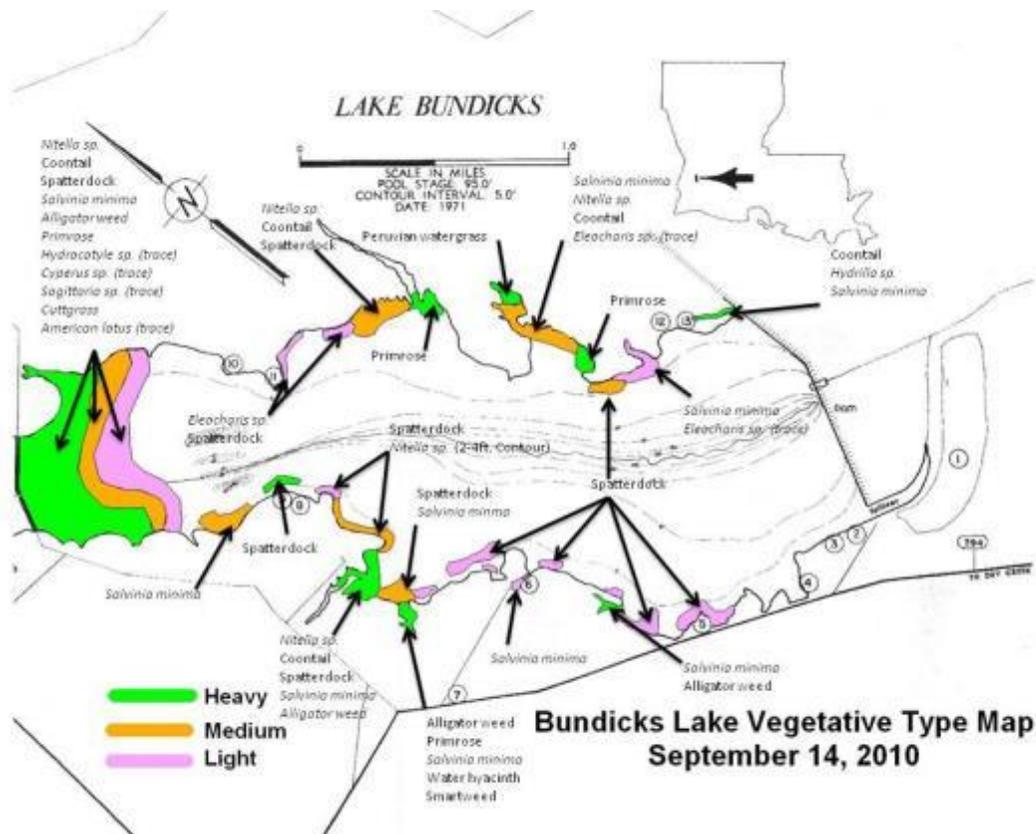
Areas of observed occurrence were designated as "Heavy", "Medium", or "Light". The most common aquatic vegetations observed were primrose (*Ludwigia spp.*), common salvinia (*Salvinia minima*), and spatterdock (*Nuphar luteum*). Heavy infestations of aquatic vegetation occurred on the north end of the lake and several bays and covers around the perimeter. Predominant species associated with these areas were common salvinia, spatterdock, alligatorweed (*Alternanthera philoxeroides*), and coontail (*Ceratophyllum demersum*).

A heavy infestation of aquatic vegetation was observed in a small canal near the north end of the dam. This area contained moderate amounts of coontail, common salvinia, duckweed (*Lemna. sp.*), and hydrilla (*Hydrilla verticillata*). The hydrilla appears to be confined to this small area, far it was observed in no other location.

Submerged aquatic vegetation (SAV) most commonly observed were stonewort (*Nitella spp.*) and coontail (*Ceratophyllum demersum*). Occurrences were generally regarded as medium to light at the 2-4ft contours. Spikerush (*Eliocharis spp.*) was also found in light to trace amounts in several locations around the lake.

Other species of aquatic plants found in light to trace amounts include water pennywort (*Hydrocotyle spp.*), giant cutgrass (*Zizaniopsis miliacea*), American lotus (*Nelumbo lutea*), duck potato (*Sagittaria spp.*), water sedge (*Cyperus spp.*), and smartweed (*Polygonum hydropiperoides*).

Peruvian water grass (*Luziola peruviana*) continues to be found in high concentrations near the Baptist Cove area; however the spray efforts by District 5 spray crew have reduced the affected area to only about 10 acres or less. Efforts will continue to treat this area to prevent expansion.

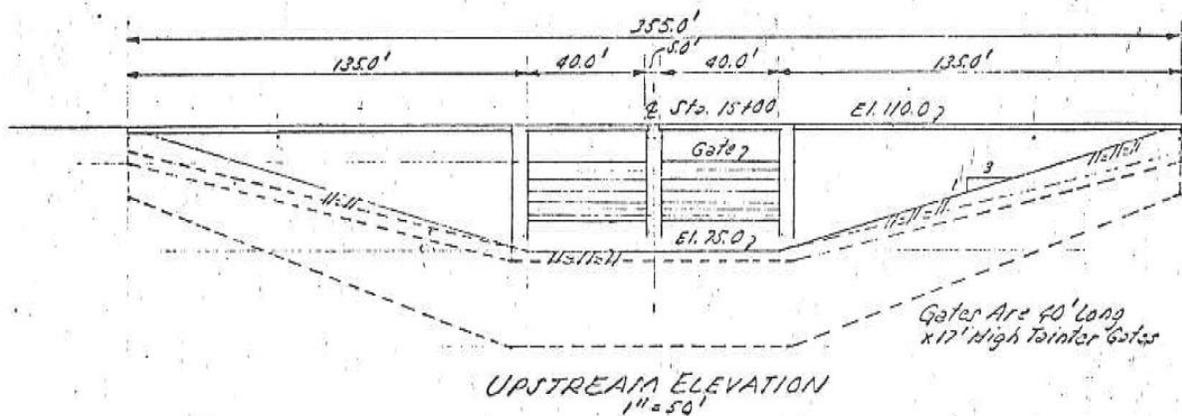
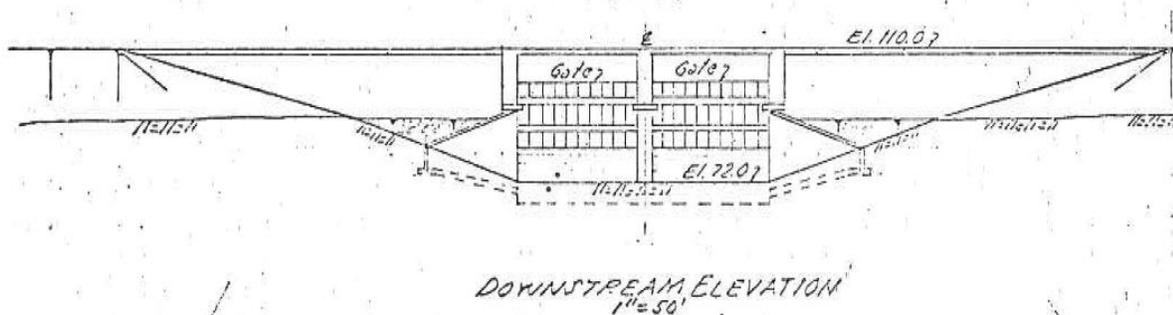
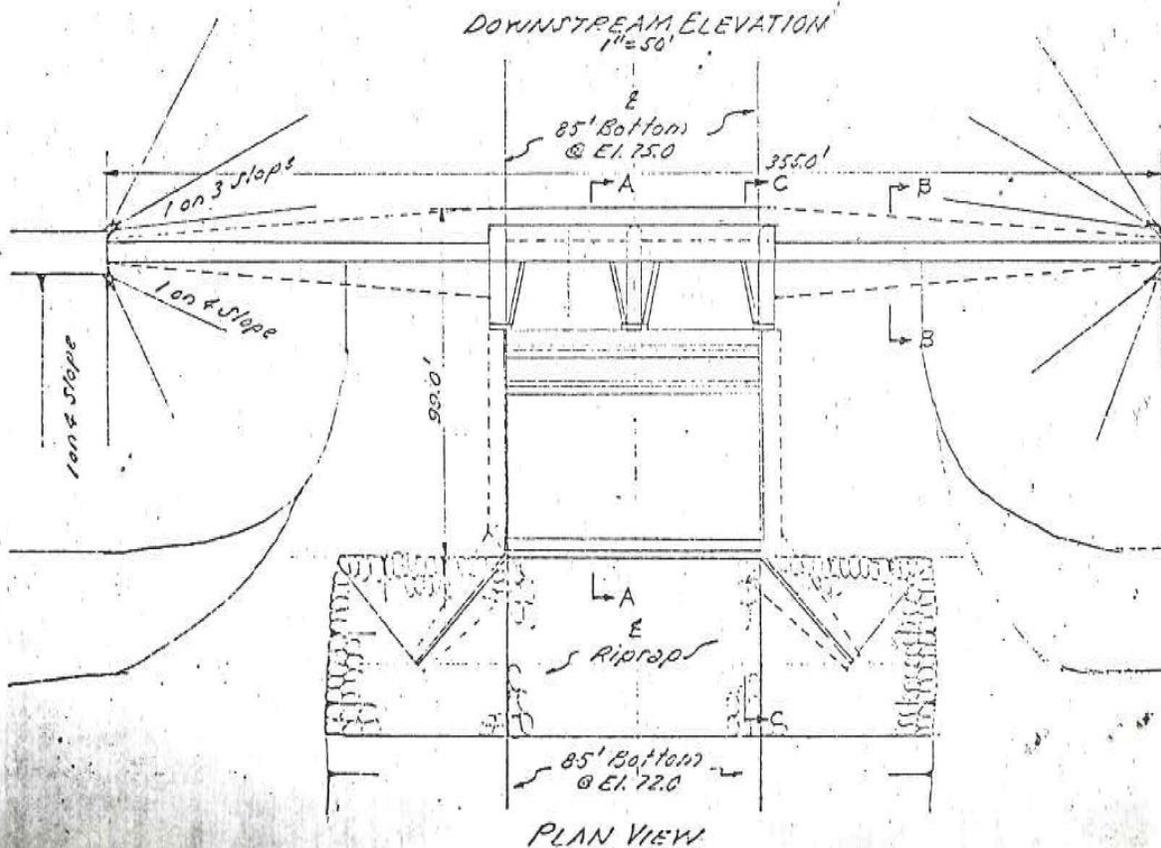
Sketches

PARISH <i>Beauregard</i>	COMPUTED BY <i>Sexton</i>	DATE <i>11-28-66</i>
SUBJECT <i>Bundicks Lake Gated Spillway</i>	CHECKED BY	DATE

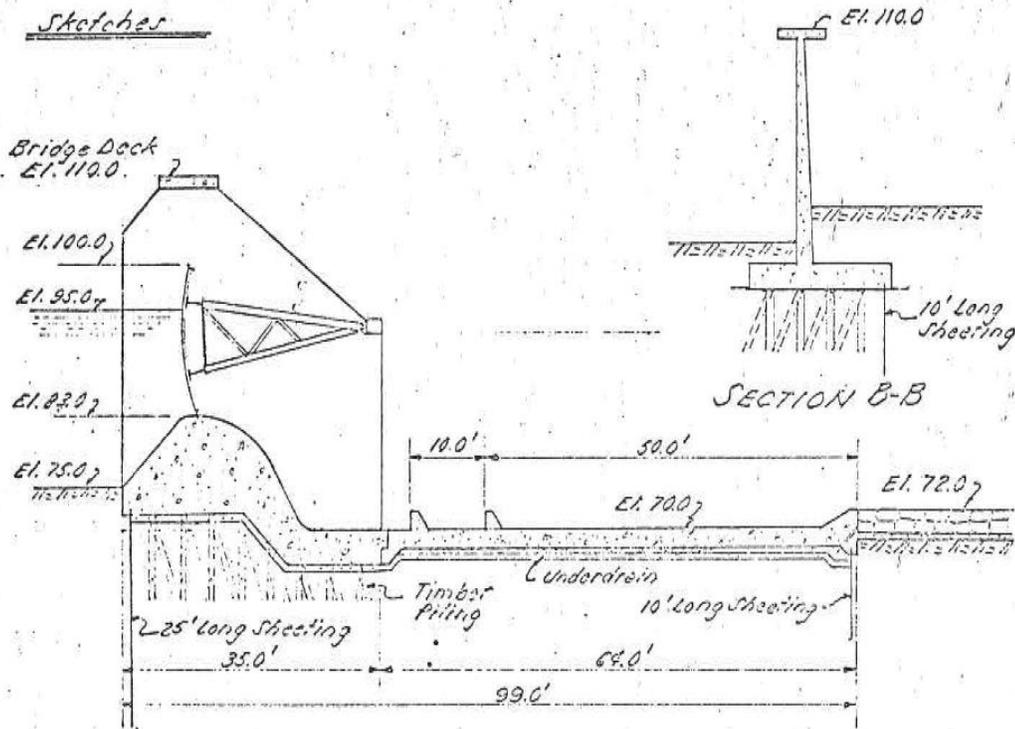
SECTION A-A  
1" = 20'

PARISH <i>Beauregard</i>	COMPUTED BY <i>Sexton</i>	DATE <i>12-1-66</i>
SUBJECT <i>Bundicks Lake Gated Spillway</i>	CHECKED BY	DATE
