# **LOUISIANA DEPARTMENT OF WILDLIFE & FISHERIES**

**PART VI -A**

**HENDERSON LAKE**

**LAKE HISTORY & MANAGEMENT ISSUES**

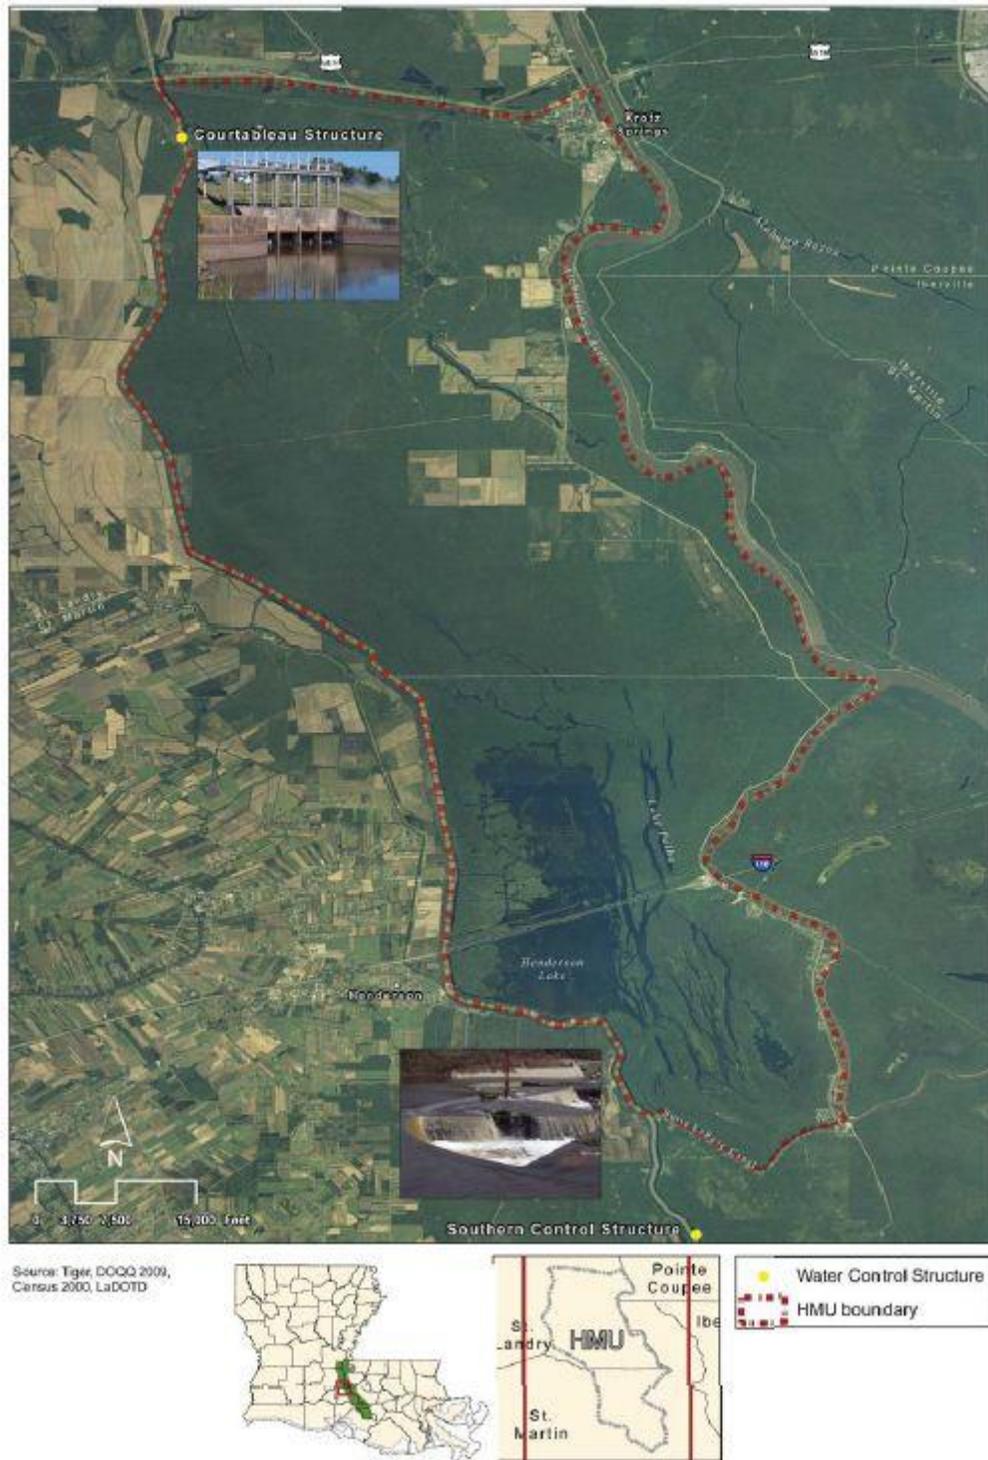
Figure 1. Location of water control structures within Henderson Lake, LA.

The southern control structure is located in St. Martin Parish, south of Henderson Lake in the borrow canal adjacent to the West Atchafalaya Basin Protection Levee (WABPL). The drawdown structure is a gated system that can be opened to allow ingress and egress of boat traffic and can be used to dewater the lake (See map of structure locations, Figure 1).

At the northern end of Henderson Lake, the Courtableau control structure is owned and operated by the USACE. It is located approximately one mile south of U. S. Highway 190 between Port Barre and Krotz Springs. The structure is made up of two features. A diversion control structure completed in 1942 consisting of two weirs with crests set at 18 feet National Geodetic Vertical Datum (NGVD) that puts water in the borrow canal located on the landside of the WABPL. This diversion is also used to maintain low flows in Bayou Teche and the Vermilion River for rice irrigation and water quality control. In addition, there is a drainage structure, the Bayou Courtableau Control Structure, in the WABPL that diverts landside flood waters into the northern end of Henderson Lake. This structure, consisting of five reinforced concrete box culverts measuring 10 ft. by 15 ft. by 234 ft. deep, was built by the USACE in 1956. This is one of only two structures that provide entry points for water into the Henderson Lake area other than precipitation. When the Atchafalaya River rises, its backwaters flow northward through the southern control structure, which is the other point of entry into the lake. Water entering through the southern structure also has to exit through that same structure. Water flowing into Henderson Lake from the Courtableau Structure is

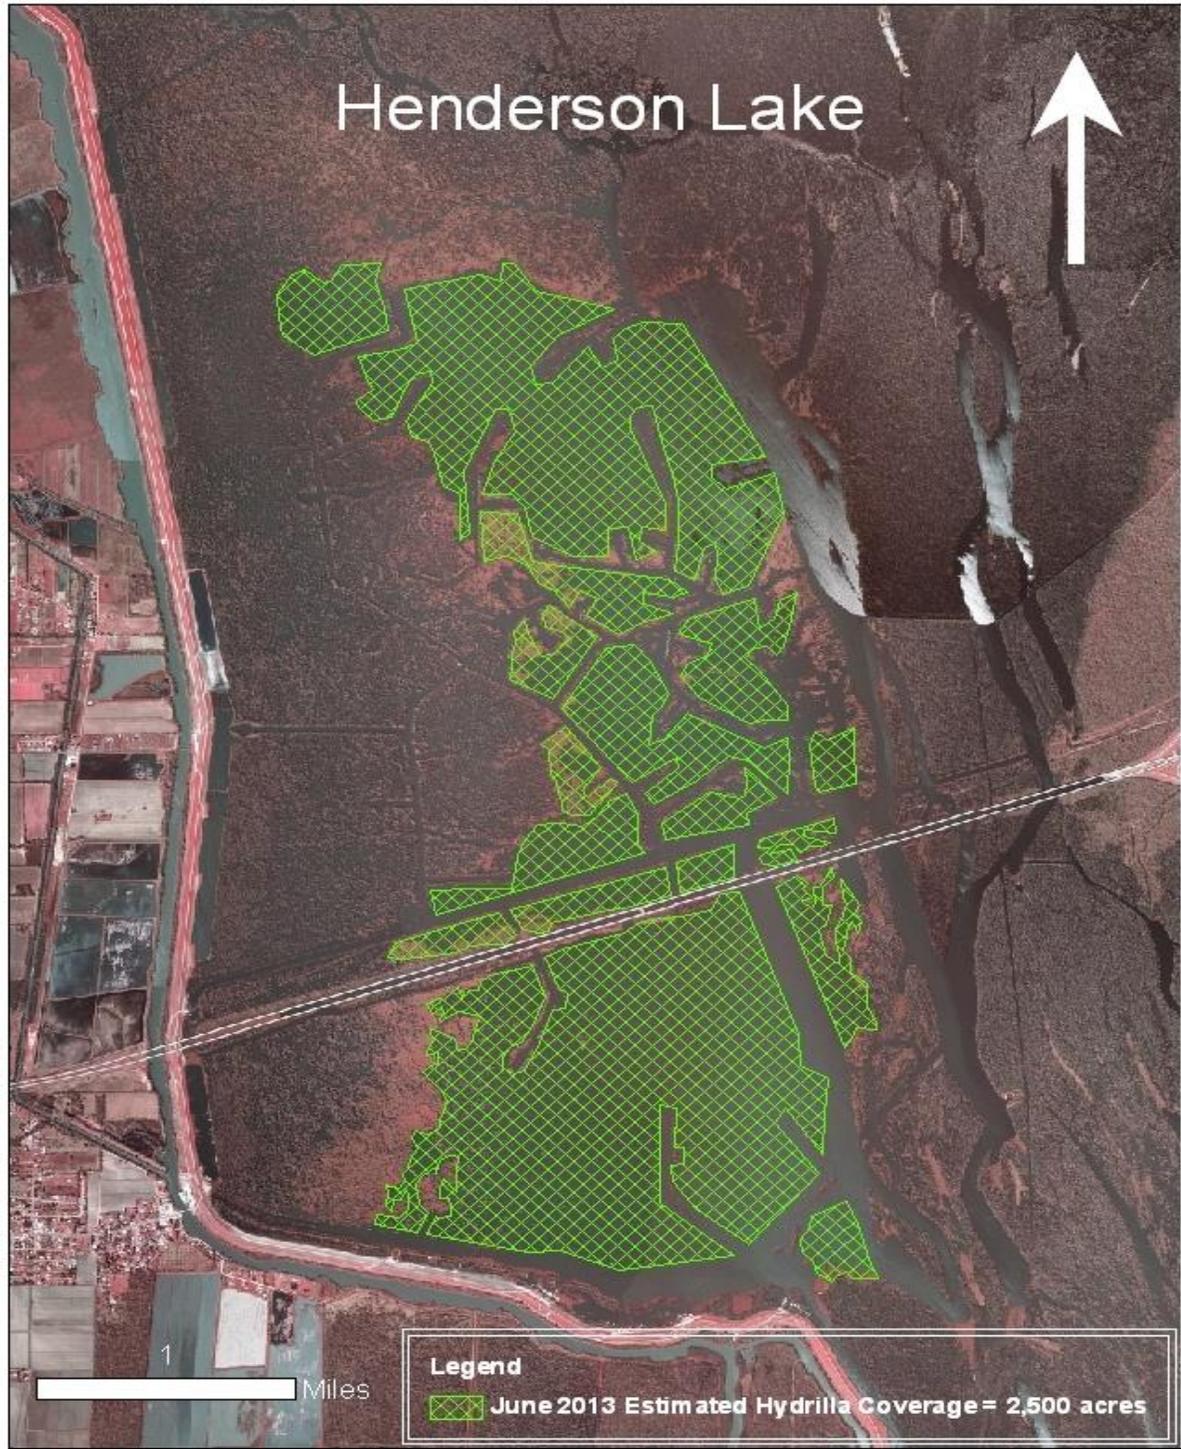
Figure 1. Henderson Lake hydrilla coverage as of June, 2013

There is an ongoing concern with the infestation of the aquatic plants, hydrilla (*Hydrilla verticillata*) and water hyacinth (*Eichhornia crassipes*). Annual requests are received from fishermen, hunters, camp owners, and boat launch operators to clear floating plants (mainly water hyacinth) for boating access. Many requests come from owners of private pay-to-launch boat ramps and tourism businesses. Unfortunately, immediate relief is expected when vegetation is treated. However, the chemical used to control water hyacinth is a systemic herbicide and can take more than a few days to several weeks to completely kill the plants depending on the air temperature. Private boat landings as well as the public launch at the I-10 Butte La Rose Welcome Center are often cleared of water hyacinth only to have rafts of new plants block the ramps after changes in wind direction or water levels. Presently, there is approximately 50% coverage of hydrilla in Henderson Lake (Figure 1).

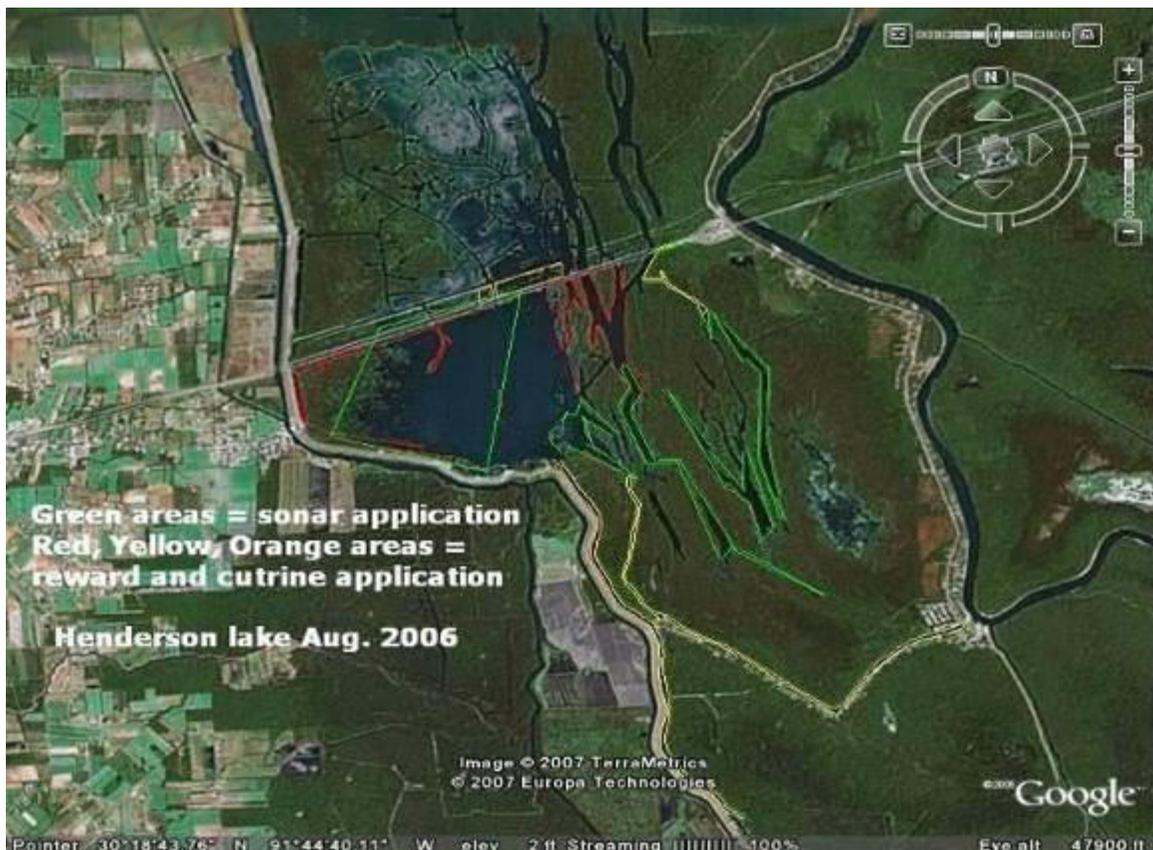
Henderson Lake, St. Martin parish, recently (8/28/06) was treated using SONAR to control the heavy infestation of Hydrilla south of interstate 10. Water levels in the lake were lowered two feet below pool stage to allow for adequate control; pool stage is 9.0 ft. (MSL).
