LOUISIANA DEPARTMENT OF WILDLIFE & FISHERIES

WATERBODY MANAGEMENT PLAN SERIES

RODEMACHER LAKE

LAKE HISTORY & MANAGEMENT ISSUES

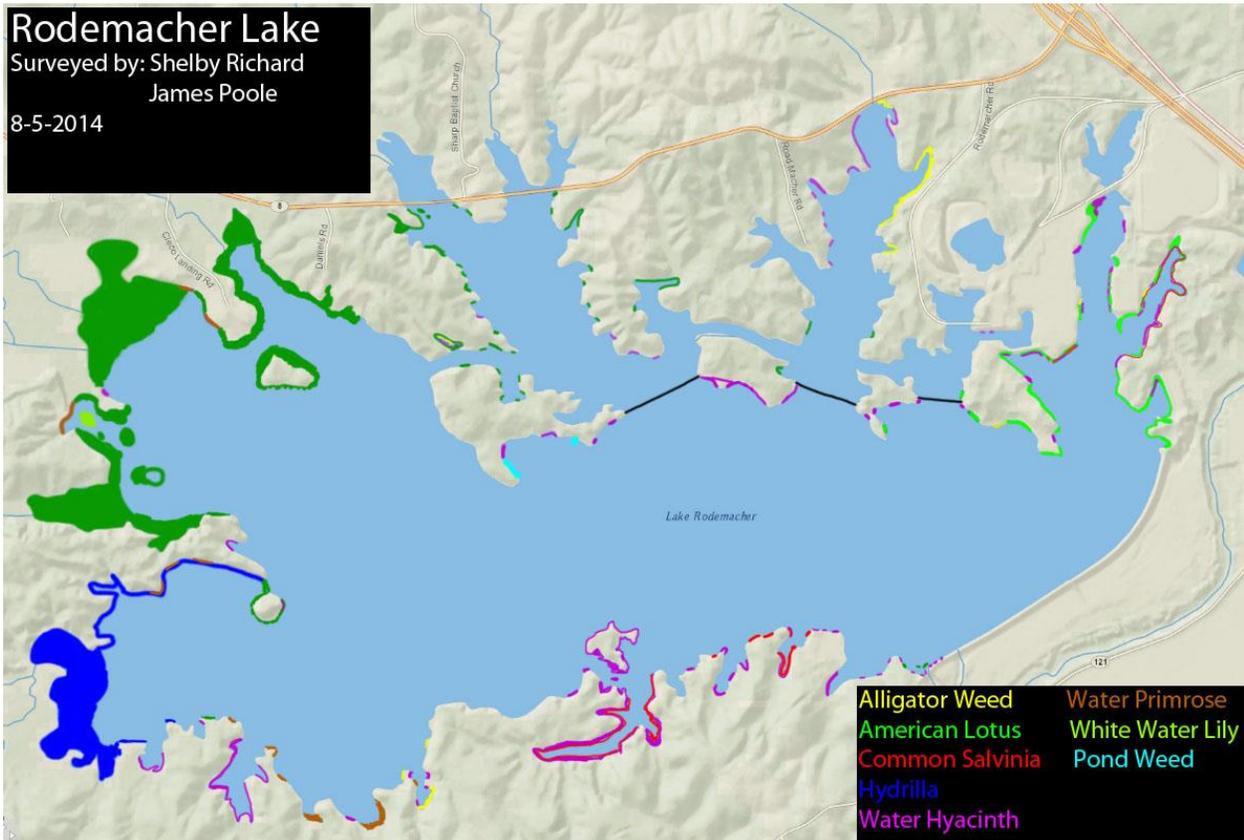
Appendix II
([return to Typemap](#))

Vegetation survey for Rodemacher Lake, Rapides Parish, Louisiana

Aquatic vegetation surveys have been conducted sporadically by LDWF personnel since 2000 due to a lack of vegetation, and lake surveys are also conducted quarterly by the CLECO environmental specialist. No significant vegetation problems have been documented since the late 1990's. The most current vegetative survey was conducted in August of 2014. A minimal amount of emergent and floating vegetation was observed. The type map can be viewed in [Appendix II](#).
