LOUISIANA DEPARTMENT OF WILDLIFE AND FISHERIES

**AQUATIC VEGETATION MANAGEMENT PLAN
2018**

HORSESHOE LAKE – MER ROUGE

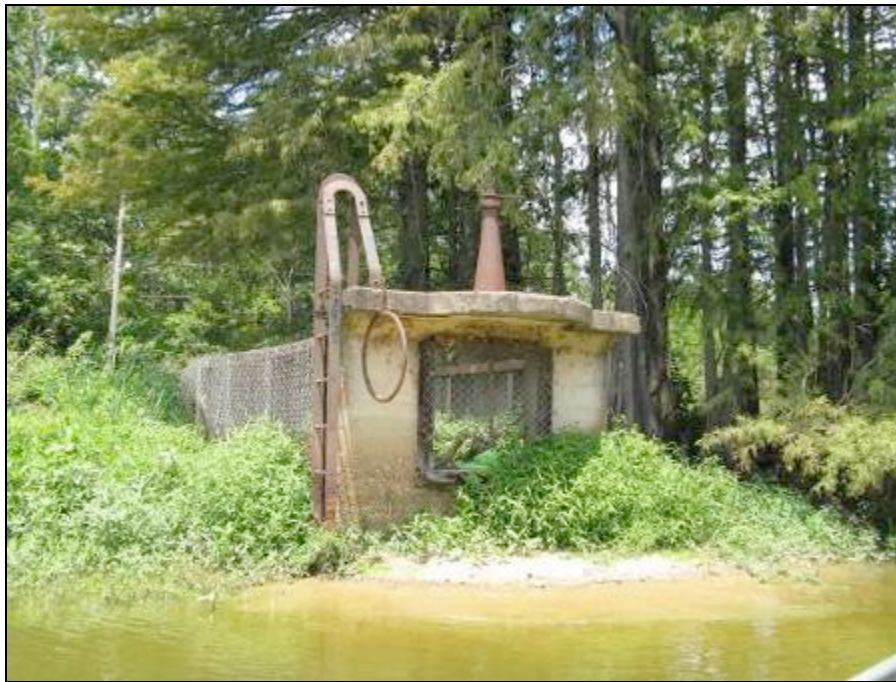
1. Waterbody type – Inactive oxbow lake formed by impoundment from Bayou Bonne Idee. The levee construction forming the current lake was completed in 1947.
2. Age and condition of control structure – Constructed in 1947, inoperable; the structure needs to be replaced.
3. Type of control structure – 3 ft x 3 ft concrete drop box with manually operated slide gate (size unknown) (Figure 1).

Figure 1. Horseshoe Lake control structure at 2.5 ft. below pool stage.

In 1993, the Lake Commission proposed a drawdown of the lake for repair of the leaking water control structure. The lake had reached levels over 2 ft. below pool stage. Lakeside residents expressed opposition to the drawdown and the effort was abandoned. The structure has remained inoperable.
