LOUISIANA DEPARTMENT OF WILDLIFE AND FISHERIES

**OFFICE OF FISHERIES
INLAND FISHERIES SECTION**

2018 AQUATIC VEGETATION MANAGEMENT PLAN

SPANISH LAKE

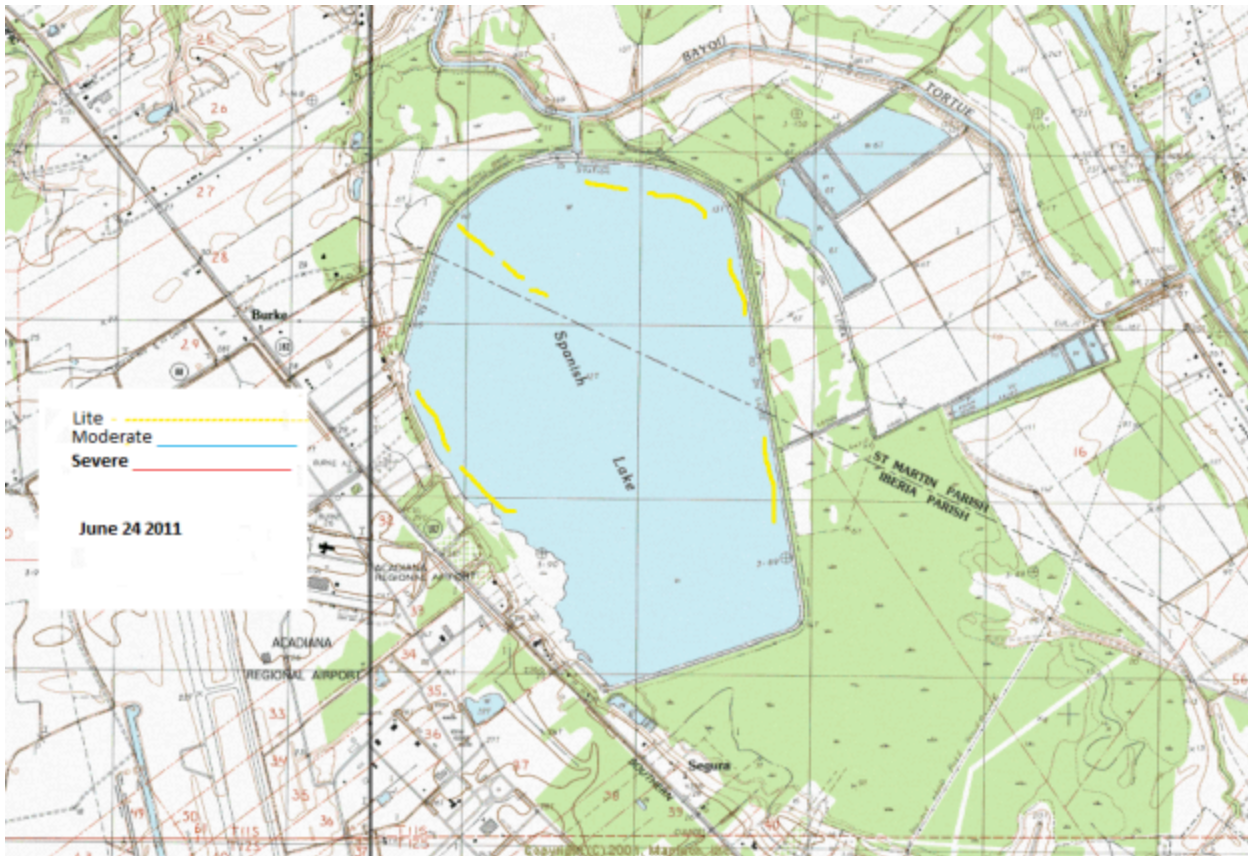
Spanish Lake Vegetation Survey 6-24-2011 - Martin Plonsky

A survey of aquatic vegetation found in Spanish Lake resulted in the conclusion that there is little to no aquatic vegetation in the lake. Very thin amounts of water hyacinth were observed in the vicinity of the boat launch and on the shoreline of the breakwater islands on the eastern side of the lake. The lake water was saturated (“bloom” condition) with planktonic algae and water ph was above 8.0. Small bunches of iris were seen growing along the eastern bank of the lake. Average water depth was 2 feet. The vegetation survey was conducted on the same day we investigated the report of a fish kill at the lake. No dead fish were observed.
